## **Appendix I Waterway Assessments**

## Waterway and Wetland Assessment:

**Table 3 Waterways Assessments**

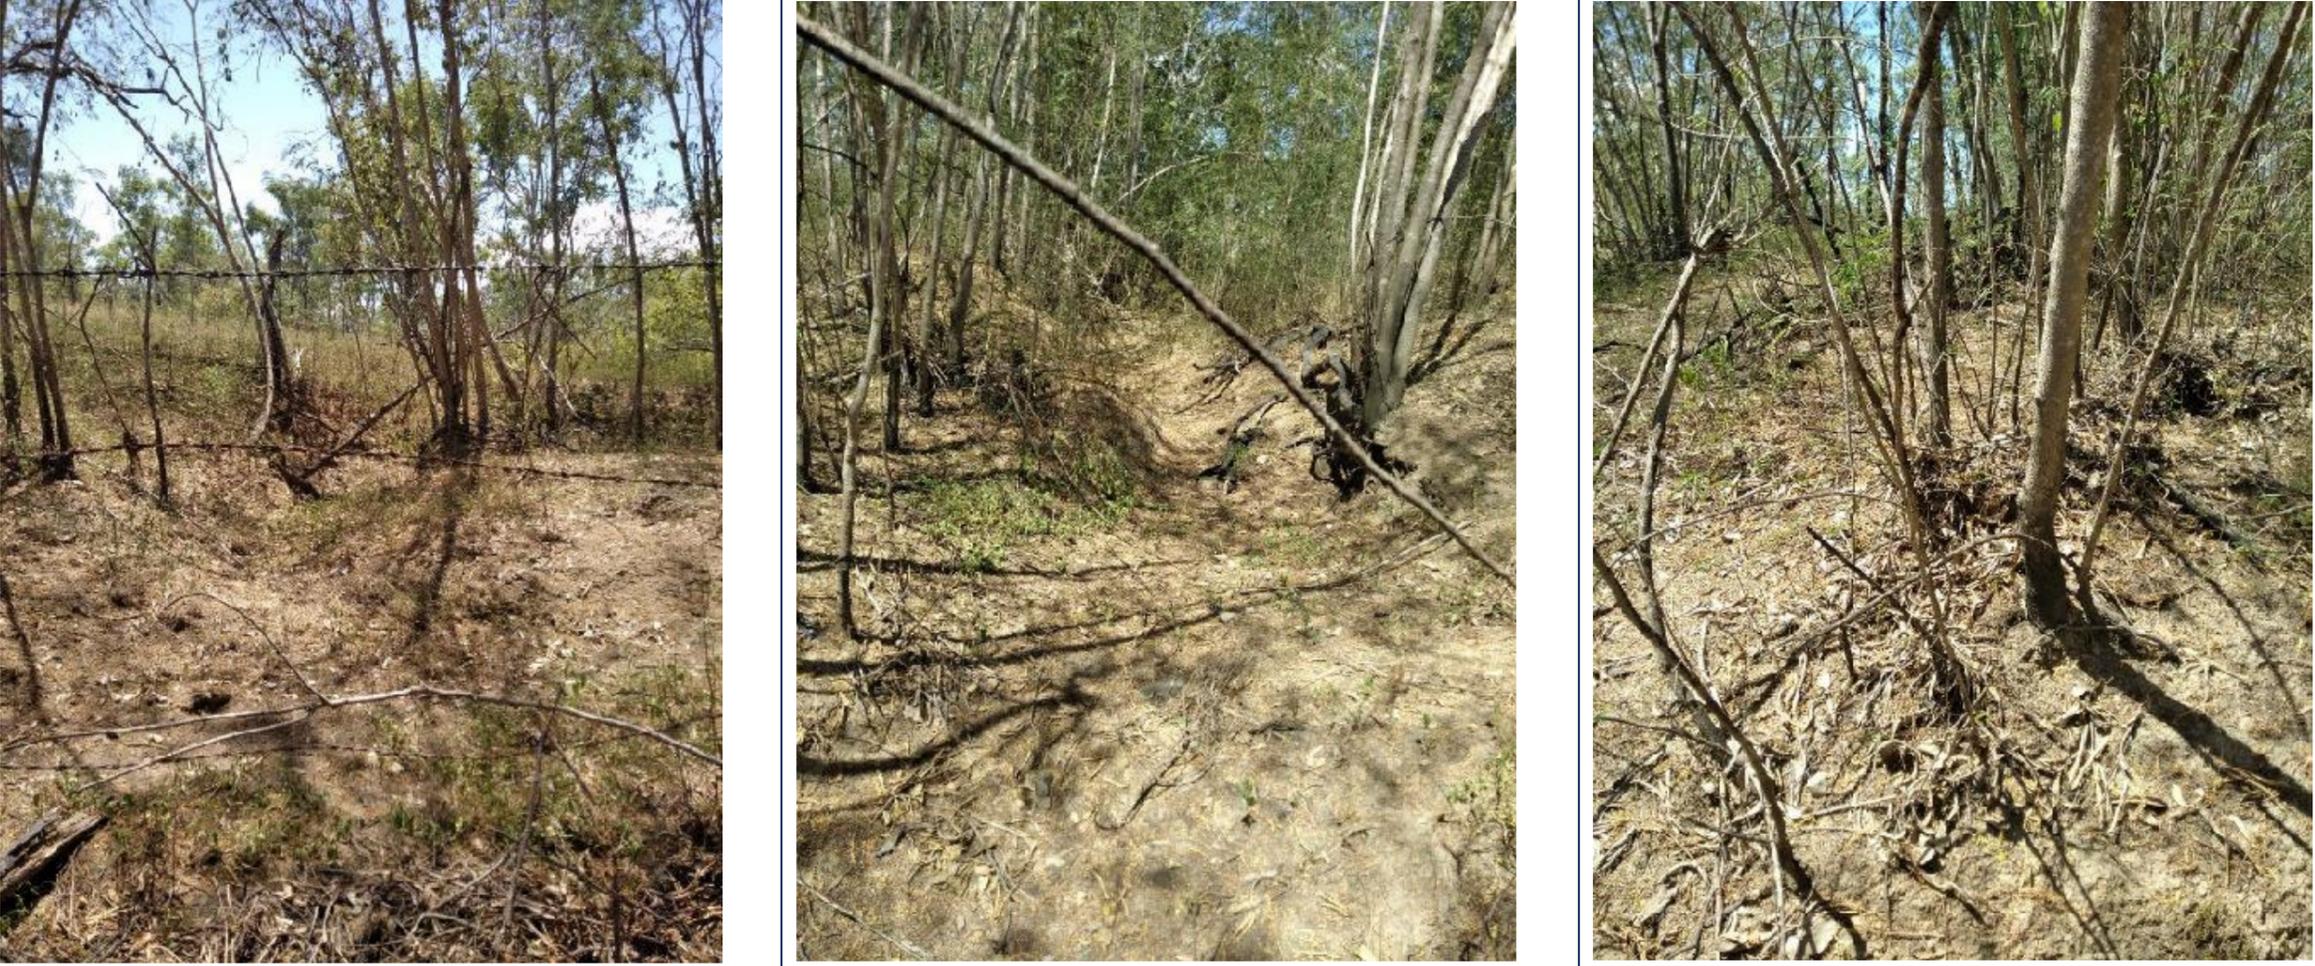
WW3	146.828003	-19.618186	Unmapped	<p><u>Bed and banks:</u></p> <ul style="list-style-type: none"> <li>- Top of bank to top of bank of bank is estimated to be 8m. Waterway has been dissected by Ghost Gum Road. Any flows would have to sheet flow over the unformed road. Defined bed and bank features are present either side of the road.</li> </ul> <p><u>Period of flow:</u></p> <ul style="list-style-type: none"> <li>- Pooled water would suggest that extended periods of flow would occur at this site.</li> </ul> <p><u>Flow adequacy:</u></p> <ul style="list-style-type: none"> <li>- Potentially – pooled water would suggest that flow adequacy would exist. However, with the damming of the waterway from the unformed Ghost Gum Road this cannot be hypothesised with any great certainty.</li> </ul> <p><u>Fish habitat:</u></p> <ul style="list-style-type: none"> <li>- Yes – Waterway is located in the upper reaches of Gilligan Creek which ultimately flows into Serpentine Lagoon. Suitable fish habitat therefore is noted directly upstream of this survey point.</li> </ul>	Road transects the waterway, no culverts noted.

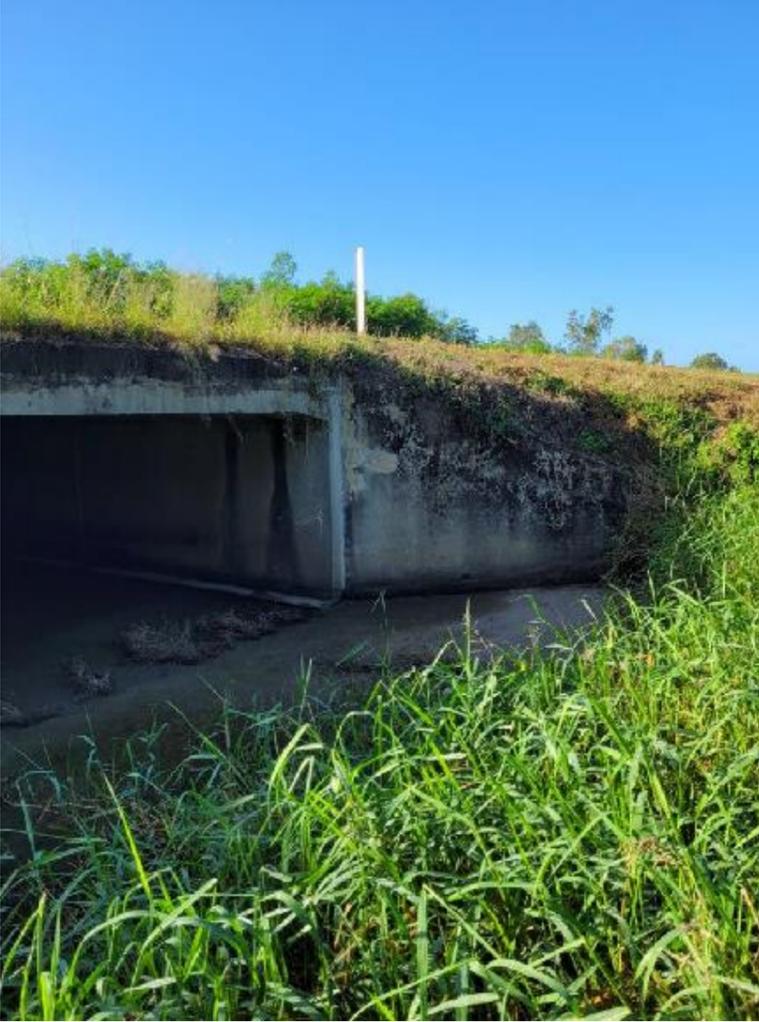
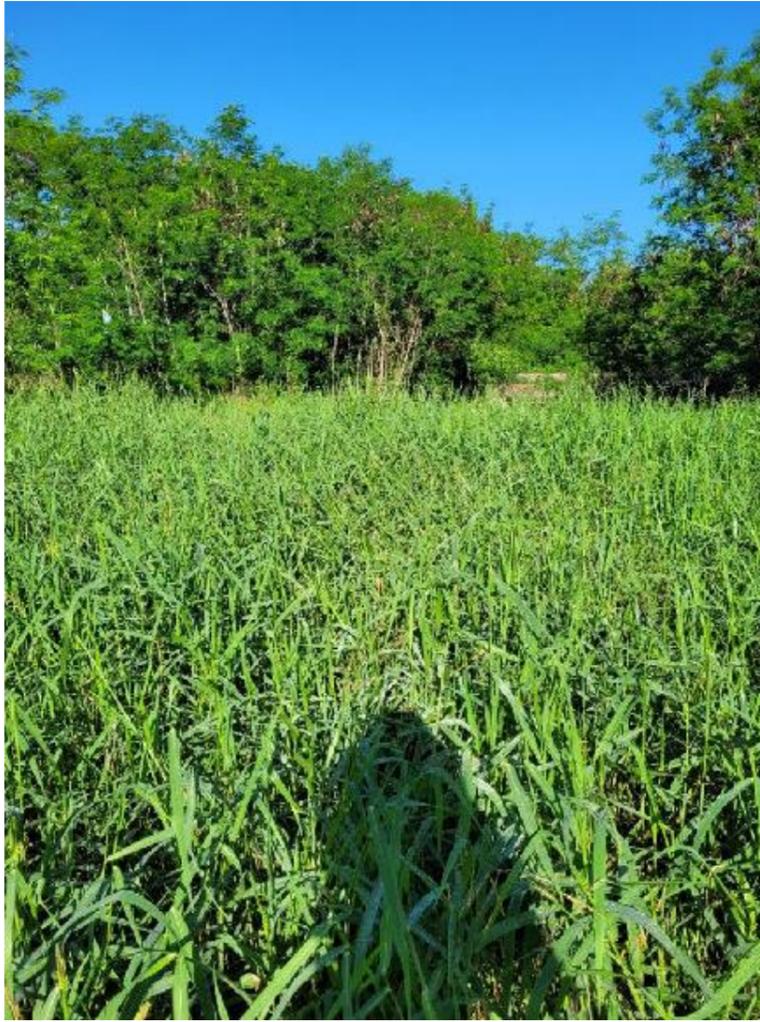
Survey Reference(s)	GPS		Water Act Classification	Field Survey Summary	Distinguishable Features
	Longitude	Latitude			
<b>WW4</b> (Refer to drawing 2378 in Appendix C of the Preliminary Documentation)	146.836332	-19.614398	Unmapped	<p><u>Bed and banks:</u></p> <ul style="list-style-type: none"> <li>- Defined top of bank is present and is estimated at 8m from top of bank to top of bank</li> </ul> <p><u>Period of flow:</u></p> <ul style="list-style-type: none"> <li>- No - at the time of survey the area was dry. However, evidence of downstream deposition was found through sandy bed features.</li> </ul> <p><u>Flow adequacy:</u></p> <ul style="list-style-type: none"> <li>- Potentially – due to extremely dry conditions no signs of flow were seen during the survey. However, sand bed deposition does allude to seasonal flow occurring during the wet season.</li> </ul> <p><u>Fish habitat:</u></p> <ul style="list-style-type: none"> <li>- Yes – Waterway is the upper reaches of Gilligan creek which ultimately flows into Serpentine Lagoon. Suitable fish habitat therefore is noted directly upstream of this survey point</li> </ul>	Drainage feature <i>Leucaena sp.</i> Dominated banks

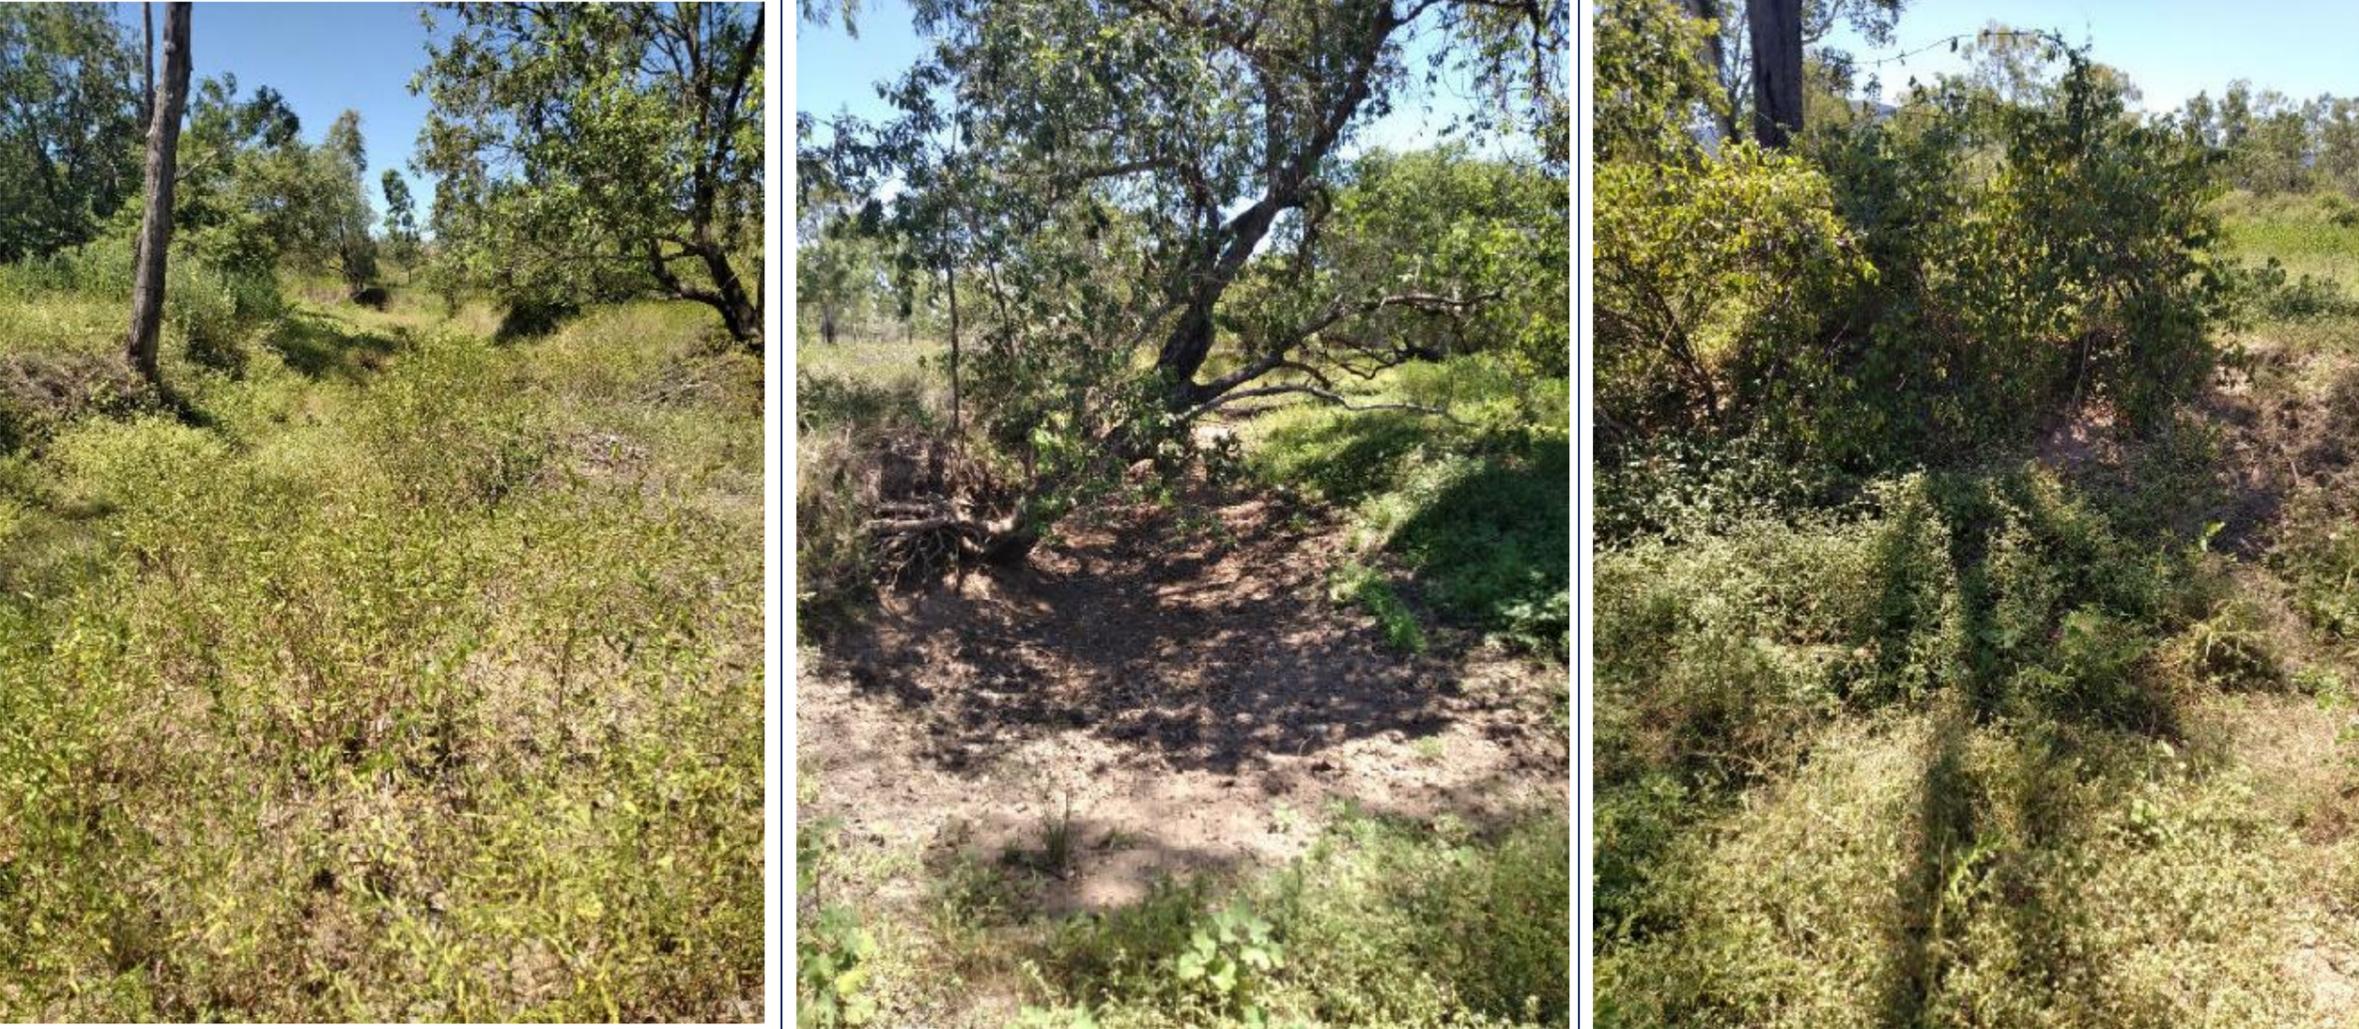
Survey Reference(s)	GPS		Water Act Classification	Field Survey Summary	Distinguishable Features
	Longitude	Latitude			
<b>WW5</b> (Refer to drawing 2372 in Appendix C of the Preliminary Documentation)	146.891013	-19.600119	Unmapped	<p><u>Bed and banks:</u></p> <ul style="list-style-type: none"> <li>- Defined top of bank is present, approximately 15m in distance</li> </ul> <p><u>Period of flow:</u></p> <ul style="list-style-type: none"> <li>- At the time of assessment, the crossing area was dry. Both upstream and downstream of the crossing point water permeance was noted. This suggest that flow occurs beyond the initial rain period with adequate structure to allow for water conveyance.</li> </ul> <p><u>Flow adequacy:</u></p> <ul style="list-style-type: none"> <li>- At time of assessment there was no flow at the point of assessment. Fringing vegetation indicates that the creek would be wet at least on a semi permeant basis.</li> </ul> <p><u>Fish habitat:</u></p> <ul style="list-style-type: none"> <li>- Upstream of the crossing point a large lagoon is present which would provide suitable fish habitat.</li> </ul>	Site exhibited traditional woody wetland indicator species near and adjacent to the survey point.

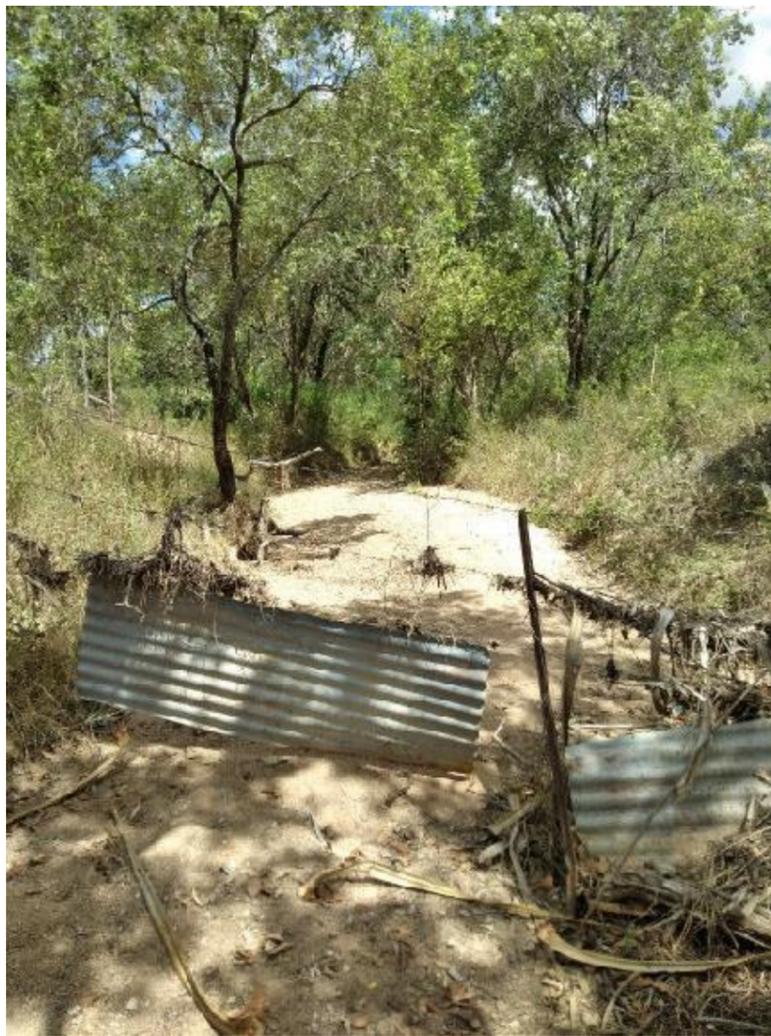
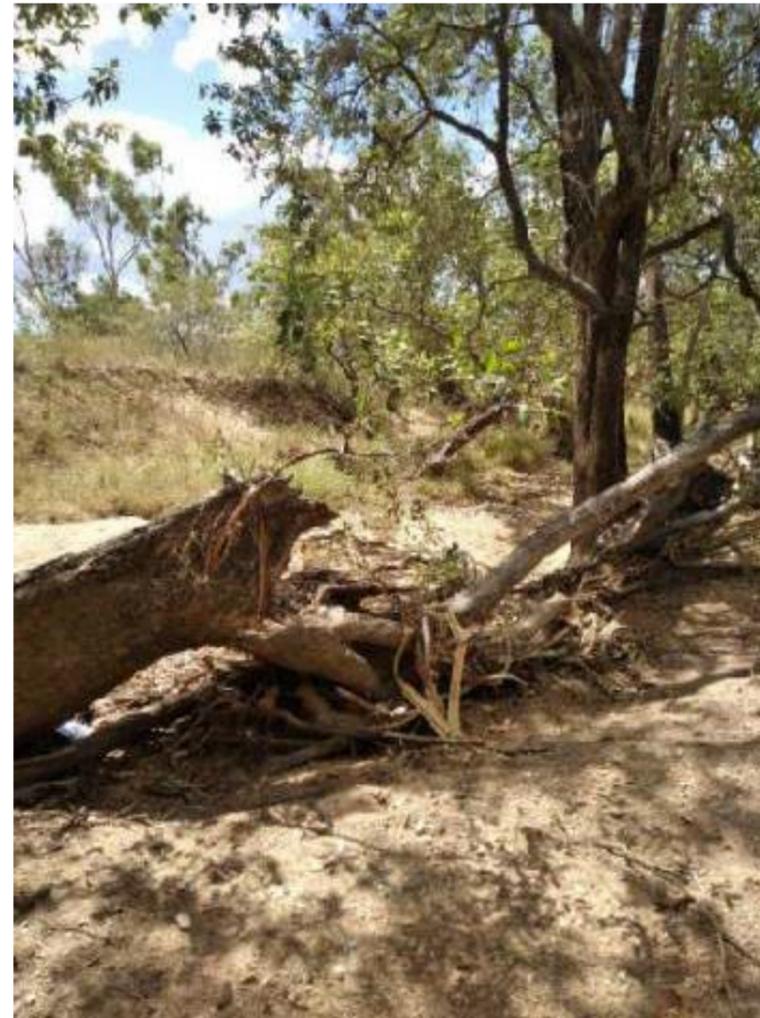
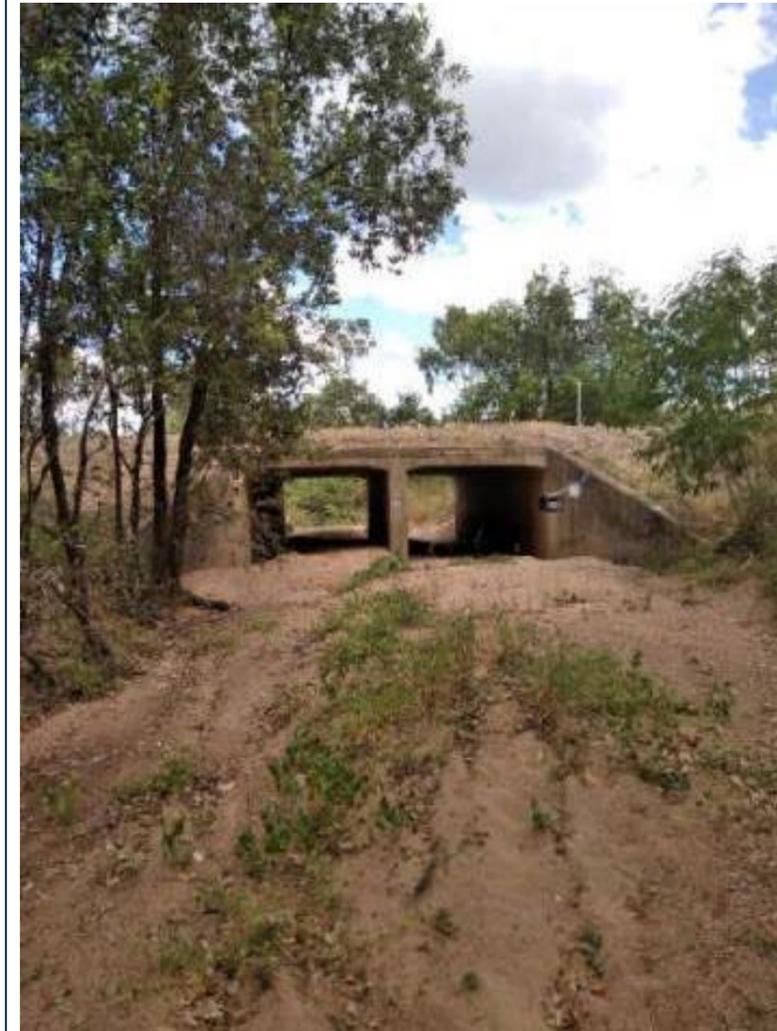
WW6 Photos – Photos taken 28/03/2022

<b>WW6</b> (Refer to drawing 2373 in Appendix C of the Preliminary Documentation)	146.870588	-19.599207	Drainage Feature	<p><u>Bed and banks:</u></p> <ul style="list-style-type: none"> <li>- Defined top of bank is estimated to be 8m in width at the point of the water pipeline crossing</li> </ul> <p><u>Period of flow:</u></p> <ul style="list-style-type: none"> <li>- At the time of survey, the area was dry. However, evidence of downstream deposition was found through a sandy bed feature.</li> </ul> <p><u>Flow adequacy:</u></p> <ul style="list-style-type: none"> <li>- Due to extremely dry conditions no signs of flow were seen during the survey. However, sand bed deposition does allude to times for peak flow and movement during the wet season</li> </ul> <p><u>Fish habitat:</u></p> <ul style="list-style-type: none"> <li>- Gilligan creek ultimately flows into Serpentine Lagoon. Suitable fish habitat therefore is noted directly upstream of this survey point.</li> </ul>	<p>Steep batters at intervals, approximately 1 in 2 slopes. Bed completely devoid of vegetation. Bed mostly comprised of coarse sand.</p>

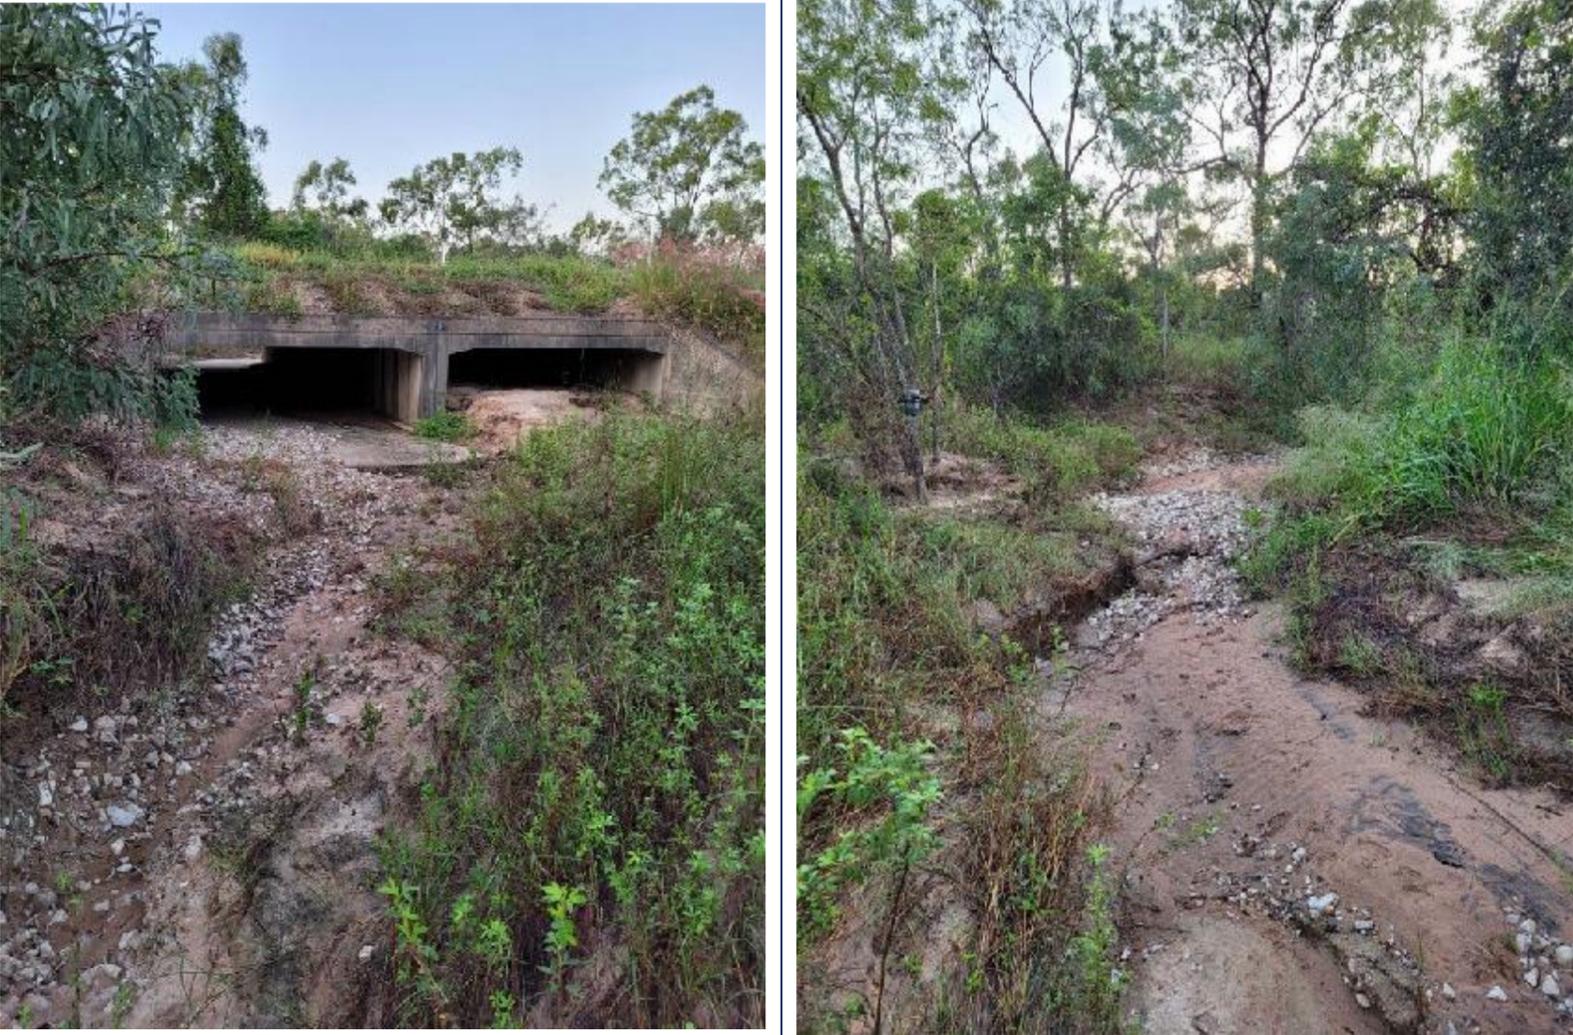
Survey Reference(s)	GPS		Water Act Classification	Field Survey Summary	Distinguishable Features
	Longitude	Latitude			
<b>WW7</b> (Refer to drawing 2374 in Appendix C of the Preliminary Documentation)	146.869722	-19.600019	Unmapped	<p><u>Bed and banks:</u></p> <ul style="list-style-type: none"> <li>- Defined top of bank is approximately 6.5m in width.</li> </ul> <p><u>Period of flow:</u></p> <ul style="list-style-type: none"> <li>- No water was present during the time of survey. Vegetation species found near bed and banks were not wetland indicator species suggesting the channel remains dry for extended periods.</li> </ul> <p><u>Flow adequacy:</u></p> <ul style="list-style-type: none"> <li>- Crossing point had significant erosional evidence at time of survey showing that a significant volume of water has flowed through the area in the recent past.</li> </ul> <p><u>Fish habitat:</u></p> <ul style="list-style-type: none"> <li>- Upstream and downstream habitats are similar to that of the crossing point. No water pools or wetland indicator species could be found.</li> </ul>	Area dominated by <i>Stylosanthes scabra</i> .

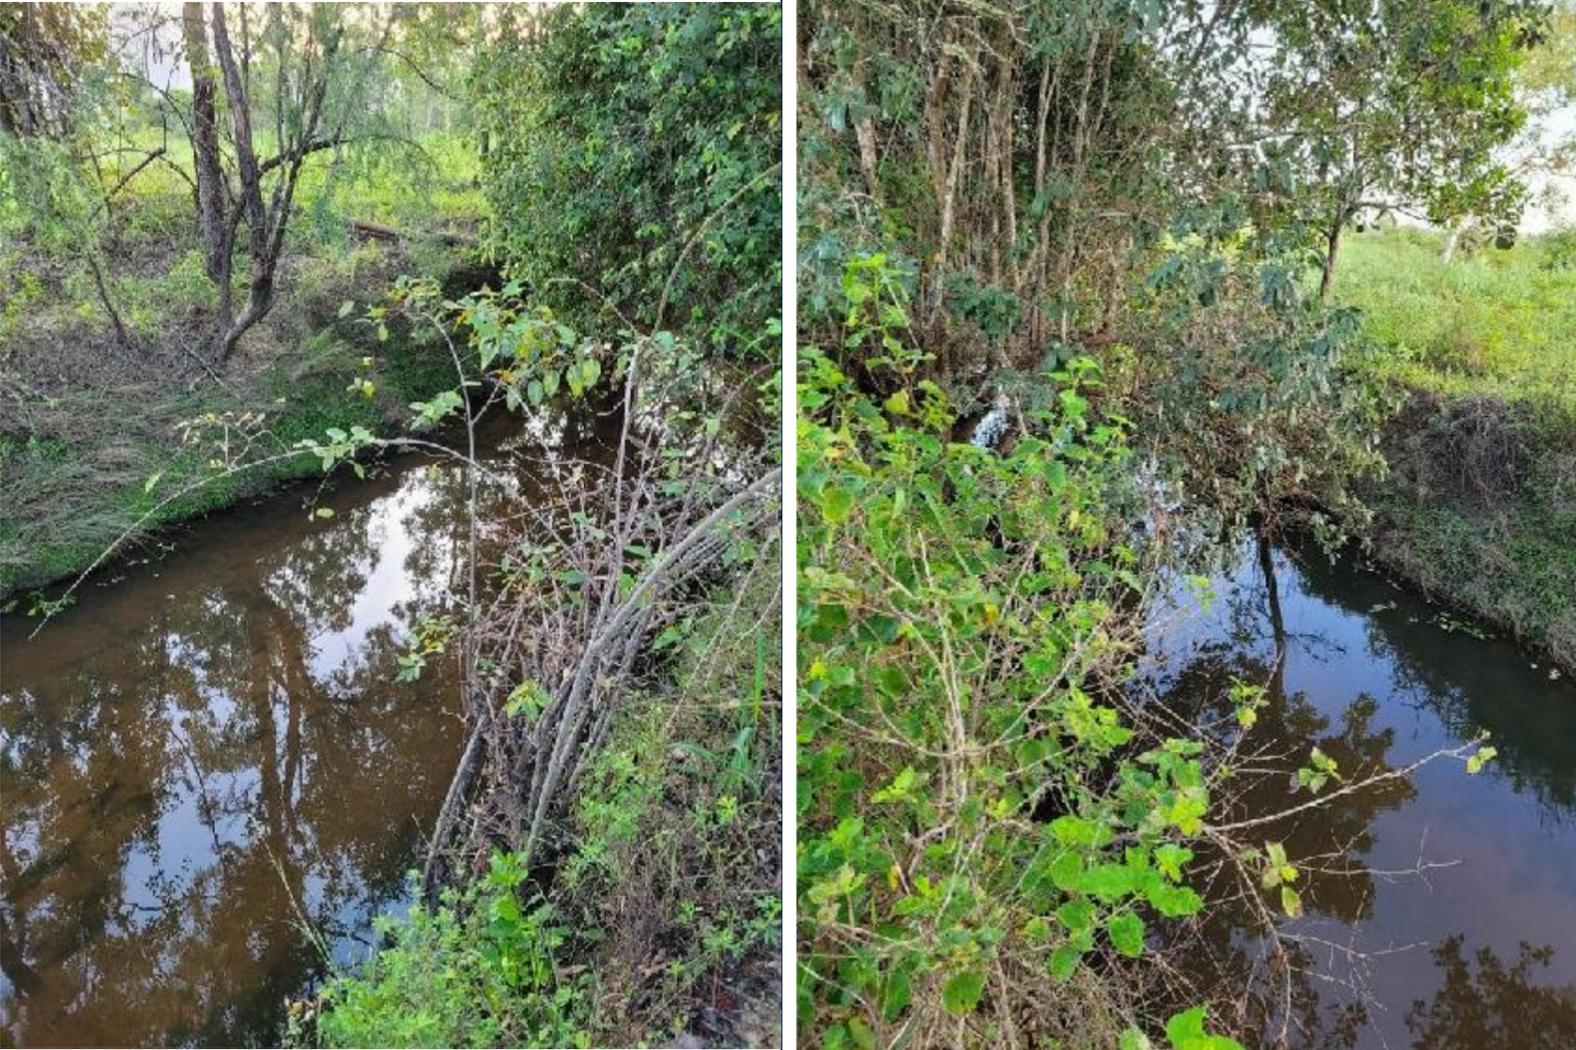
WW8	146.882962	-19.599509	Unmapped	<p><u>Bed and banks:</u></p> <ul style="list-style-type: none"> <li>- Defined top of bank is approximately 6m in width</li> </ul> <p><u>Period of flow:</u></p> <ul style="list-style-type: none"> <li>- Water was present within the waterway at the time of survey. Vegetation observed on low banks showed evidence of recent water flow.</li> </ul> <p><u>Flow adequacy:</u></p> <ul style="list-style-type: none"> <li>- Water was present within the waterway at the time of survey.</li> </ul> <p><u>Fish habitat:</u></p> <ul style="list-style-type: none"> <li>- Yes - the waterway connects upstream to a large body of water in Serpentine Lagoon.</li> </ul>	<i>Lophostemon grandiflorus</i> located on waterway banks.
WW8 Photos – Photos taken 26/05/2022

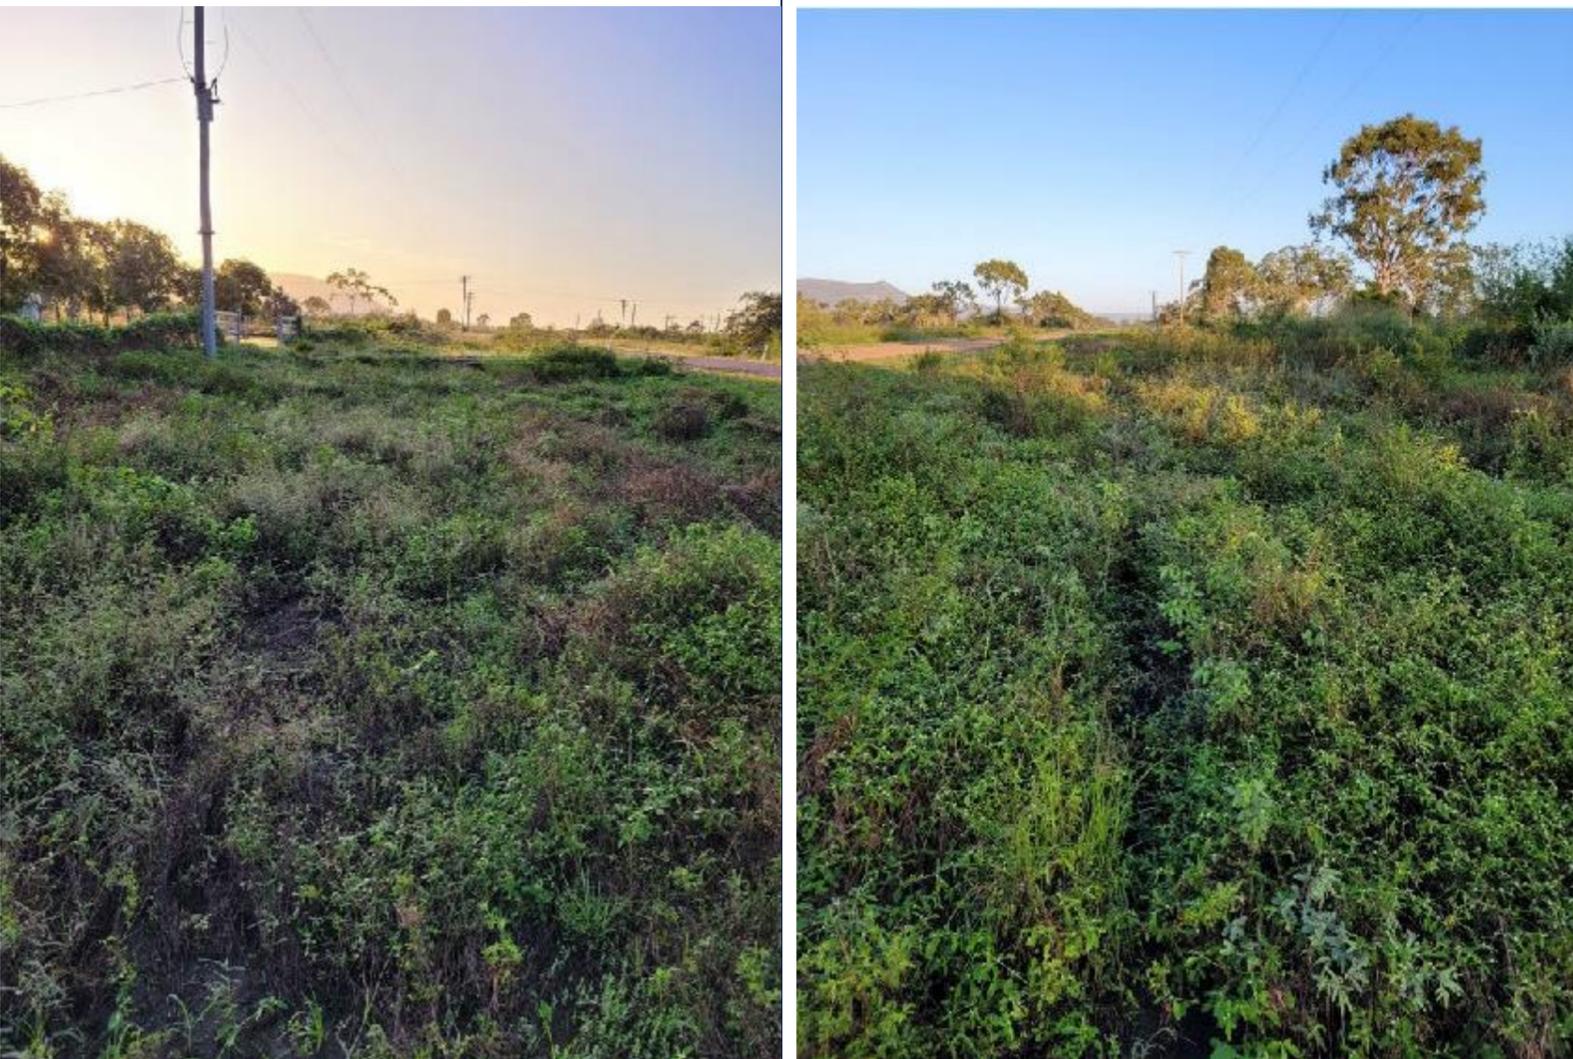
Survey Reference(s)	GPS		Water Act Classification	Field Survey Summary	Distinguishable Features
	Longitude	Latitude			
WW9	146.831717	-19.593497	Unmapped	<p><u>Bed and banks:</u></p> <ul style="list-style-type: none"> <li>- No clearly defined banks discernible.</li> </ul> <p><u>Period of flow:</u></p> <ul style="list-style-type: none"> <li>- Potentially – pooled water upstream and downstream of the location would suggest that flow exists. However, alteration of the waterway at multiple locations to form dammed areas for agricultural use as visible in arial imagery may affect the period of flow.</li> </ul> <p><u>Flow adequacy:</u></p> <ul style="list-style-type: none"> <li>- Potentially – pooled water upstream and downstream of the location would suggest that flow adequacy would exist.</li> </ul> <p><u>Fish habitat:</u></p> <ul style="list-style-type: none"> <li>- Yes – pooled water is visible on arial imagery both upstream and downstream of the surveyed location.</li> </ul>	<i>Cyperus sp.</i> present.

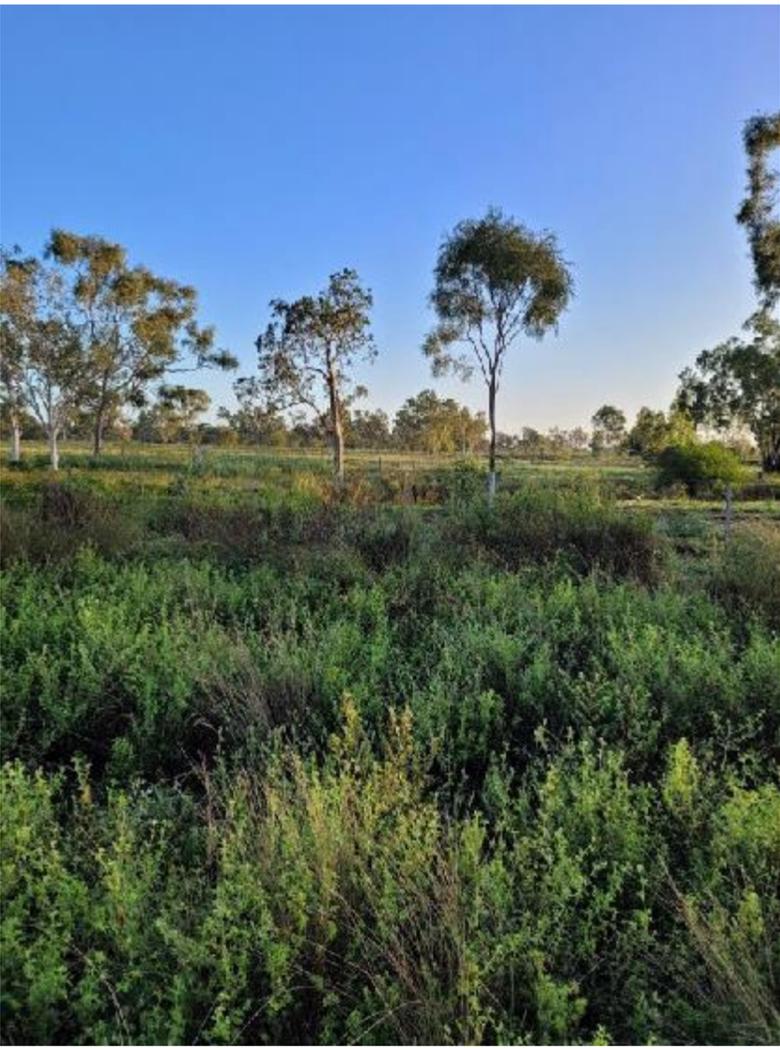
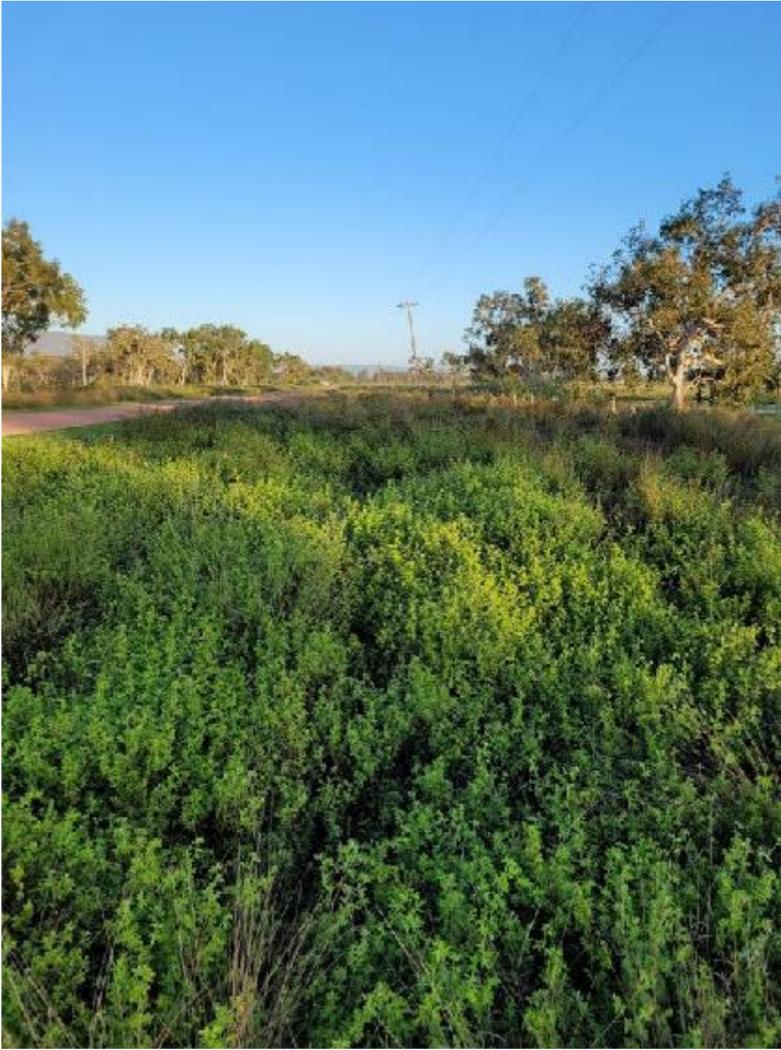
Survey Reference(s)	GPS		Water Act Classification	Field Survey Summary	Distinguishable Features
	Longitude	Latitude			
WW10 Photos – Photos taken 26/05/2022

<b>WW10</b>	146.829152	-19.59325	Unmapped	<p><u>Bed and banks:</u></p> <ul style="list-style-type: none"> <li>- No – roadside depression with no defined banks or wetland indicator species present</li> </ul> <p><u>Period of flow:</u></p> <ul style="list-style-type: none"> <li>- Potentially - at the time of survey the sand substrate was waterlogged.</li> </ul> <p><u>Flow adequacy:</u></p> <ul style="list-style-type: none"> <li>- No – no signs of flow were seen during the survey.</li> </ul> <p><u>Fish habitat:</u></p> <ul style="list-style-type: none"> <li>- Yes – a farm dam is located upstream of the survey location, and a substantial body of pooled water was noted within the waterway located adjacent.</li> </ul>	Wetland indicator species absent from road reserve.

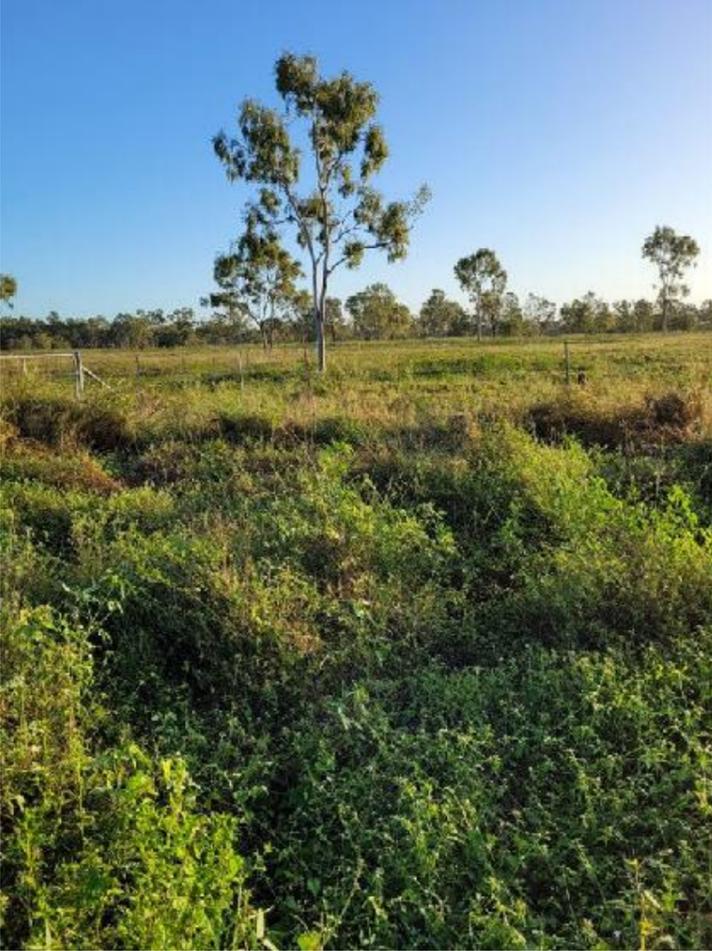
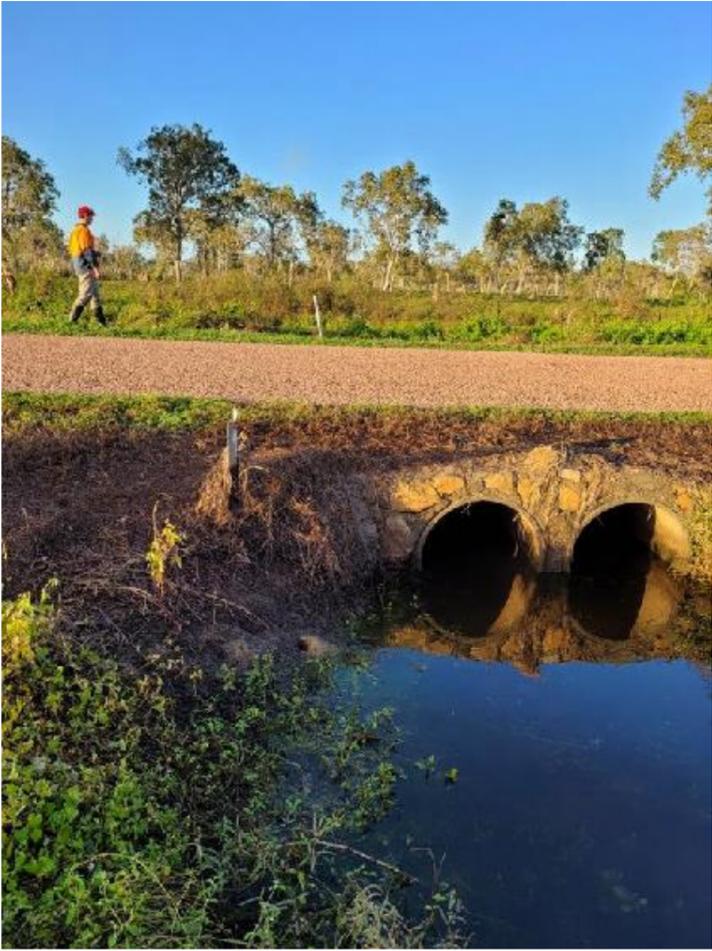
Survey Reference(s)	GPS		Water Act Classification	Field Survey Summary	Distinguishable Features
	Longitude	Latitude			
WW11	146.827147	-19.5930	Unmapped	<p><u>Bed and banks:</u></p> <ul style="list-style-type: none"> <li>- No – roadside depression with no defined banks except immediately adjacent to where a culvert crossing has been installed under Jones Road.</li> </ul> <p><u>Period of flow:</u></p> <ul style="list-style-type: none"> <li>- Yes - at the time of assessment the pooled water was present adjacent to the culvert crossing. Both upstream and downstream of the crossing point water permanence was noted. This suggests that flow occurs beyond the initial rain period with adequate structure to allow for water conveyance.</li> </ul> <p><u>Flow adequacy:</u></p> <ul style="list-style-type: none"> <li>- Potentially - at time of assessment there was no flow at the point of assessment. Fringing vegetation indicates that the creek would be wet at least on a semi-permanent basis.</li> </ul> <p><u>Fish habitat:</u></p> <ul style="list-style-type: none"> <li>- Yes - upstream of the crossing point a farm dam is present which would provide suitable fish habitat.</li> </ul>	<p><i>Ludwigia octovalvis</i>, a wetland indicator species was noted at the survey location.</p>

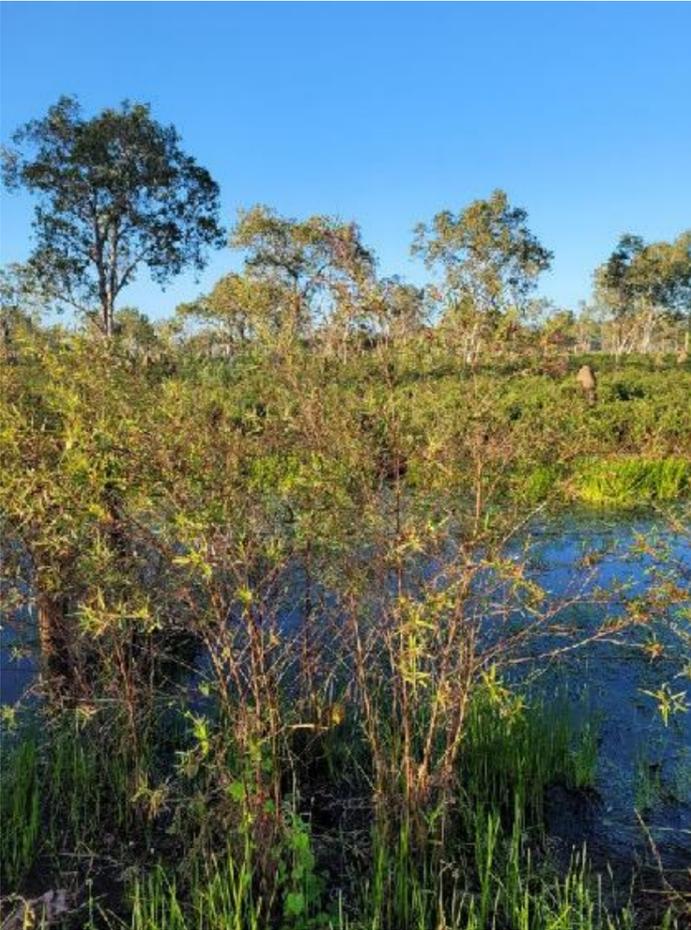
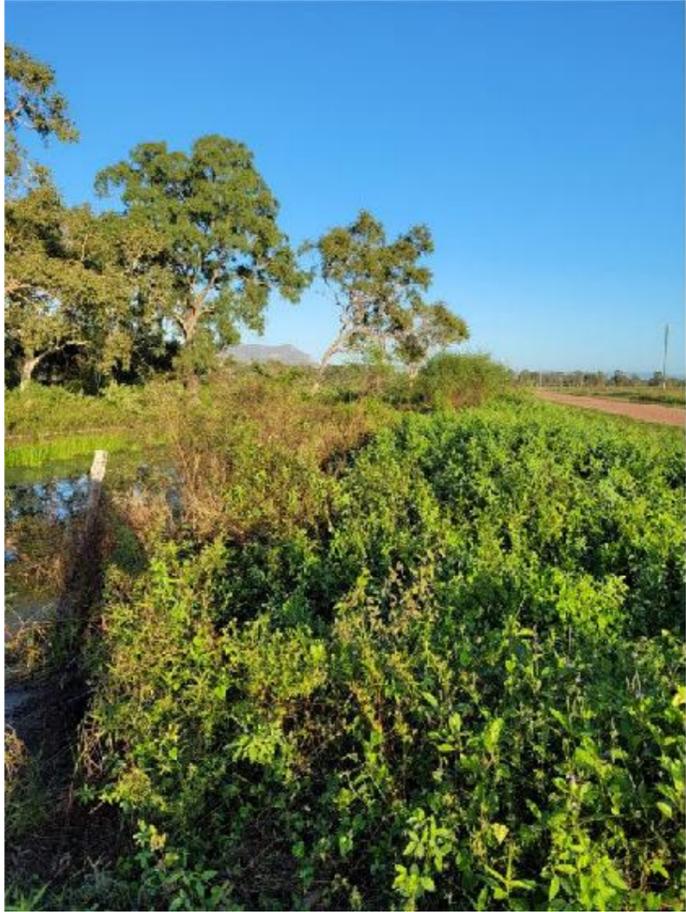
Survey Reference(s)	GPS		Water Act Classification	Field Survey Summary	Distinguishable Features
	Longitude	Latitude			
WW12 Photos – Photos taken 26/05/2022

WW12	146.826725	-19.59329	Unmapped	<p><u>Bed and banks:</u></p> <ul style="list-style-type: none"> <li>- No – roadside depression with no defined banks except immediately adjacent to where a culvert crossing has been installed under Jones Road.</li> </ul> <p><u>Period of flow:</u></p> <ul style="list-style-type: none"> <li>- Yes - At the time of assessment the pooled water was present adjacent to the culvert crossing and along the boundary of lot 101 on EP1666. Water permanence was noted both upstream and downstream, suggesting that flow occurs beyond the initial rain period with adequate structure to allow for water conveyance.</li> </ul> <p><u>Flow adequacy:</u></p> <ul style="list-style-type: none"> <li>- Potentially - At time of assessment there was no flow at the point of assessment. Fringing vegetation indicates that the creek would be wet at least on a semi-permanent basis.</li> </ul> <p><u>Fish habitat:</u></p> <ul style="list-style-type: none"> <li>- Upstream of the crossing point a farm dam is present which would provide suitable fish habitat.</li> </ul>	<p><i>Ludwigia octovalvis</i>, and <i>Eleocharis sp.</i> which are wetland indicators were extensively present at the boundary between the road reserve and lot 101 on EP1666.</p>

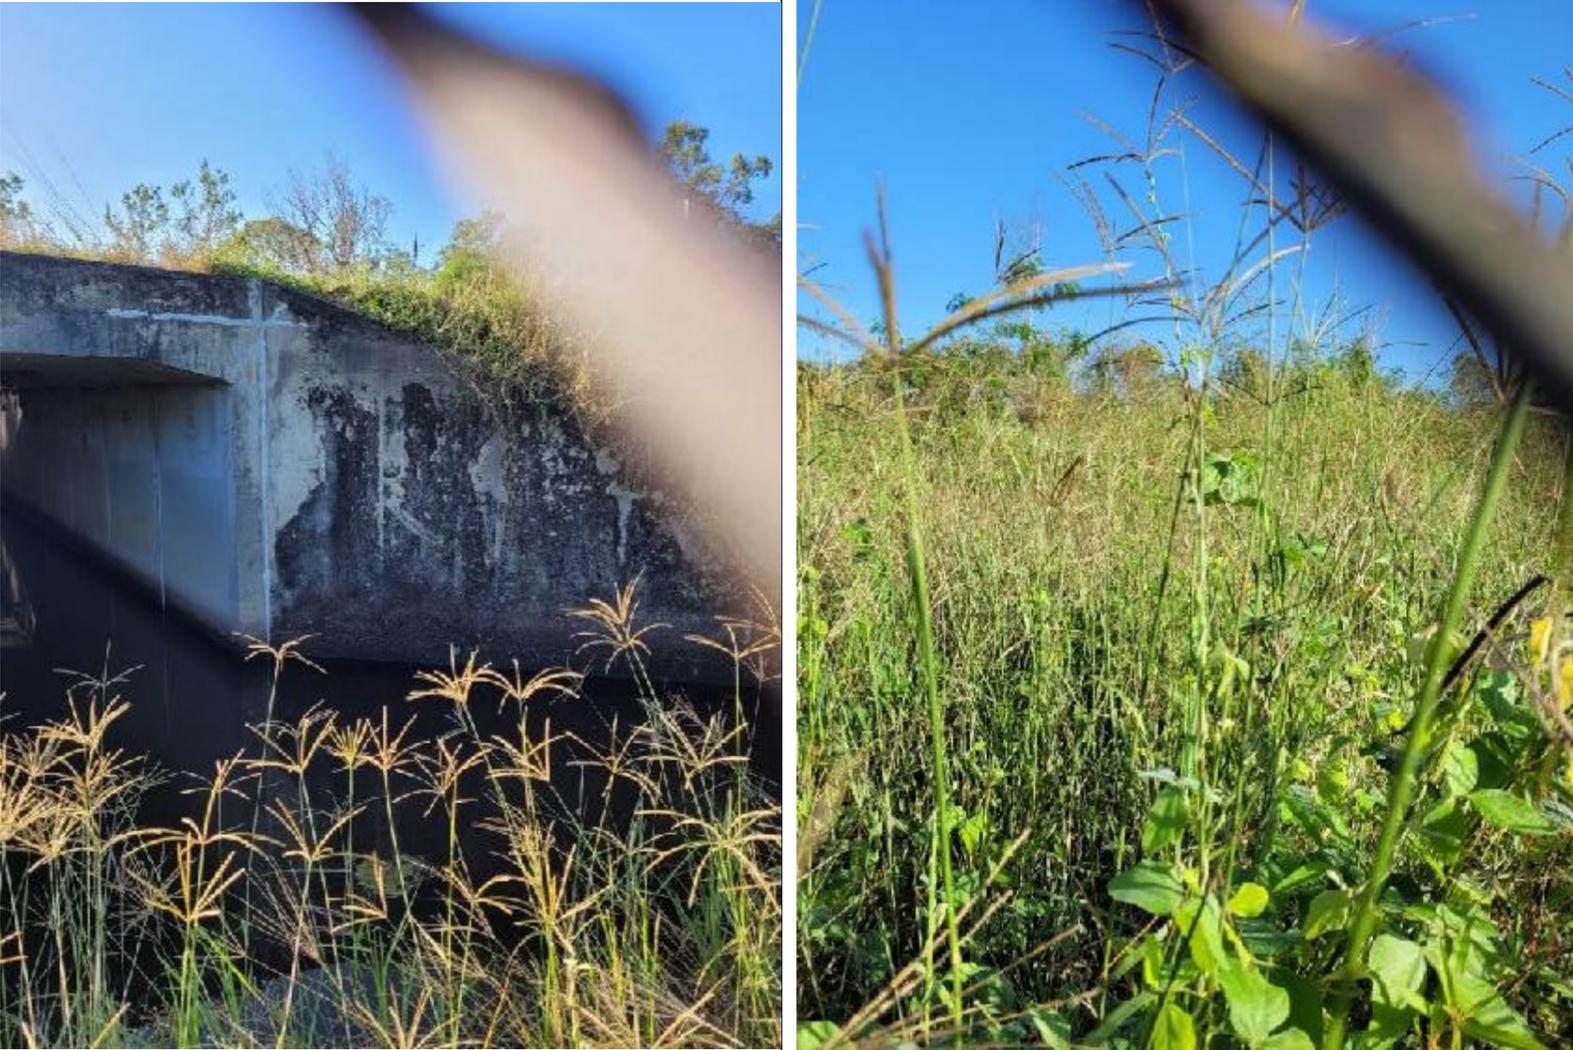
<b>WW13</b> (Refer to drawing 2378 in Appendix C of the Preliminary Documentation)	146.836657	-19.613873	Unmapped	<p><u>Bed and banks:</u></p> <ul style="list-style-type: none"> <li>- Defined top of bank is approximately 6m in width</li> </ul> <p><u>Period of flow:</u></p> <ul style="list-style-type: none"> <li>- At the time of assessment, the pooled water was present adjacent to the culvert crossing</li> </ul> <p><u>Flow adequacy:</u></p> <ul style="list-style-type: none"> <li>- At time of assessment there was no flow at the point of assessment. Evidence of sediment deposition is present.</li> </ul> <p><u>Fish habitat:</u></p> <ul style="list-style-type: none"> <li>- No - WW13 is a short (558m) tributary of Gilligan creek extending with 395m of dry creek bed upstream of the survey location.</li> </ul>	<p><i>Ludwigia octovalvis</i>, a wetland indicator species was noted at the survey location.</p>
