## **Appendix I Waterway Assessments**

## Waterway and Wetland Assessment:

**Table 3 Waterways Assessments**

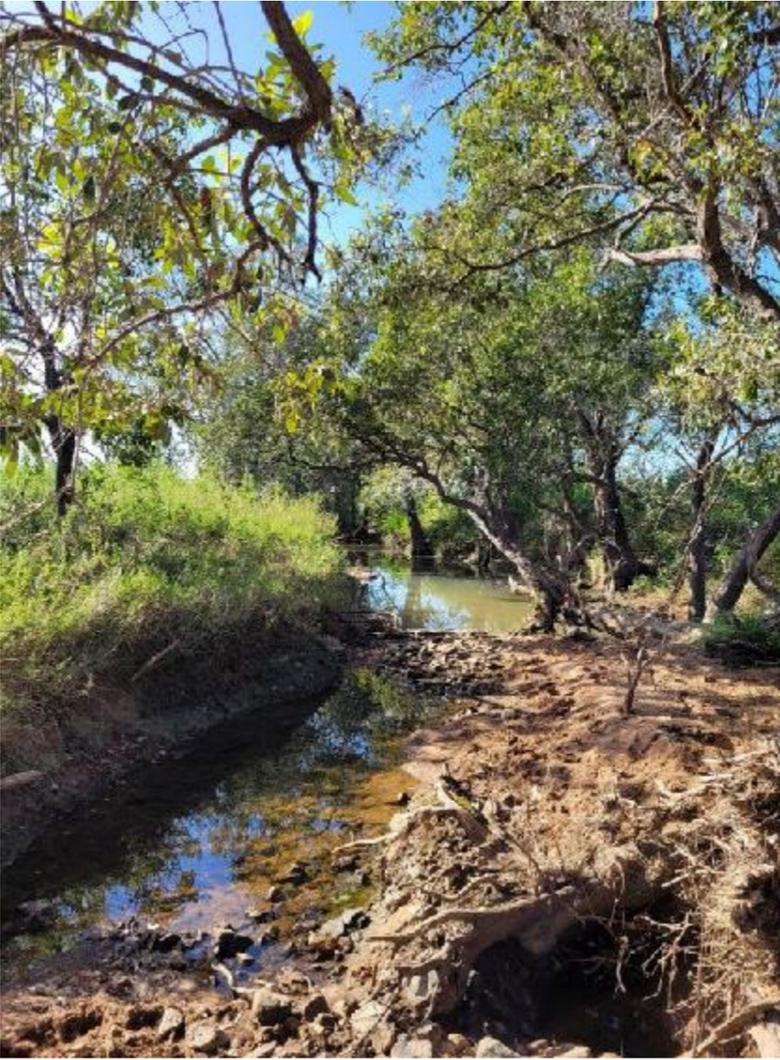
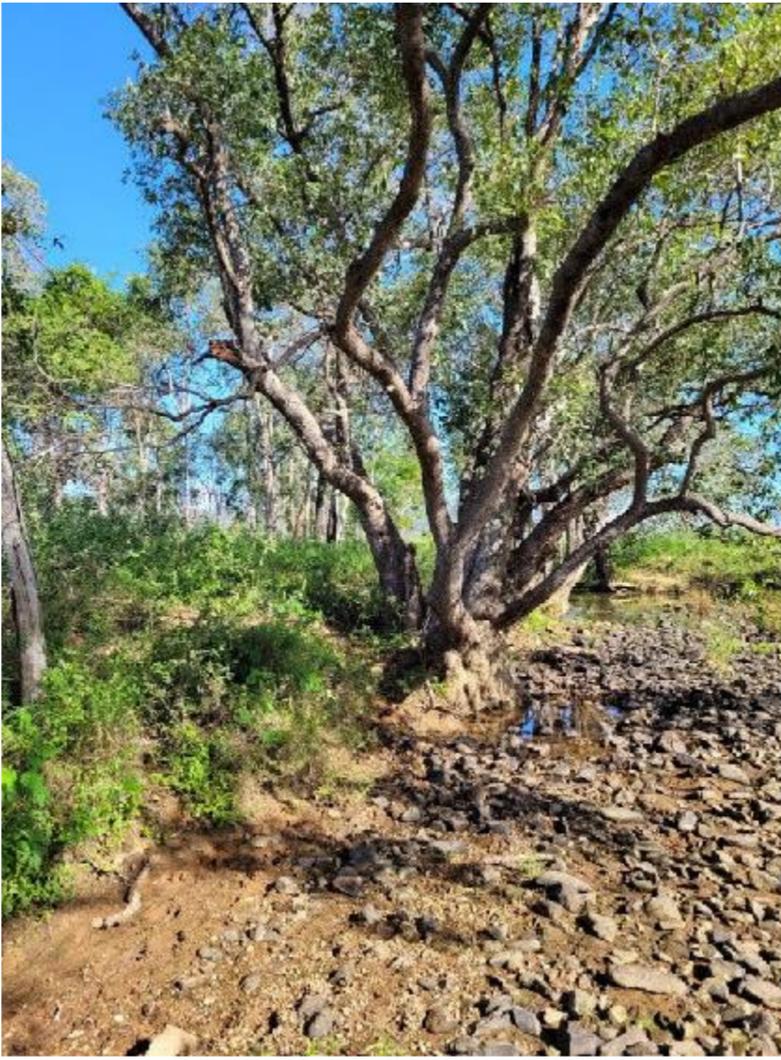
Survey Reference(s)	GPS		Water Act Classification	Field Survey Summary	Distinguishable Features
	Longitude	Latitude			
WW14 – Photos taken 26/05/2022

<b>WW14</b>	146.82148	-19.632125	Unmapped	<p><u>Bed and banks:</u></p> <ul style="list-style-type: none"> <li>- Defined top of bank is approximately 12m in width.</li> </ul> <p><u>Period of flow:</u></p> <ul style="list-style-type: none"> <li>- At the time of assessment pools of water were visible along the waterway.</li> </ul> <p><u>Flow adequacy:</u></p> <ul style="list-style-type: none"> <li>- At the time of assessment there was no flow. Evidence of sediment deposition is present.</li> </ul> <p><u>Fish habitat:</u></p> <ul style="list-style-type: none"> <li>- Yes – Pools of water were visible both up and downstream of the survey location at the time of observation.</li> </ul>	<p><i>Lophostemon grandiflorus</i> fringing waterway. Evidence of cattle accessing waterway.</p>

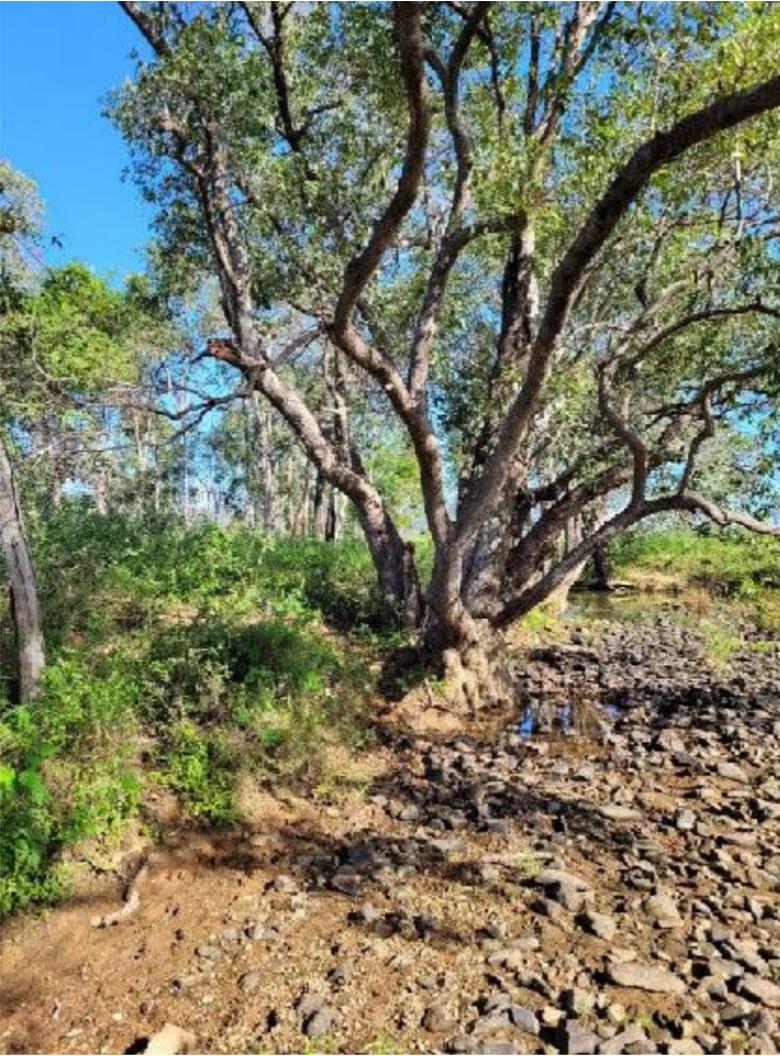
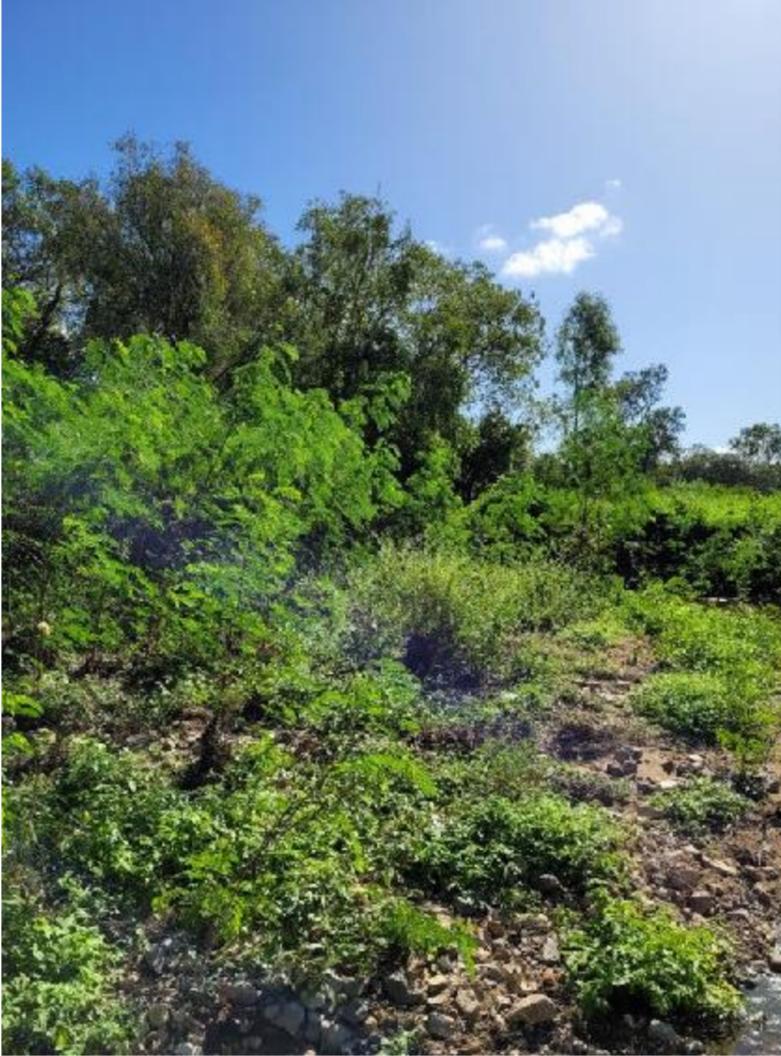
Survey Reference(s)	GPS		Water Act Classification	Field Survey Summary	Distinguishable Features
	Longitude	Latitude			
WW15	146.819665	-19.649601	Drainage feature	<p><u>Bed and banks:</u></p> <ul style="list-style-type: none"> <li>- Defined top of bank is approximately 12m in width.</li> </ul> <p><u>Period of flow:</u></p> <ul style="list-style-type: none"> <li>- At the time of assessment pools of water were visible along the waterway although water was not flowing.</li> </ul> <p><u>Flow adequacy:</u></p> <ul style="list-style-type: none"> <li>- At the time of assessment there was no flow. Evidence of sediment erosion and deposition is present.</li> </ul> <p><u>Fish habitat:</u></p> <ul style="list-style-type: none"> <li>- Yes – Pools of water were visible both up and downstream of the survey location at the time of observation.</li> </ul>	<i>Lophostemon grandiflorus</i> and <i>Leucaena</i> fringing waterway.

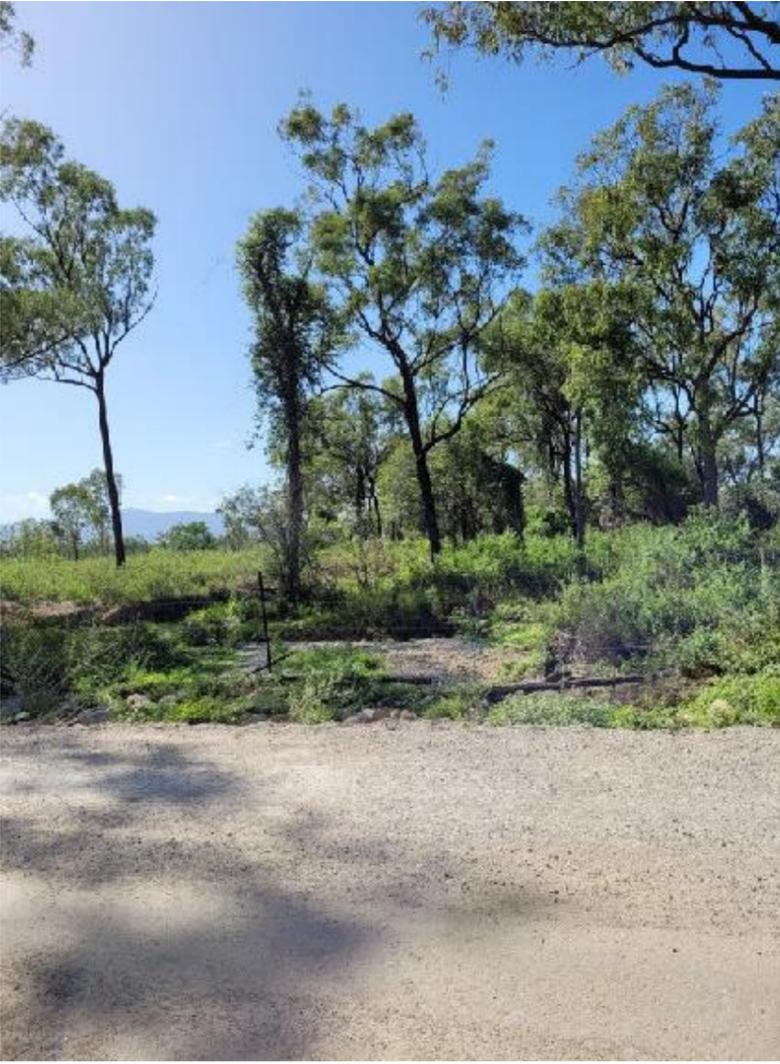
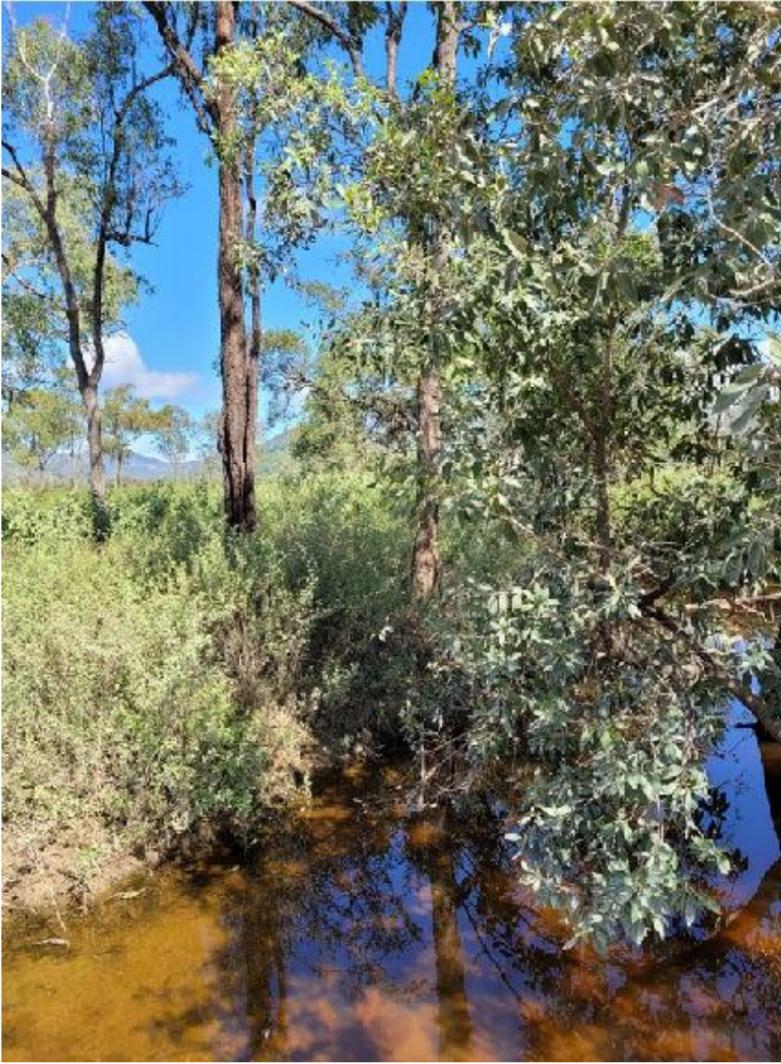
Survey Reference(s)	GPS		Water Act Classification	Field Survey Summary	Distinguishable Features
	Longitude	Latitude			
WW16	146.821179	-19.643381	Drainage feature	<p><u>Bed and banks:</u></p> <ul style="list-style-type: none"> <li>- Defined top of bank is approximately 8m in width.</li> </ul> <p><u>Period of flow:</u></p> <ul style="list-style-type: none"> <li>- At the time of assessment pools of water were visible along the waterway although water was not flowing. Evident raising of the roadway above the bed level of the waterway is expected to adversely affect water flow.</li> </ul> <p><u>Flow adequacy:</u></p> <ul style="list-style-type: none"> <li>- At time of assessment there was no flow at the point of assessment. Pooling water and evidence of sediment deposition is present.</li> </ul> <p><u>Fish habitat:</u></p> <ul style="list-style-type: none"> <li>- Yes – Pools of water were visible both up and downstream of the survey location at the time of observation.</li> </ul>	<p><i>Corymbia clarksoniana, Eucalyptus crebra and Stylosanthes scabra</i> fringing waterway.</p>

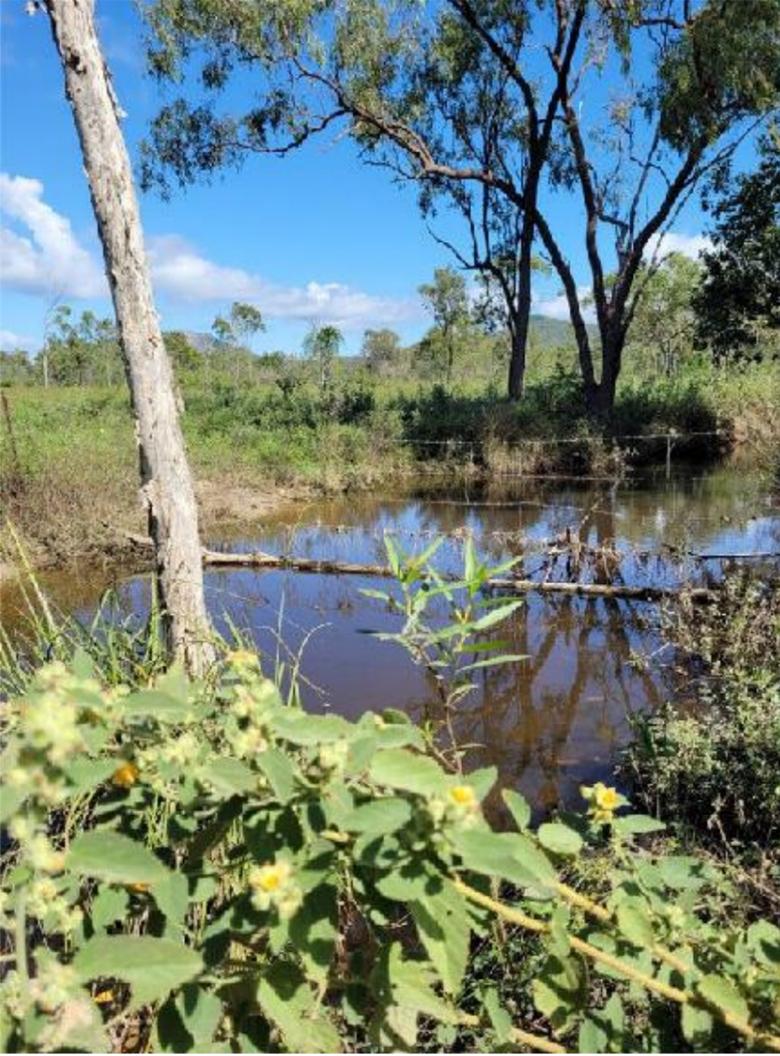
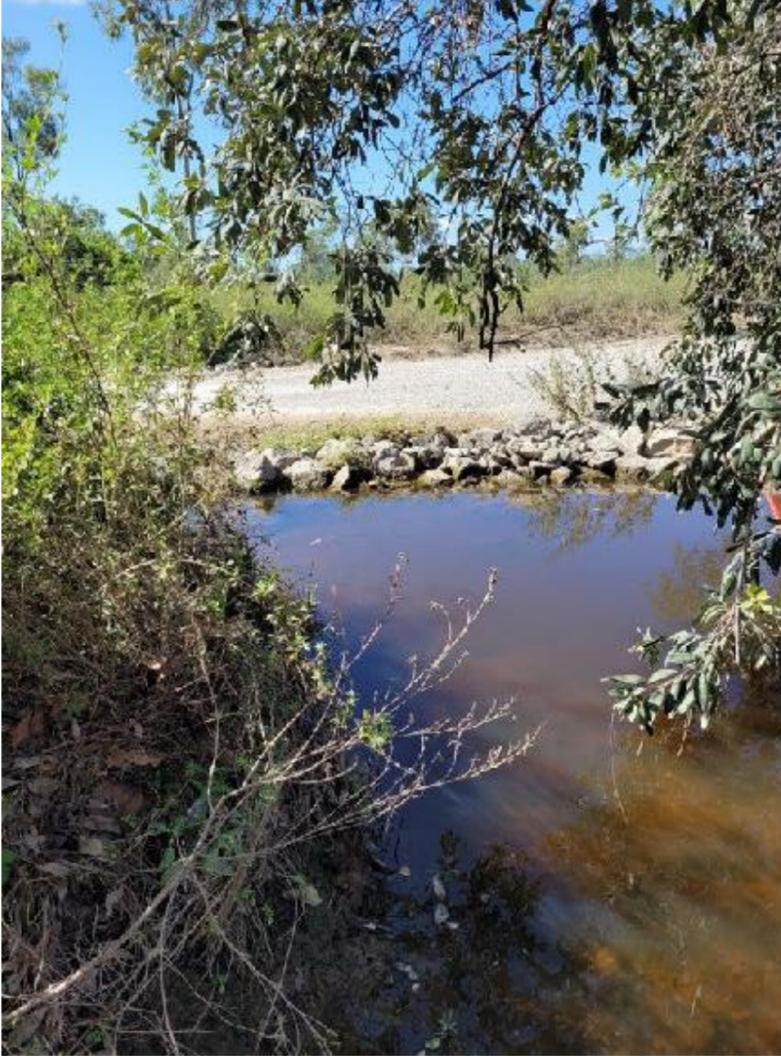
Survey Reference(s)	GPS		Water Act Classification	Field Survey Summary	Distinguishable Features
	Longitude	Latitude			
WW17	146.821609	-19.639182	Drainage feature	<p><u>Bed and banks:</u></p> <ul style="list-style-type: none"> <li>- Defined top of bank is approximately 7m in width.</li> </ul> <p><u>Period of flow:</u></p> <ul style="list-style-type: none"> <li>- At the time of assessment pools of water were visible along the waterway although water was not flowing. Evident raising of the roadway above the bed level has caused pooling upstream of the roadway, reducing waterflow.</li> </ul> <p><u>Flow adequacy:</u></p> <ul style="list-style-type: none"> <li>- At time of assessment there was no flow at the point of assessment. Pooling water and evidence of sediment deposition is present.</li> </ul> <p><u>Fish habitat:</u></p> <ul style="list-style-type: none"> <li>- Yes – Pools of water were visible both up and downstream of the survey location at the time of observation.</li> </ul>	<i>Lophostemon grandiflorus</i> growing in waterway.

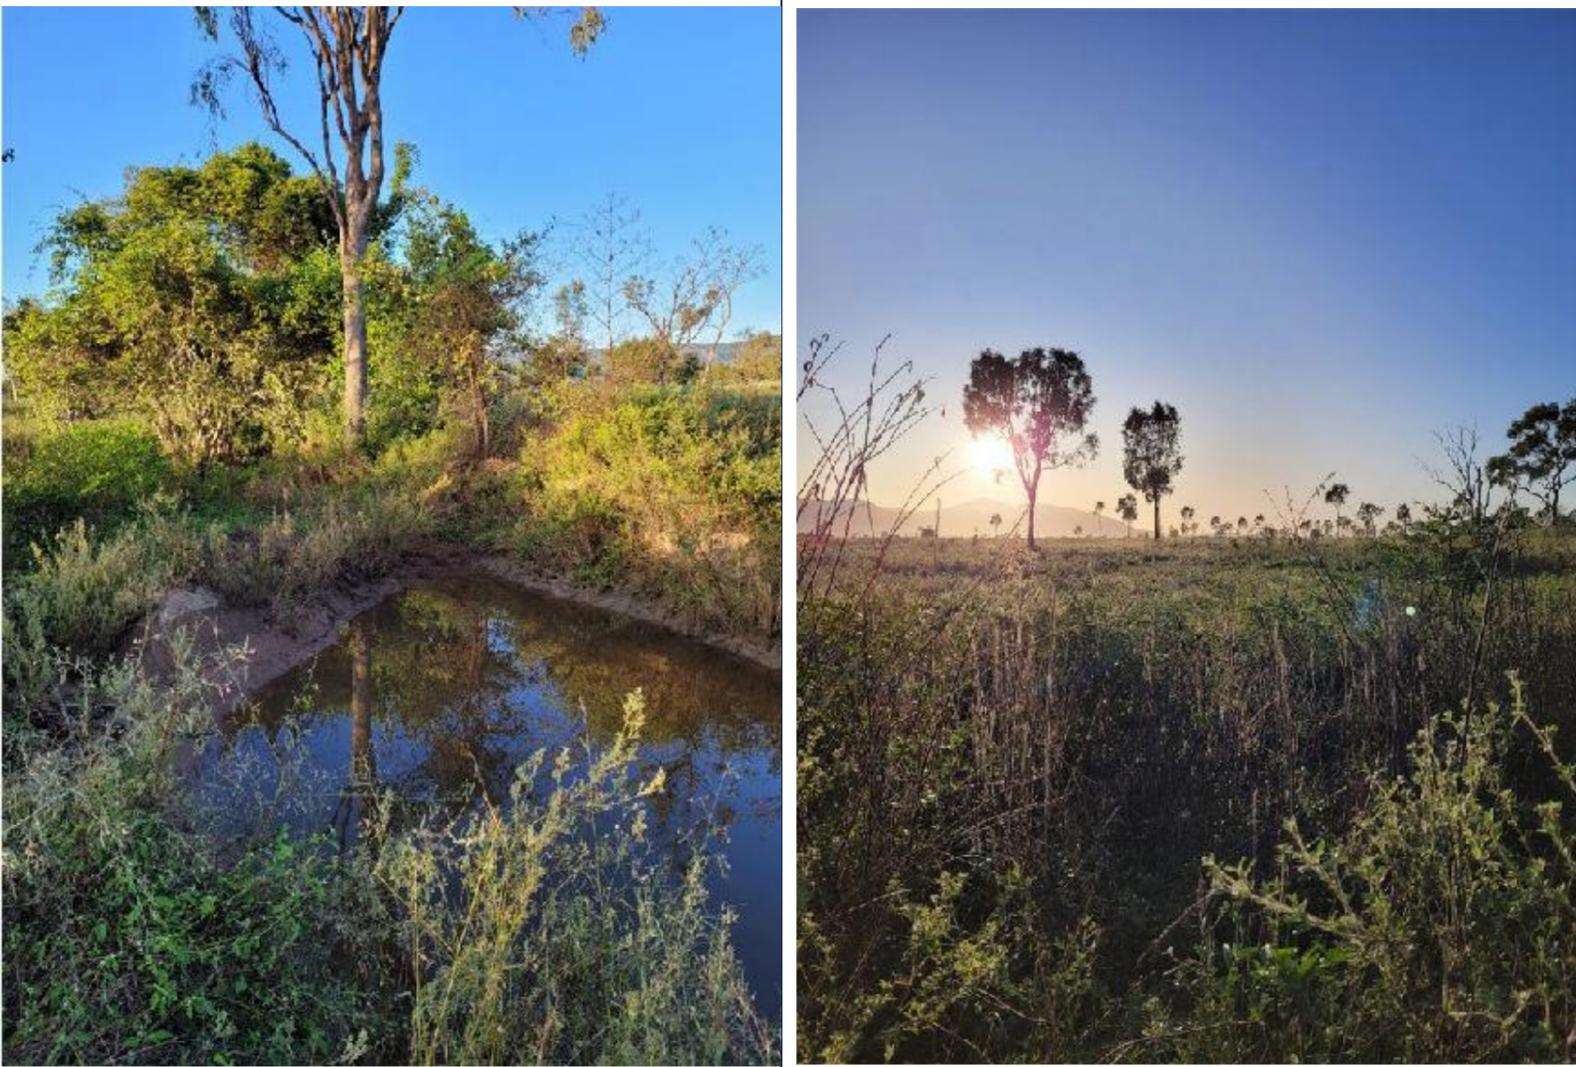
Survey Reference(s)	GPS		Water Act Classification	Field Survey Summary	Distinguishable Features
	Longitude	Latitude			
WW18	146.817842	-19.631102	Unmapped	<p><u>Bed and banks:</u></p> <ul style="list-style-type: none"> <li>- Defined top of bank is approximately 5m in width.</li> </ul> <p><u>Period of flow:</u></p> <ul style="list-style-type: none"> <li>- At the time of assessment pools of water were visible along the waterway although water was not flowing.</li> </ul> <p><u>Flow adequacy:</u></p> <ul style="list-style-type: none"> <li>- At time of assessment there was no flow at the point of assessment. Evidence of sediment deposition is present.</li> </ul> <p><u>Fish habitat:</u></p> <ul style="list-style-type: none"> <li>- Yes – Pools of water were visible both up and downstream of the survey location at the time of observation.</li> </ul>	Area dominated by <i>Stylosanthes scabra</i> .
WW18 – Photos taken 27/05/2022

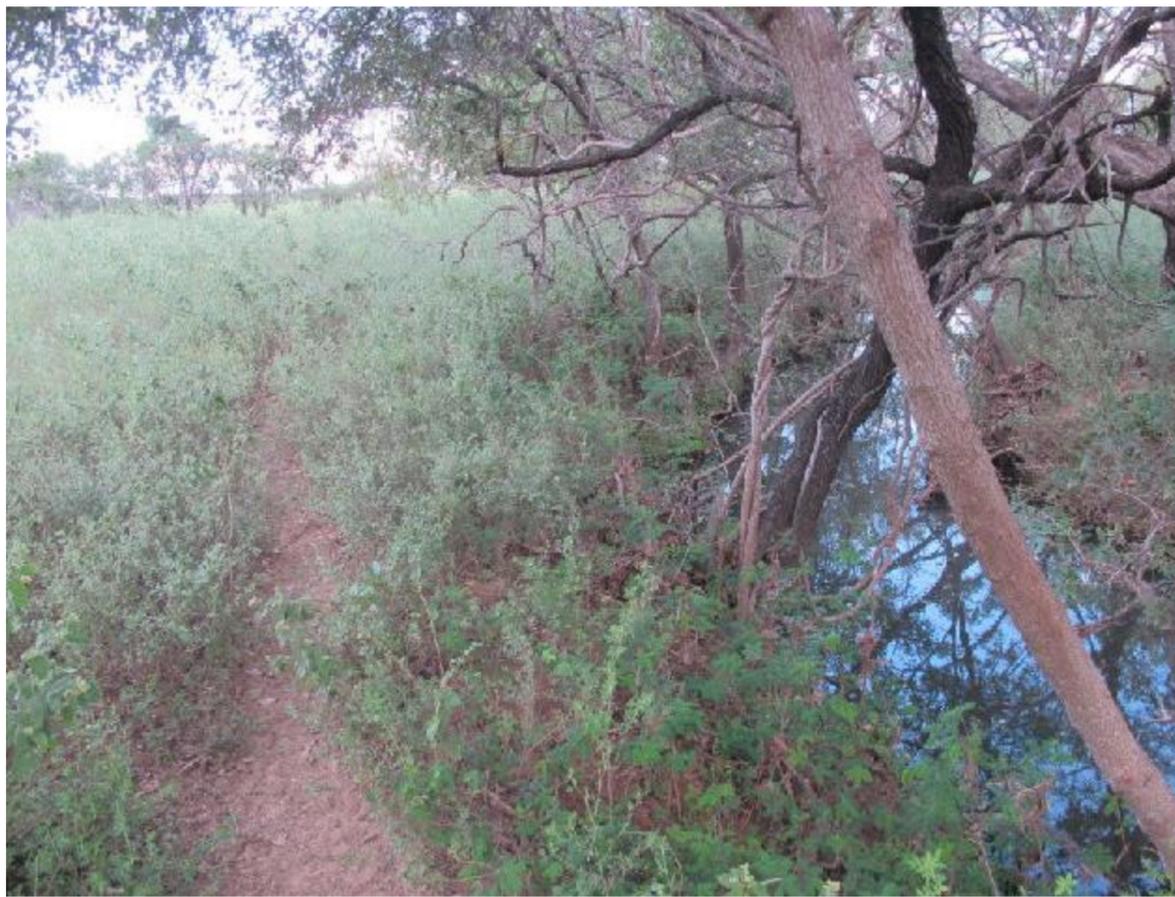
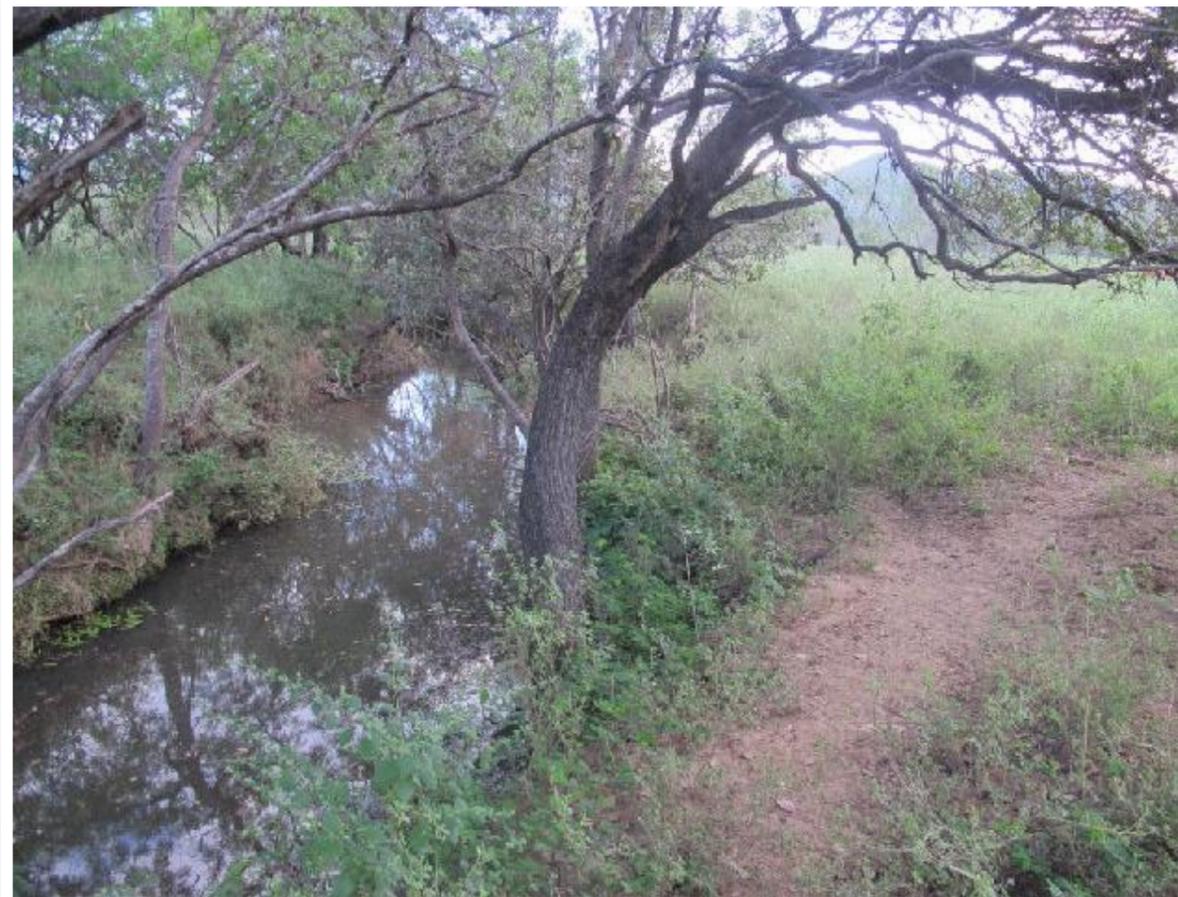
WW19– Photos taken 23/05/2022

Survey Reference(s)	GPS		Water Act Classification	Field Survey Summary	Distinguishable Features
	Longitude	Latitude			
WW19	146.818511	-19.633603	Unmapped	<p><u>Bed and banks:</u></p> <ul style="list-style-type: none"> <li>- Defined top of bank is approximately 5m width</li> </ul> <p><u>Period of flow:</u></p> <ul style="list-style-type: none"> <li>- At the time of assessment, a deep pool of water was present at the assessment location, although flow was not evident.</li> </ul> <p><u>Flow adequacy:</u></p> <ul style="list-style-type: none"> <li>- At time of assessment there was no flow at the point of assessment. Steep waterway banks indicate sufficient periodic flow to produce erosional activity.</li> </ul> <p><u>Fish habitat:</u></p> <ul style="list-style-type: none"> <li>- A substantial pool of water was present at the assessment site. Pools of water were also recorded downstream at WW20.</li> </ul>	<p><i>Lophostemon grandiflorus</i>, <i>Acacia sp.</i> and <i>Cryptostegia grandiflora</i> (Indian rubber vine) fringing waterway. Steep waterway banks.</p>

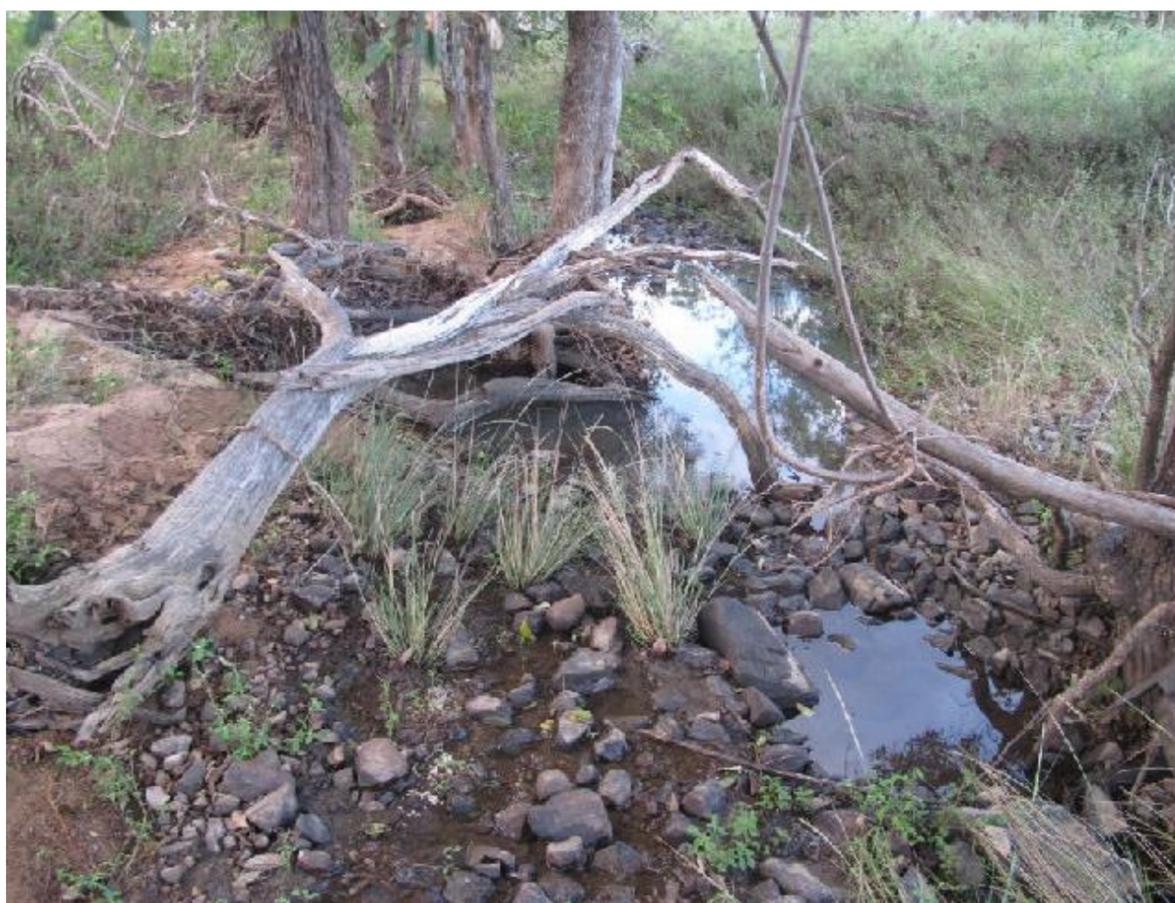
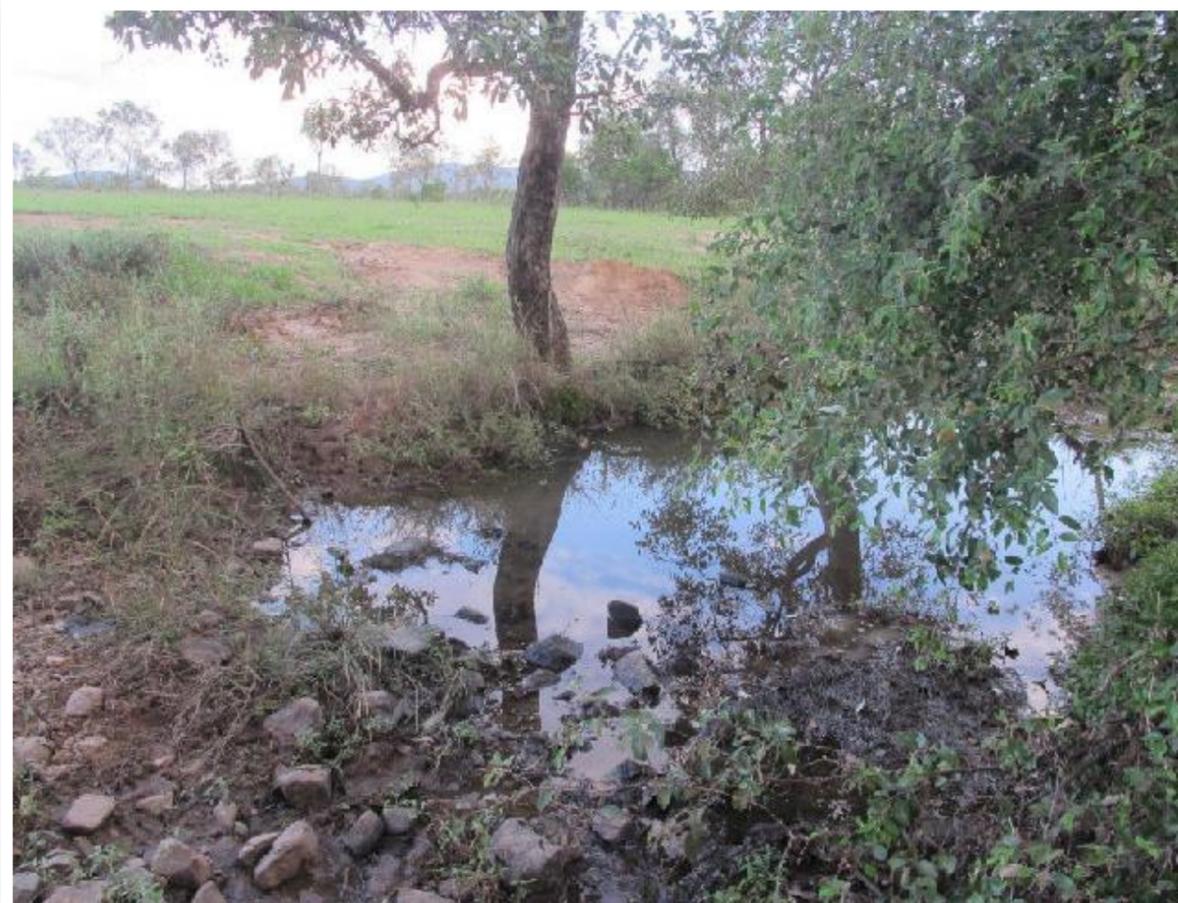
Survey Reference(s)	GPS		Water Act Classification	Field Survey Summary	Distinguishable Features
	Longitude	Latitude			
WW20	146.819245	-19.633788	Unmapped	<p><u>Bed and banks:</u></p> <ul style="list-style-type: none"> <li>- Defined top of bank is approximately 8m.</li> </ul> <p><u>Period of flow:</u></p> <ul style="list-style-type: none"> <li>- At the time of assessment pools of water were visible immediately either side of the assessment point.</li> </ul> <p><u>Flow adequacy:</u></p> <ul style="list-style-type: none"> <li>- At time of assessment there was no flow at the point of assessment. Pooling water and evidence of sediment deposition is present.</li> </ul> <p><u>Fish habitat:</u></p> <ul style="list-style-type: none"> <li>- Yes – Pools of water were visible both up and downstream of the survey location at the time of observation.</li> </ul>	<p><i>Lophostemon grandiflorus</i> growing along waterway banks. Evidence of cattle crossing of waterway.</p>

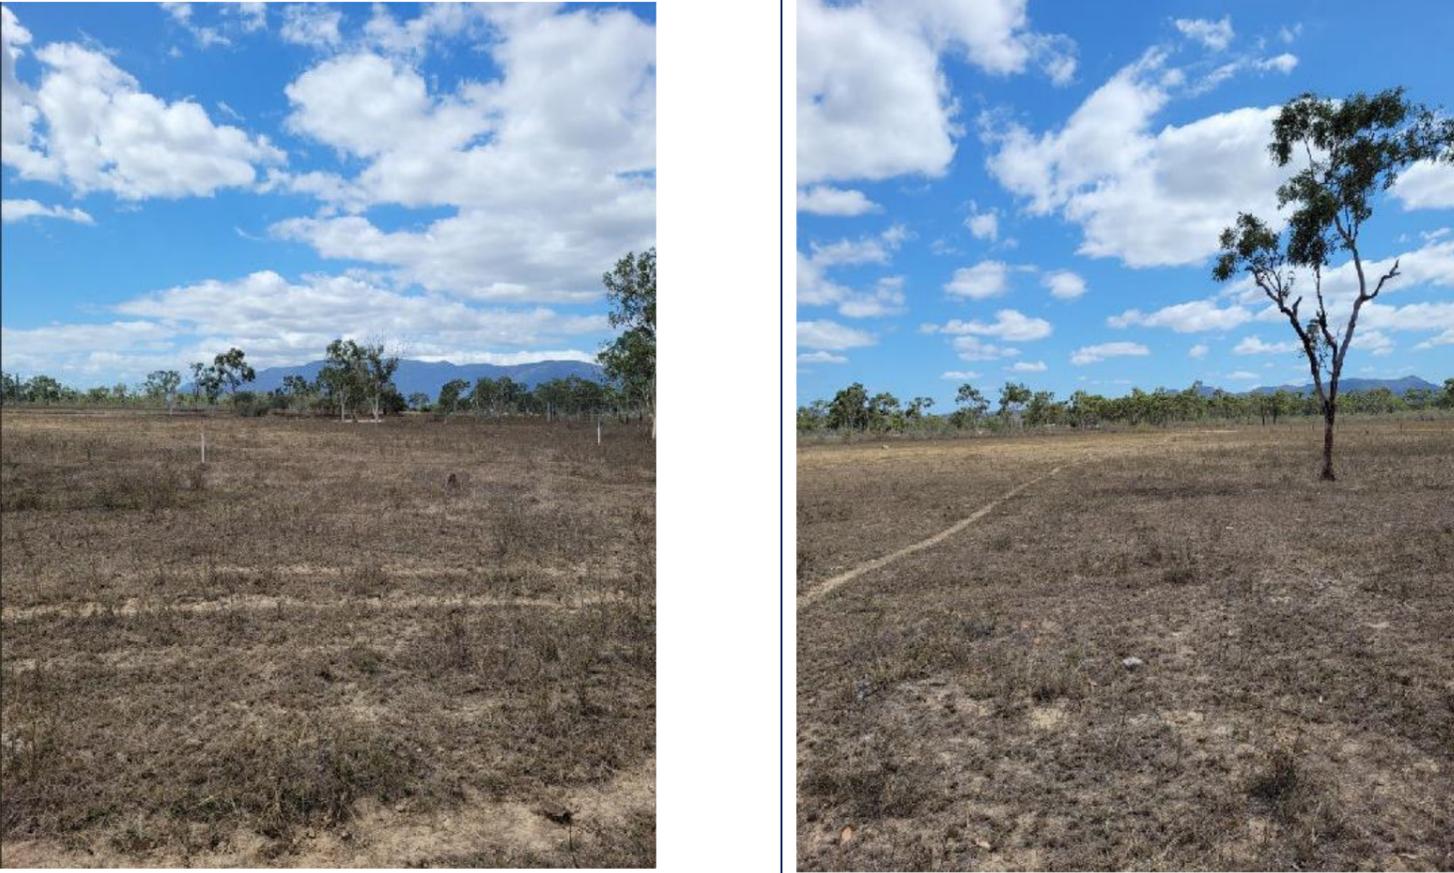
Survey Reference(s)	GPS		Water Act Classification	Field Survey Summary	Distinguishable Features
	Longitude	Latitude			
WW21	146.825489	-19.594135	Unmapped	<p><u>Bed and banks:</u></p> <ul style="list-style-type: none"> <li>- No defined bed or banks were evident at the time of traversing the site either upstream or downstream.</li> </ul> <p><u>Period of flow:</u></p> <ul style="list-style-type: none"> <li>- Unlikely – No flow was observed during either assessment period, however the landholder indicated that seasonal flow occurs from the dam located on Lot 80 E124325, through Lot 14 E124325 to the dam located on Lot 101 EP1666 during the wettest months at period of high rainfall.</li> <li>- Flows between farm dam on Lot 80 E124325 and link with the farm dam at WW21. A review of historical aerial imagery has not identified any water connections between these dams indicating that connection likely only occurs during periods of high and intense rainfall. This path is more representative of overland flow during high intensity rain events that funnels immediate rainfall and it therefore not considered to meet this criteria.</li> <li>- Culverts will be included as part of design to allow overland flow during high rainfall events from the farms dams to pass under the road.</li> </ul> <p><u>Flow adequacy:</u></p> <ul style="list-style-type: none"> <li>- Unlikely – Only overland flow is likely during high rainfall events. At time of assessment there was no flow at the point of assessment, with landholder observations indicate that periods of flow occur between private farm dams. No erosion or sediment deposition was observed. Culverts will be included as part of design to allow overland flow from the farms dams to pass under the temporary/permanent road.</li> </ul> <p><u>Fish habitat:</u></p> <ul style="list-style-type: none"> <li>- Unlikely – farm dam at WW21 is a private water source and will not be affected by the development of the LEIP. Overland flow paths near this location and between farm dams do not provide fish habitat with vegetation characterised by pasture grass and legume species.</li> </ul>	Vegetation characterised by pasture grass and legume species.

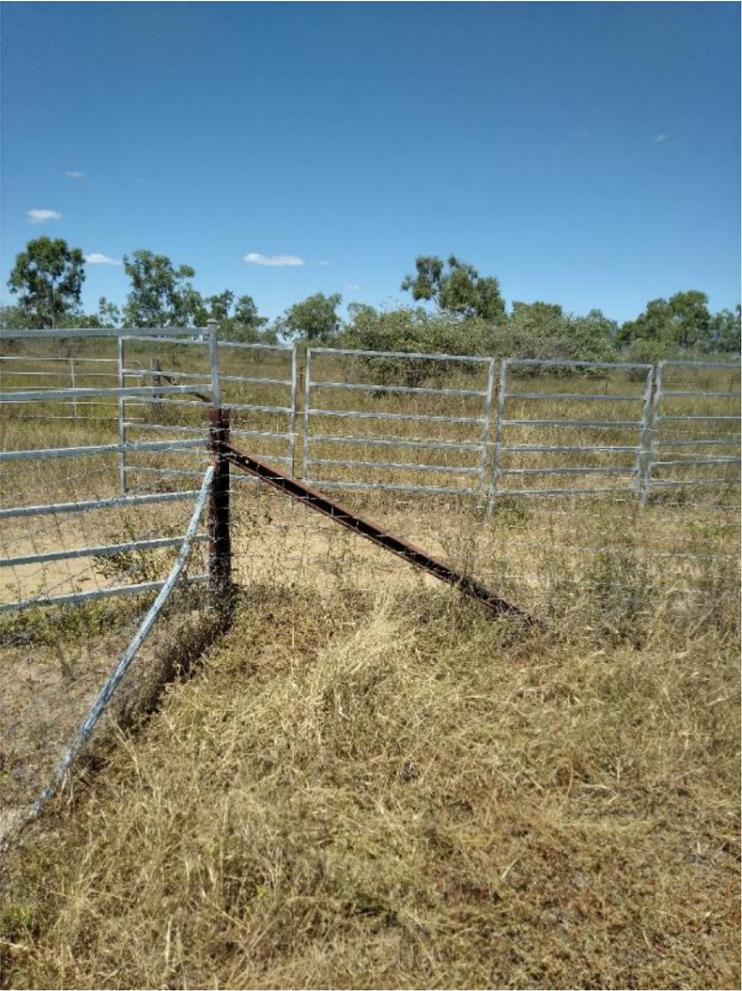
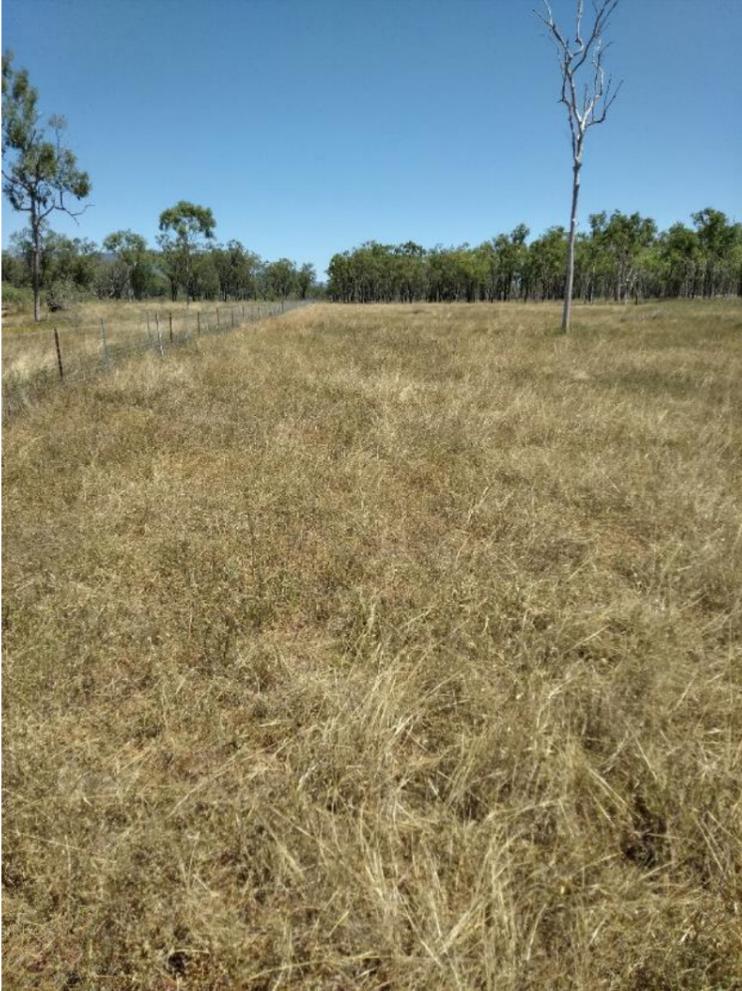
WW22	146.824499	-19.603952	Drainage feature	<p><u>Bed and banks:</u></p> <ul style="list-style-type: none"> <li>- Defined bed or banks are not in evidence</li> </ul> <p><u>Period of flow:</u></p> <ul style="list-style-type: none"> <li>- At the time of assessment, no water or waterlogging of soil was observable. Vegetation species observed in the vicinity were not wetland indicator species suggesting the area remains dry for extended periods.</li> </ul> <p><u>Flow adequacy:</u></p> <ul style="list-style-type: none"> <li>- No erosion, sediment deposition or other evidence of flow was observable.</li> </ul> <p><u>Fish habitat:</u></p> <ul style="list-style-type: none"> <li>- No water pooling or other evidence of fish habitat were observable on-ground or from available areal imagery. The waterway, as mapped extends a distance of less than 250m upstream of the observation point.</li> </ul>	Vegetation dominated by <i>Chloris virgata</i>

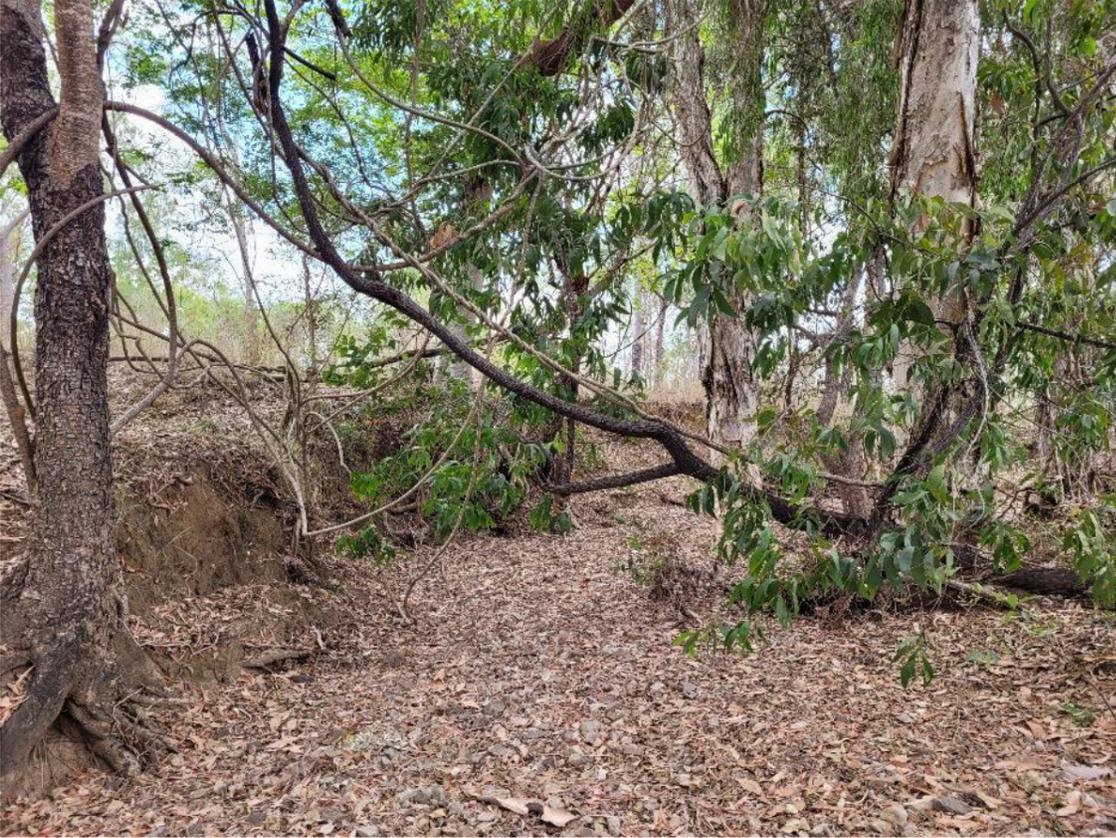
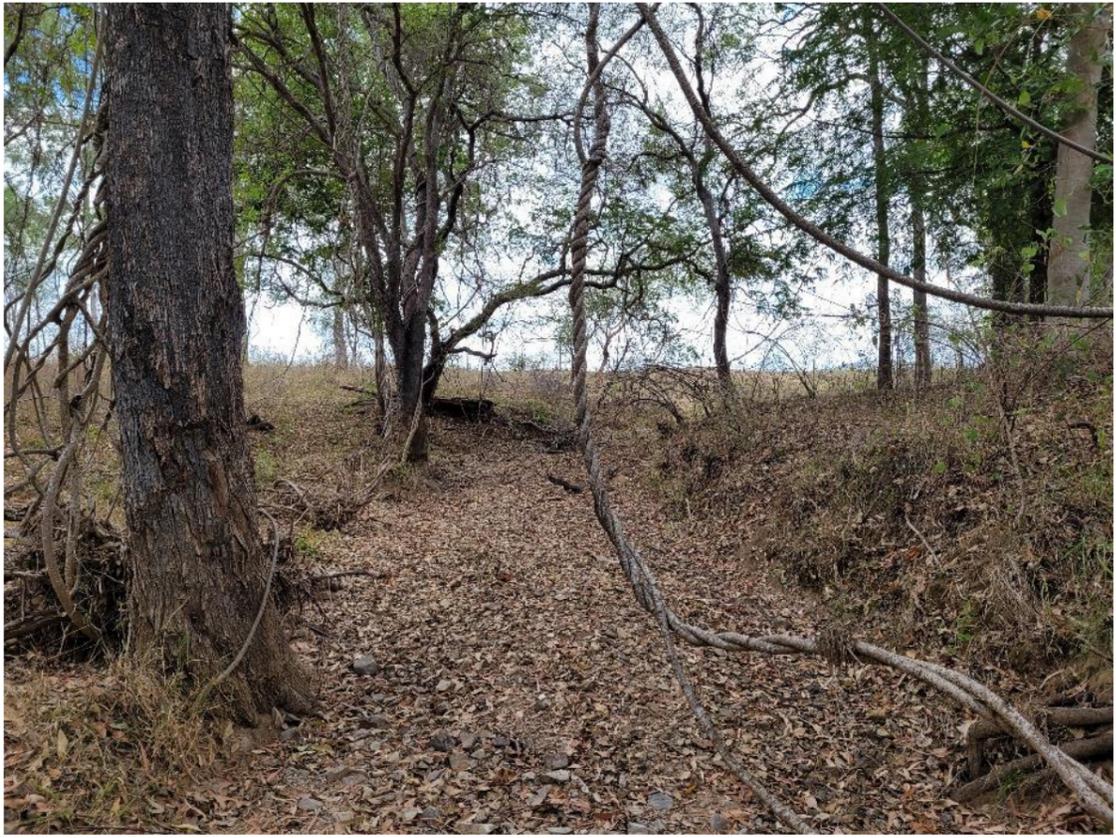
WWA	146.827636 E	-19.644679	Drainage feature	<p><u>Bed and banks:</u></p> <ul style="list-style-type: none"> <li>- Defined top of bank is approximately 13 m in width between top banks.</li> </ul> <p><u>Period of flow:</u></p> <ul style="list-style-type: none"> <li>- At the time of assessment, no water was present.</li> </ul> <p><u>Flow adequacy:</u></p> <ul style="list-style-type: none"> <li>- At the time of assessment, the North West bank showed significant erosional evidence at time of survey indicating that a significant volume of water has flowed through the area in the recent past</li> </ul> <p><u>Fish habitat:</u></p> <ul style="list-style-type: none"> <li>- Possibly - No water pools were observed in the vicinity however multiple wetland indicator species were present at the observation point and upstream.</li> </ul>	<p>Vegetation species found near bed and banks were included <i>Lophostemon grandifloras</i>, <i>Cyperus gracilis</i> and <i>Melaleuca sp.</i>, <i>Corymbia tessellaris</i> and Indian rubber vine.</p>

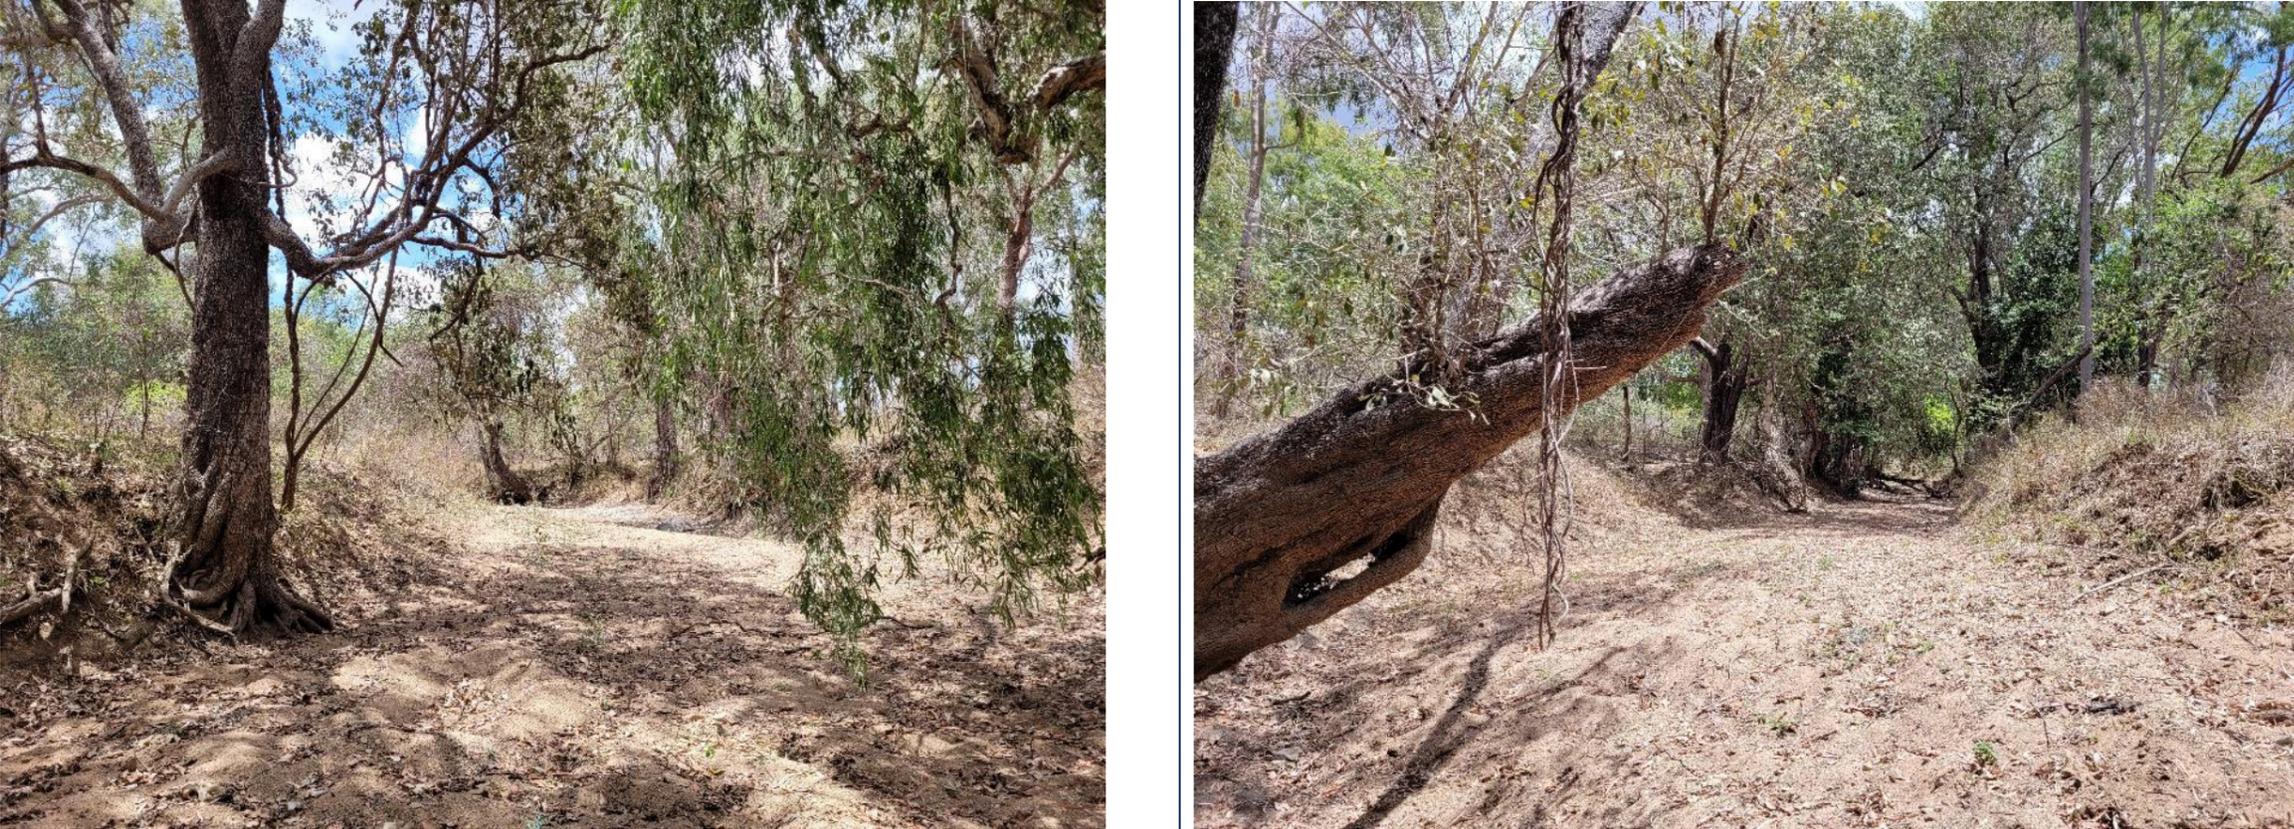
WWB	146.828531 E	-19.644767	Drainage feature	<p><u>Bed and banks:</u></p> <ul style="list-style-type: none"> <li>- Defined top of bank is approximately 3m high from lowest point of bed and 14m wide between top banks.</li> </ul> <p><u>Period of flow:</u></p> <ul style="list-style-type: none"> <li>- At the time of assessment, no water was present.</li> </ul> <p><u>Flow adequacy:</u></p> <ul style="list-style-type: none"> <li>- At the time of assessment erosional evidence was present around large tree roots at time of survey indicating that a significant volume of water has flowed through the area in the recent past.</li> </ul> <p><u>Fish habitat:</u></p> <ul style="list-style-type: none"> <li>- Possibly - No water pools were observed in the vicinity however multiple wetland indicator species were present at the observation point and upstream.</li> </ul>	<p>Drainage feature</p> <p><i>Lophostemon grandiflorus</i> and <i>Melaleuca sp.</i> located on waterway banks.</p>
