## **Appendix I Waterway Assessments**

## Waterway and Wetland Assessment:

**Table 3 Waterways Assessments**

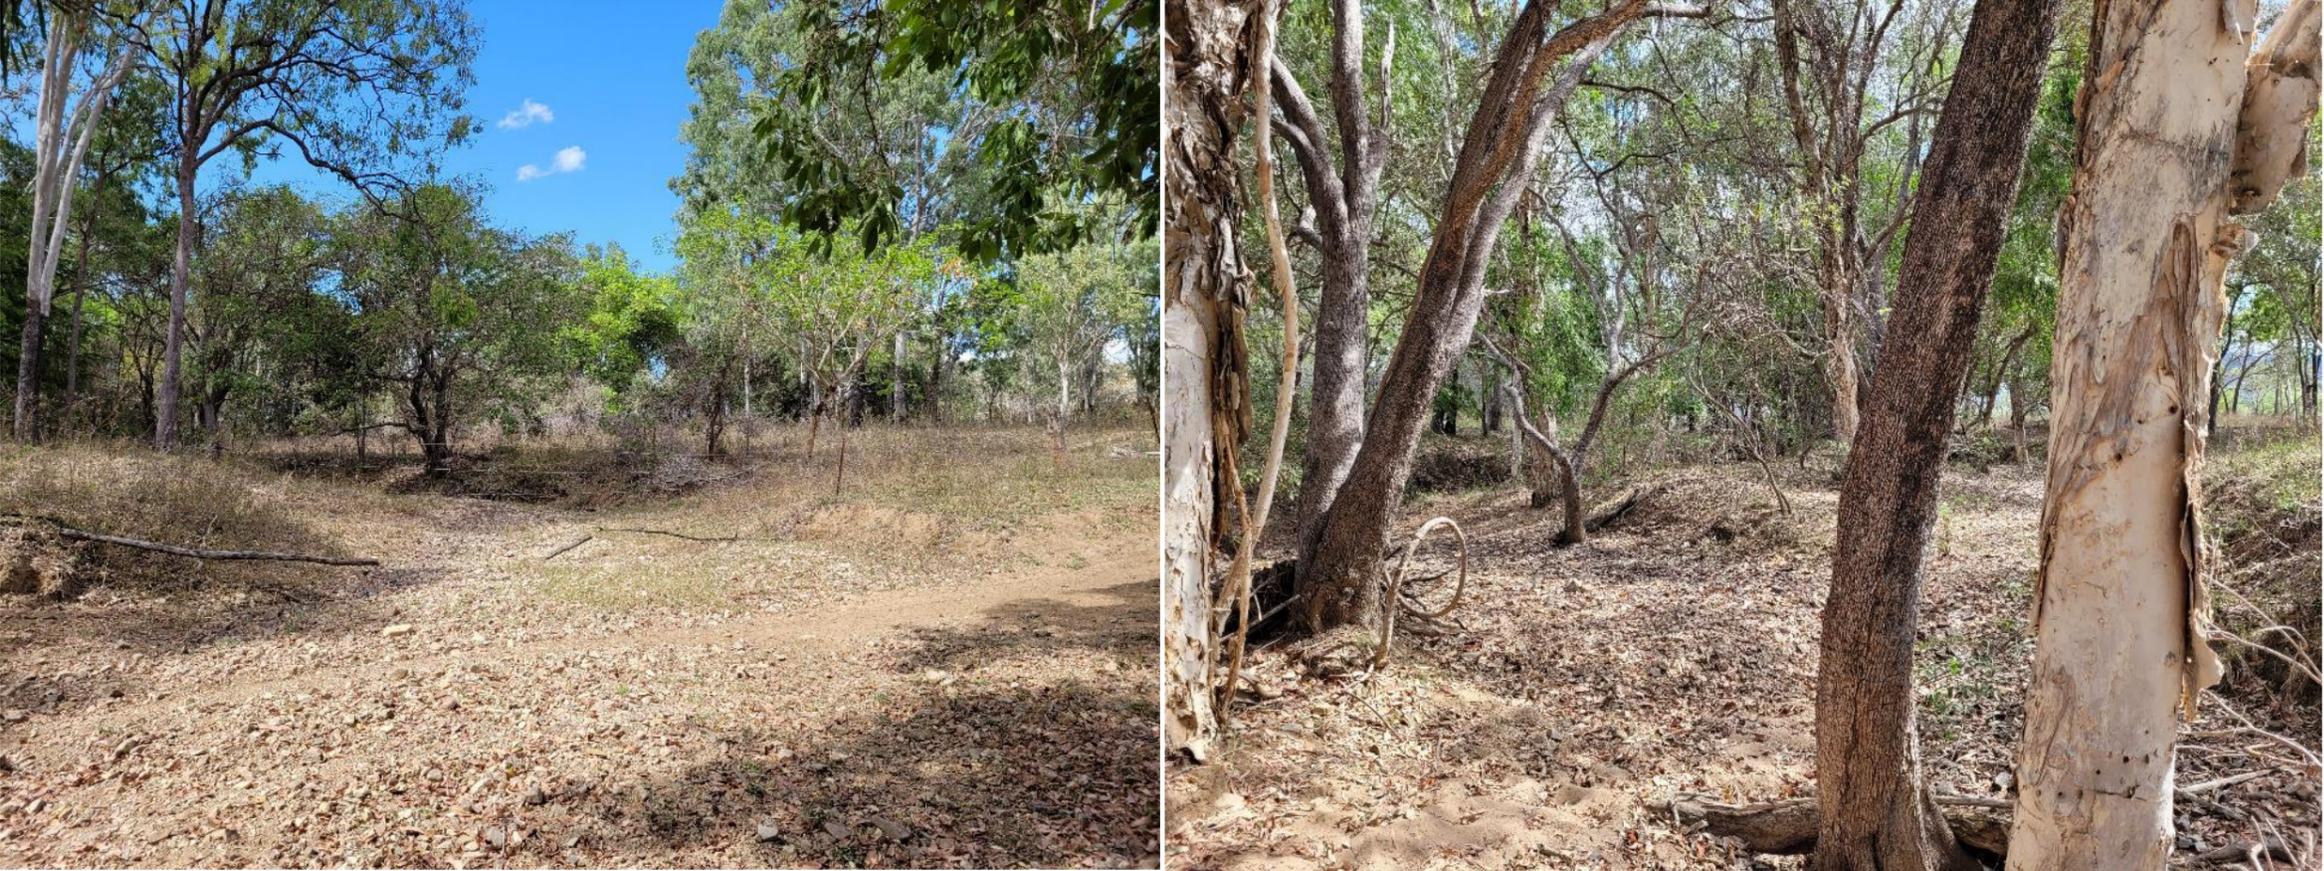
WWF	146.827662 E	-19.645087	Drainage feature	<p><u>Bed and banks:</u></p> <ul style="list-style-type: none"> <li>- Defined top of bank is approximately 1.6m high from lowest point of bed and 13m wide between top banks.</li> </ul> <p><u>Period of flow:</u></p> <ul style="list-style-type: none"> <li>- At the time of assessment pooled water upstream and downstream of the location would suggest that flow exists. However, alteration of the waterway at multiple locations to form dammed areas for agricultural use as visible in arial imagery may affect the period of flow</li> </ul> <p><u>Flow adequacy:</u></p> <ul style="list-style-type: none"> <li>- At the time of assessment pooled water upstream and downstream of the location would suggest that flow adequacy would exist.</li> </ul> <p><u>Fish habitat:</u></p> <p>Possibly - No water pools were observed in the vicinity however multiple wetland indicator species were present at the observation point and upstream.</p>	<p><i>Lophostemon grandifloras</i>, Indian rubber vine and <i>Melaleuca sp.</i> located on waterway banks. Vehicle track crossing located directly adjacent to observation point.</p>

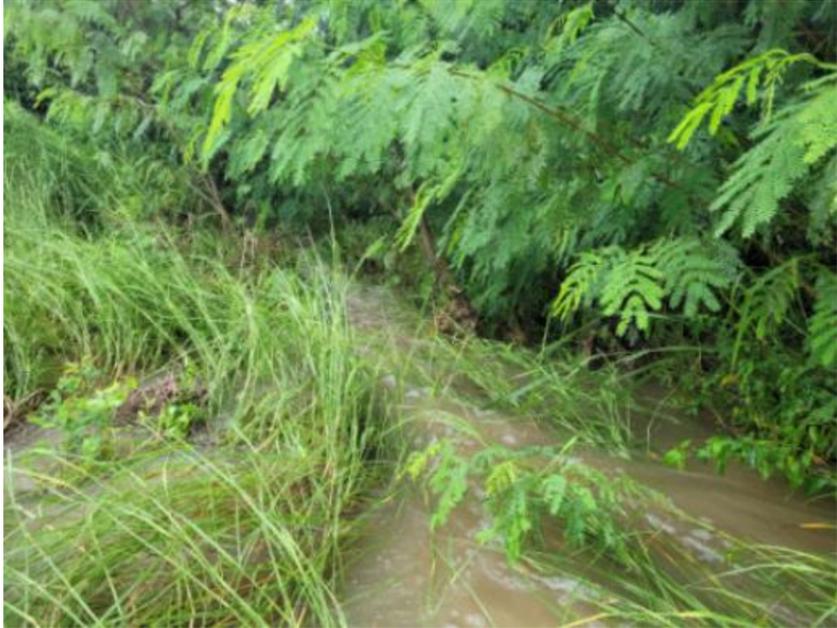
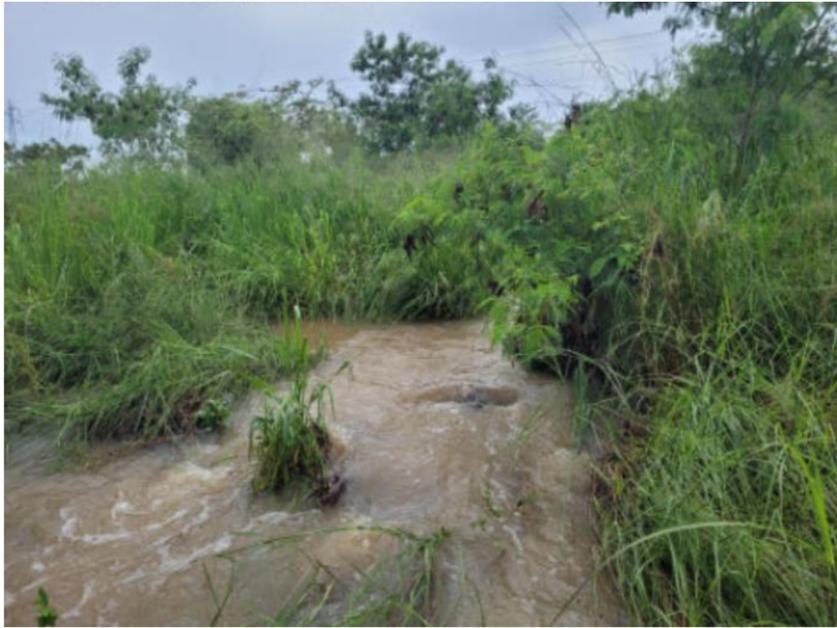
WWFA	146.835667	-19.598920	Drainage feature	<p><u>Bed and banks:</u></p> <ul style="list-style-type: none"> <li>- Defined top of bank is approximately 40 cm high from lowest point of bed and 9 m wide between top banks.</li> </ul> <p><u>Period of flow:</u></p> <ul style="list-style-type: none"> <li>- At the time of assessment, water was to an approximate depth of 20 cm.</li> </ul> <p><u>Flow adequacy:</u></p> <ul style="list-style-type: none"> <li>- At the time of assessment strong flow was observed. A deposit of brown coloured sediment was observed and water was turbid. Additionally, evidence of erosion with uprooted grass was also observed.</li> </ul> <p><u>Fish habitat:</u></p> <ul style="list-style-type: none"> <li>- Yes – A significant quantity of flowing water was present at the time of assessment</li> </ul>	<p><i>Lantana camara, Ziziphus mauritiana, Hyparrhenia rufa and Megathyrsus maximus</i></p>

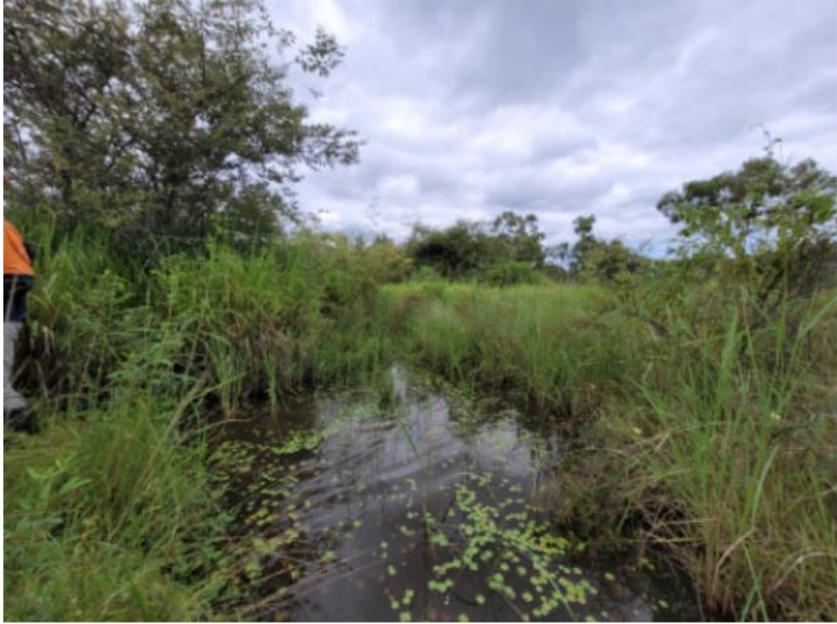
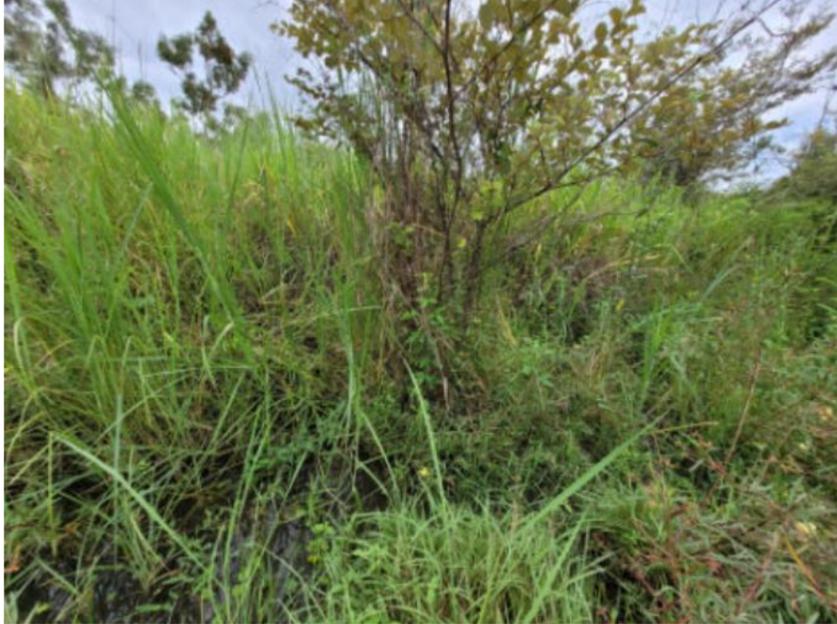
<b>WWFB</b>	146.847051	-19.593886	Not shown on mapping	<p><u>Bed and banks:</u></p> <ul style="list-style-type: none"> <li>- Defined top of bank is approximately 25 cm high from lowest point of bed and 3.5 m wide between top banks.</li> </ul> <p><u>Period of flow:</u></p> <ul style="list-style-type: none"> <li>- Potentially – water to an approximate depth of 20 cm was present during time of survey. Waterway became indistinct and was observed as a contained pond with moderately clear water.</li> </ul> <p><u>Flow adequacy:</u></p> <ul style="list-style-type: none"> <li>- Potential – Flow was not evident at the time of survey low observed.</li> </ul> <p><u>Fish habitat:</u></p> <ul style="list-style-type: none"> <li>- Yes – water was present and small (&lt;2.5cm) fish were observed.</li> </ul>	<p><i>Marsilea mutica, Ludwigia octovalvis, Cyperus spp.</i></p>

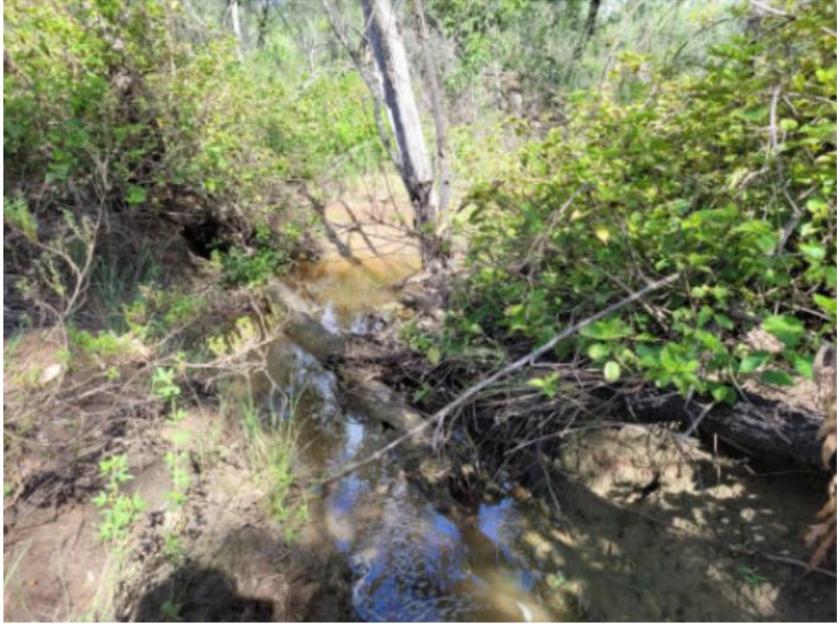
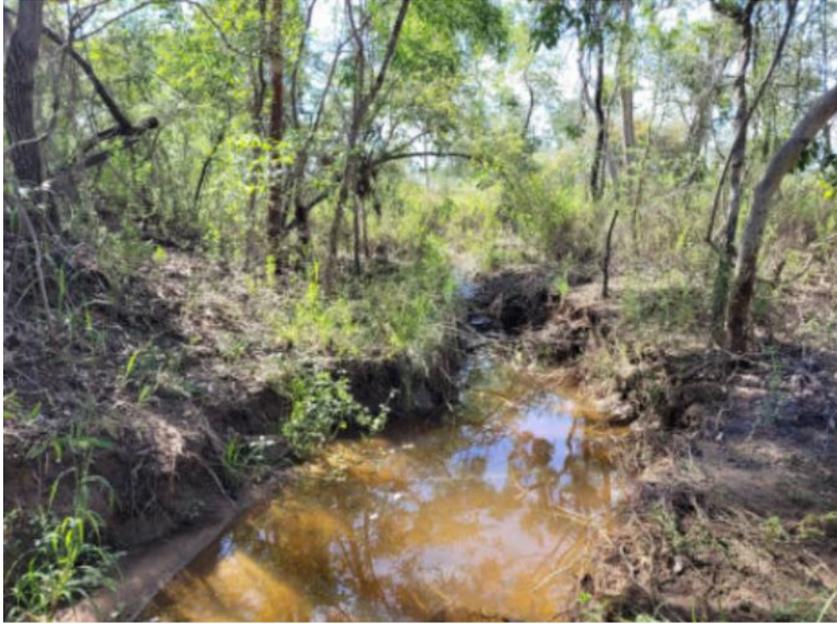
WWFC	146.868612	-19.599558	Unmapped feature	<p><u>Bed and banks:</u></p> <ul style="list-style-type: none"> <li>- Defined top of bank is approximately 50 cm high from lowest point of bed and 3 m wide between top banks.</li> </ul> <p><u>Period of flow:</u></p> <ul style="list-style-type: none"> <li>- Water was present during time of assessment.</li> </ul> <p><u>Flow adequacy:</u></p> <ul style="list-style-type: none"> <li>- Flow was observed at time of assessment. Sediment deposits varied with fine silt and clay and rocks up to 4 cm diameter in areas of stronger flow. Water was slightly tannin stained/yellow coloured. Erosion was evident on the banks.</li> </ul> <p><u>Fish habitat:</u></p> <ul style="list-style-type: none"> <li>- Yes – water was present and small fish were observed.</li> </ul>	<p>There were wetland indicator species.</p> <p>Vegetation species found near bed and banks included: <i>Lantana camara</i>, <i>Corymbia dallachiana</i>, <i>Corymbia platyphylla</i>, <i>Eremophila mitchellii</i>, <i>Stylosanthes scabra</i> &amp; <i>Cryptostegia grandiflora</i>.</p>

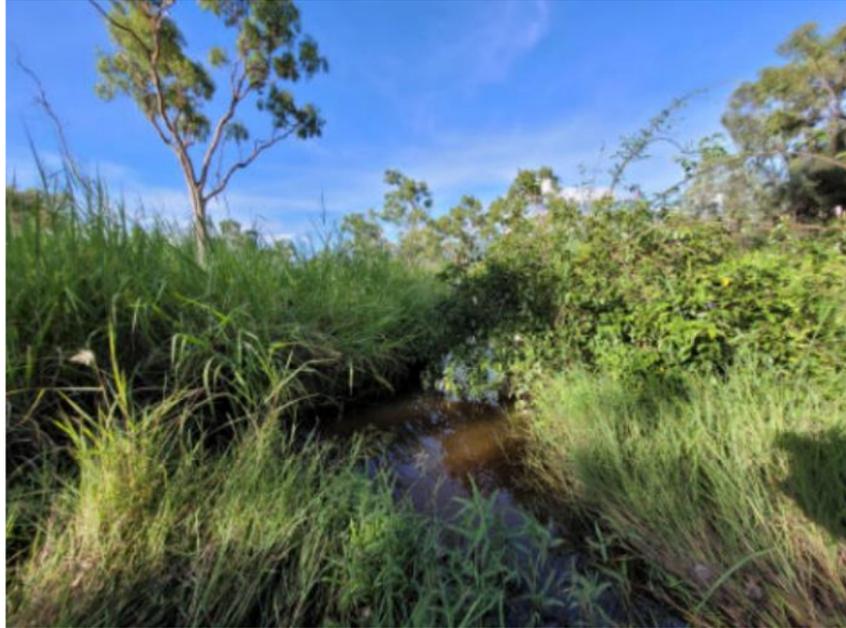
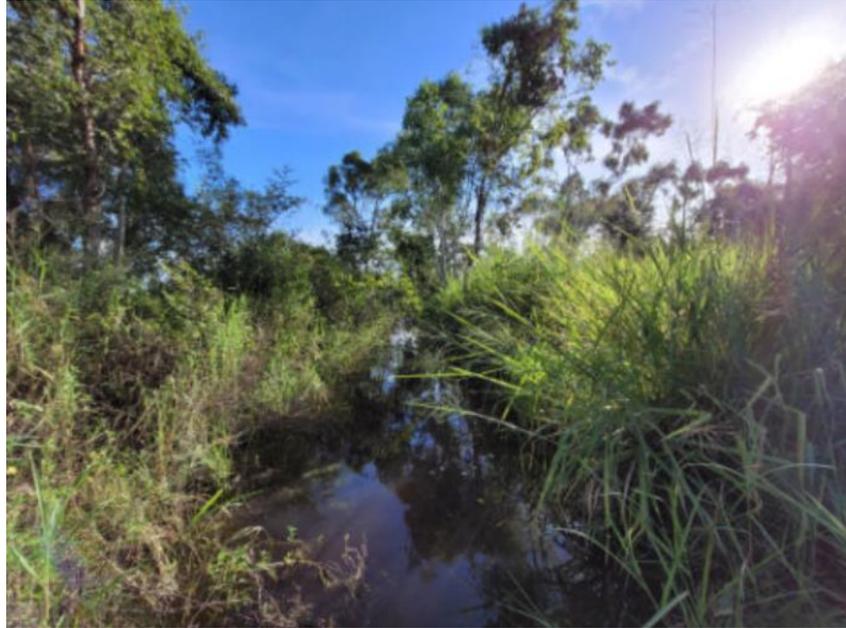
WWFD	146.872544	-19.599183	Not shown on mapping	<p><u>Bed and banks:</u></p> <ul style="list-style-type: none"> <li>- Defined top of bank is approximately 40 cm high from lowest point of bed and 3 m wide between top banks.</li> </ul> <p><u>Period of flow:</u></p> <ul style="list-style-type: none"> <li>- Water was present during time of assessment, to an approximate depth of 30 cm.</li> </ul> <p><u>Flow adequacy:</u></p> <ul style="list-style-type: none"> <li>- slow flow was observed at time of survey. There were deposits of fine silt. Water was slightly tannin stained.</li> </ul> <p><u>Fish habitat:</u></p> <ul style="list-style-type: none"> <li>- Yes – water was present and small fish were observed.</li> </ul>	<p>Vegetation species found near bed and banks included <i>Megathyrsus maximus</i>, <i>Cryptostegia grandiflora</i>, <i>Corymbia dallachiana</i>, <i>Corymbia platyphylla</i>, <i>Echinochloa sp.</i> and <i>Marsilea mutica</i></p>

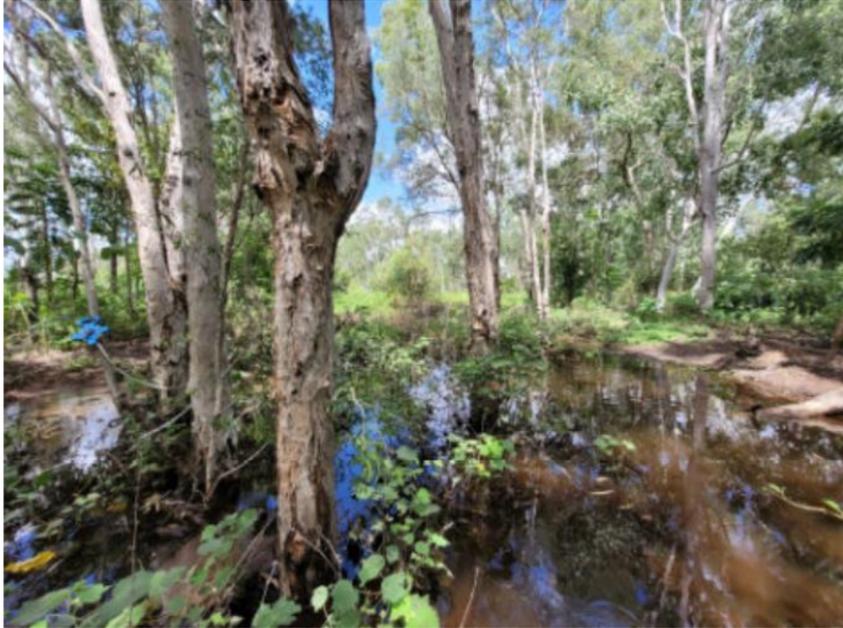
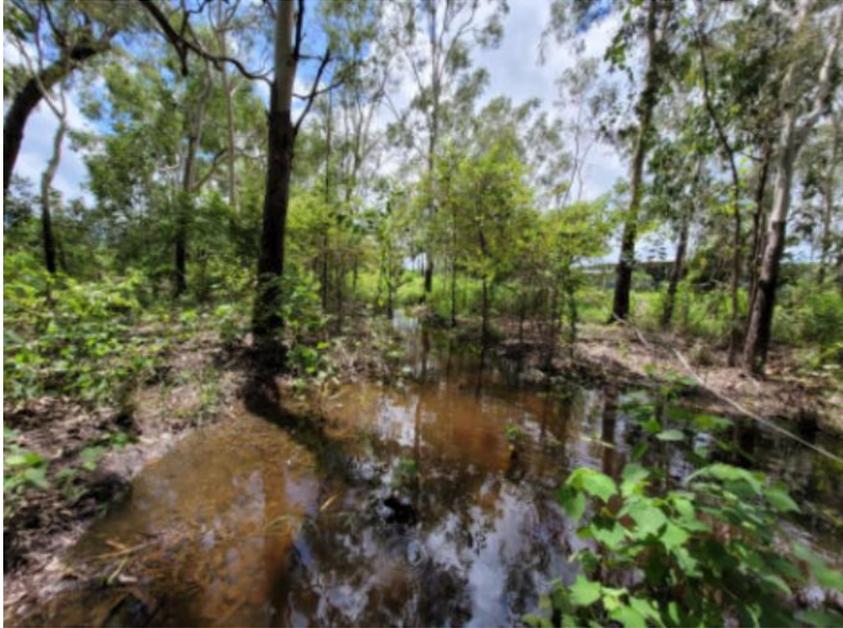
WWFE	146.898486	-19.599165	Not shown on mapping	<p><u>Bed and banks:</u></p> <ul style="list-style-type: none"> <li>- Defined top of bank is approximately 50 cm high from lowest point of bed and 15 m wide between top banks.</li> </ul> <p><u>Period of flow:</u></p> <ul style="list-style-type: none"> <li>- Water was present during time of assessment, to an approximate depth of 20 cm. Water was slightly tannin stained.</li> </ul> <p><u>Flow adequacy:</u></p> <ul style="list-style-type: none"> <li>- Yes – no flow was observed at time of survey but snags were observed to 40cm.</li> </ul> <p><u>Fish habitat:</u></p> <ul style="list-style-type: none"> <li>- Yes – water was present and small fish were observed.</li> </ul>	Vegetation species found near bed and banks included <i>Melaleuca sp.</i> , <i>Cyperus sp.</i> and <i>Juncus sp.</i>

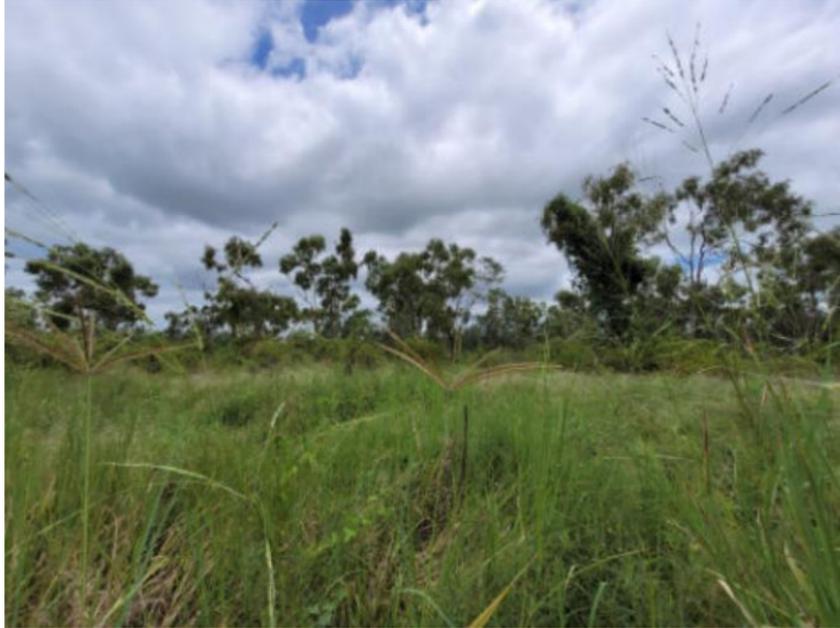
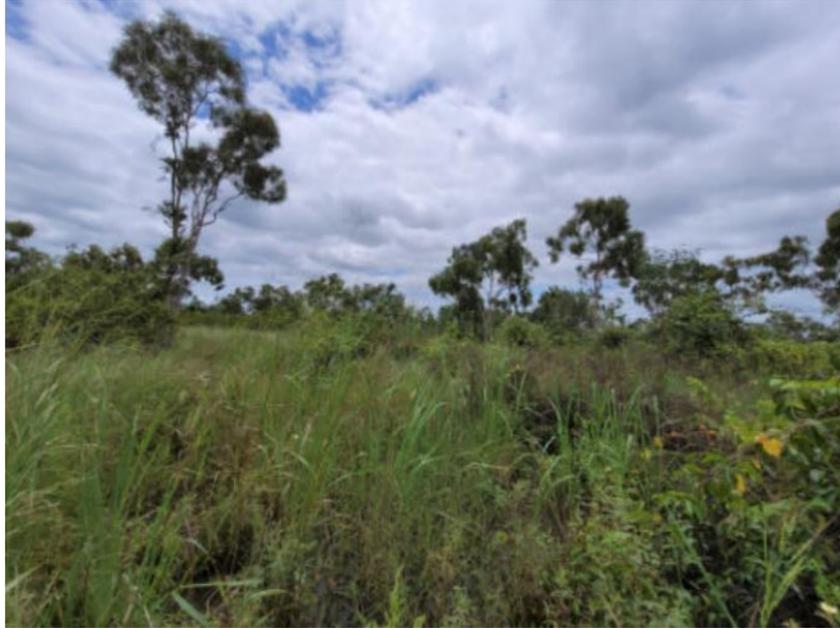
WWFF	146.853653	-19.595488	Not shown on mapping	<p><u>Bed and banks:</u></p> <ul style="list-style-type: none"> <li>- No – A waterway bed and bank was not clearly defined.</li> </ul> <p><u>Period of flow:</u></p> <ul style="list-style-type: none"> <li>- Potentially – an artificial drain may contribute to water movement. Water to a depth of 2.5cm was present with a clay substrate.</li> </ul> <p><u>Flow adequacy:</u></p> <ul style="list-style-type: none"> <li>- Potentially – flow was not evident at the time of observation.</li> </ul> <p><u>Fish habitat:</u></p> <ul style="list-style-type: none"> <li>- Yes – water was present and small fish were observed.</li> </ul>	<p>Vegetation species found near bed and banks included <i>Cyperus sp.</i>, <i>Ludwigia octovalvis</i>, <i>Marsilea mutica</i> and <i>Eclipta prostrata</i></p>

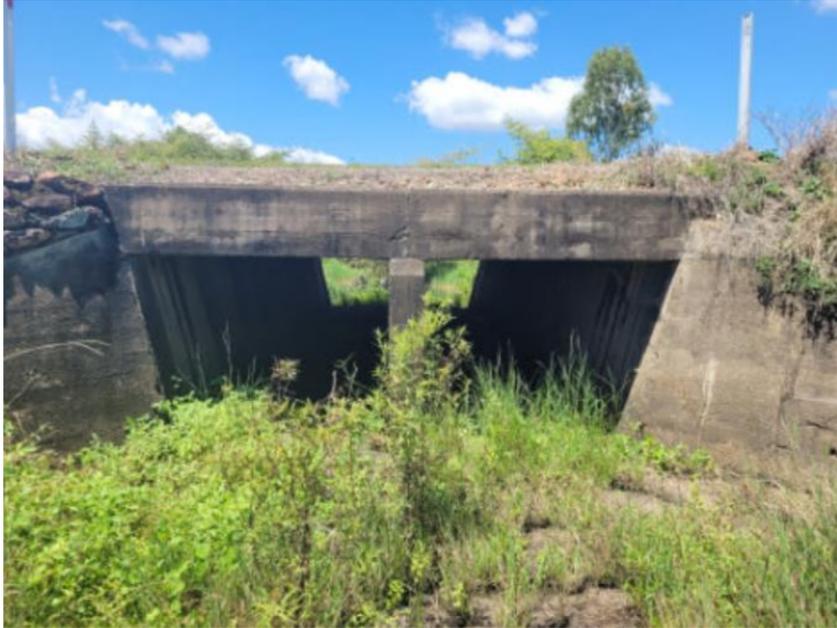
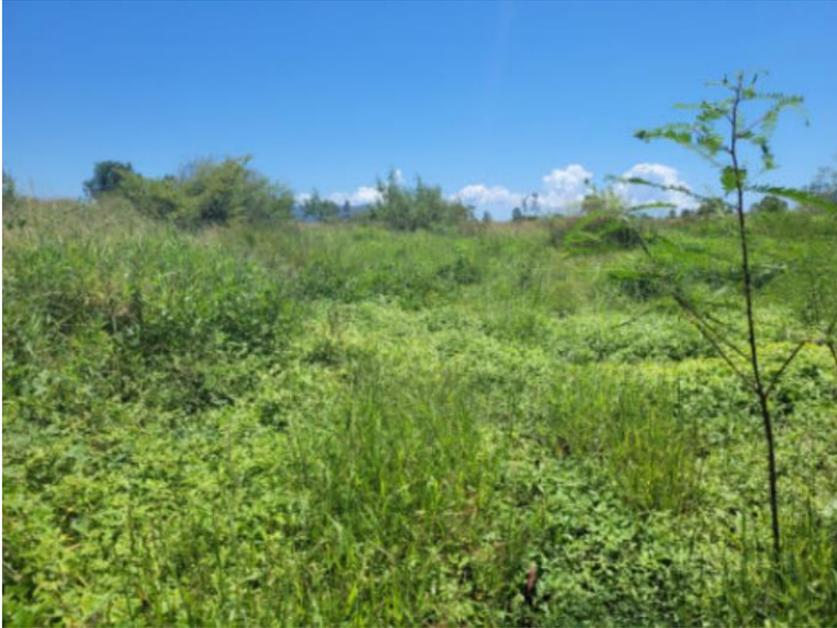
<b>WWM1</b>	146.834649	-19.591056	Unmapped feature	<p><u>Bed and banks:</u></p> <ul style="list-style-type: none"> <li>- Yes – Culvert under road. Defined top of bank is approximately 50 cm deep from top of bank and 5 m wide between top banks.</li> </ul> <p><u>Period of flow:</u></p> <ul style="list-style-type: none"> <li>- Potentially – fringing grasses were fattened in the direction of flow.</li> </ul> <p><u>Flow adequacy:</u></p> <ul style="list-style-type: none"> <li>- Potential – Water pooled downstream of assessment point location, on opposite side of road.</li> </ul> <p><u>Fish habitat:</u></p> <ul style="list-style-type: none"> <li>- Yes – small fish were observed in pooled water upstream of the assessment location, at WWM2.</li> </ul>	<p><i>Ludwigia ocovalvis</i> and <i>Alternanthera denticulata</i> in channel.</p> <p><i>Echinochloa muricata</i> and <i>Paspalum conjugatum</i> present along banks.</p>

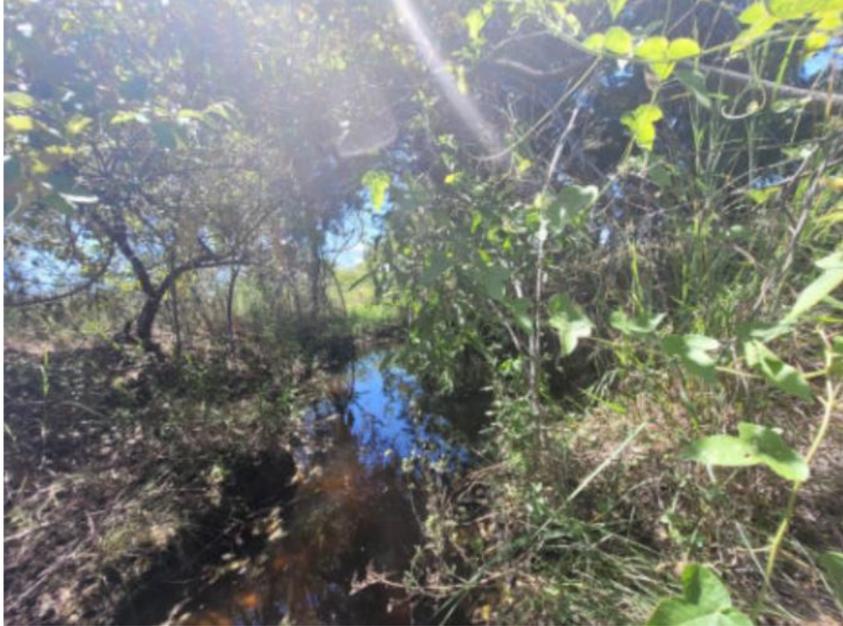
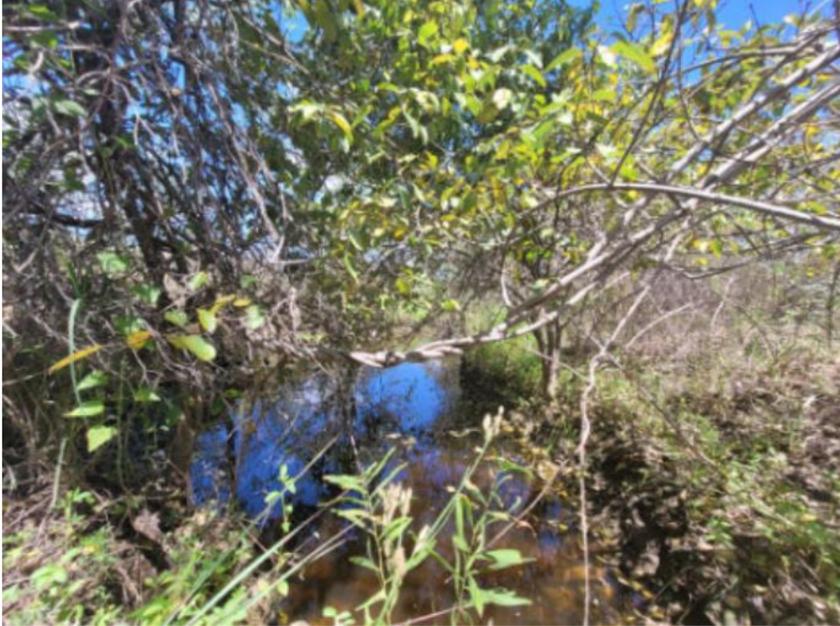
<b>WWM2</b>	146.834852	-19.591923	Not shown on mapping	<p><u>Bed and banks:</u></p> <ul style="list-style-type: none"> <li>- Defined top of bank is approximately 1 m deep from top of bank and 8 m wide between top banks.</li> </ul> <p><u>Period of flow:</u></p> <ul style="list-style-type: none"> <li>- Potentially – Pooled, tannin stained water to approximately 30cm in depth was present at the time of assessment.</li> </ul> <p><u>Flow adequacy:</u></p> <ul style="list-style-type: none"> <li>- Potential – sediment deposition of clay.</li> </ul> <p><u>Fish habitat:</u></p> <ul style="list-style-type: none"> <li>- Yes – small fish were observed in pooled water at the time of assessment. An empty Bi-valve shell was observed at the assessment location.</li> </ul>	<p>Dominated by <i>Ziziphus mauritiana</i> and <i>Cryptostegia grandiflora</i>.</p> <p><i>Cyperus sp.</i> and <i>Bolboschoenus sp.</i> were observed on waters edge.</p>

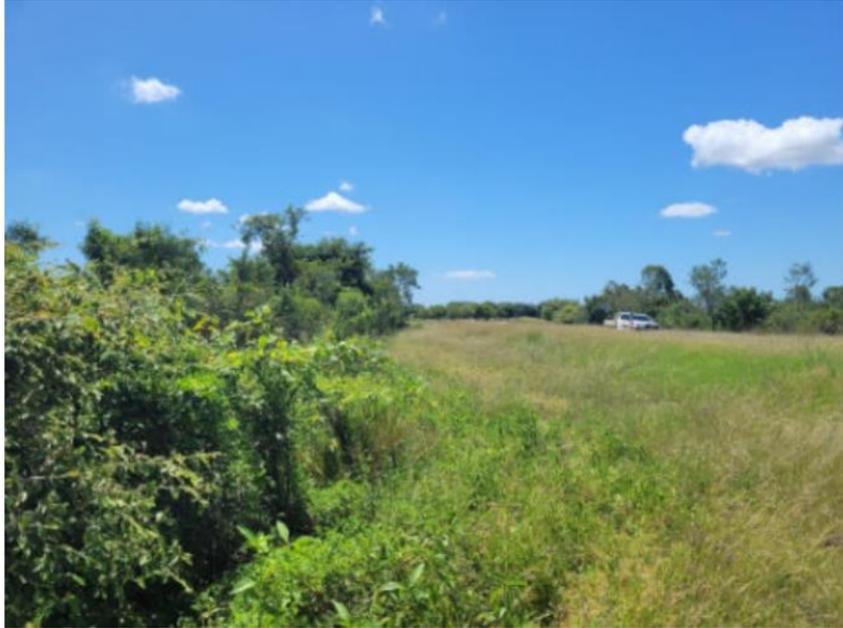
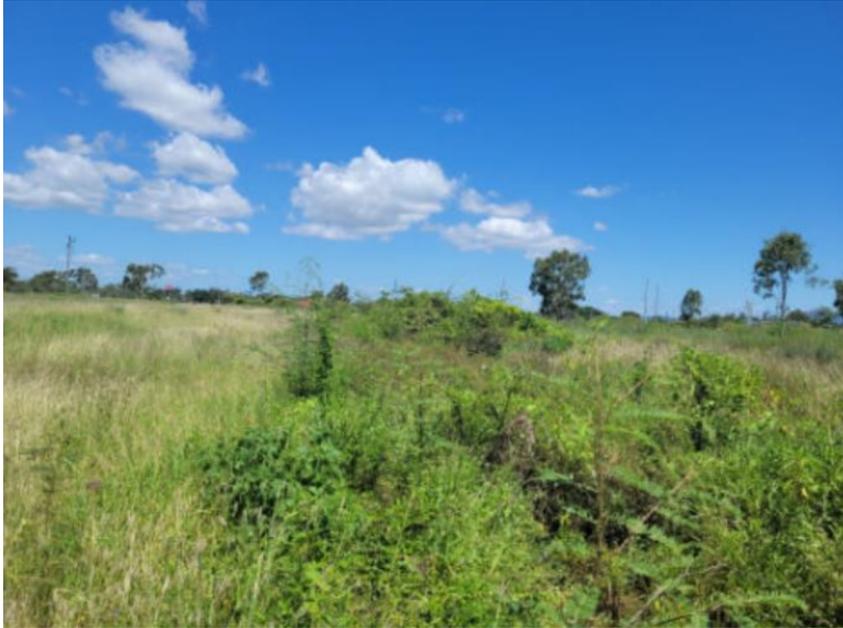
<b>WWM3</b>	146.835029	-19.592211	Not shown on mapping	<p><u>Bed and banks:</u></p> <ul style="list-style-type: none"> <li>- Defined top of bank is approximately 80 cm deep from top of bank and 5.5 m wide between top banks.</li> </ul> <p><u>Period of flow:</u></p> <ul style="list-style-type: none"> <li>- Potentially – Pooled water with algal growth to a depth of 30cm.</li> </ul> <p><u>Flow adequacy:</u></p> <ul style="list-style-type: none"> <li>- Potential – sediment deposition of clay.</li> </ul> <p><u>Fish habitat:</u></p> <ul style="list-style-type: none"> <li>- Yes – pooled water was observed upstream of the assessment location, at WWM4.</li> </ul>	<p><i>Leucas lavandulifolia</i> and <i>Ziziphus mauritiana</i> present within water channel.</p> <p>Channel fringed by mixed grass species.</p>

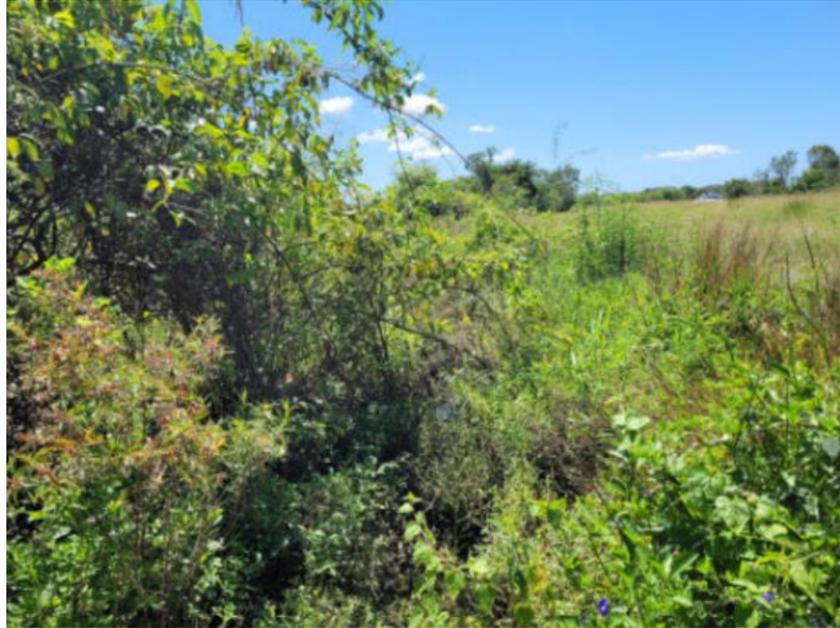
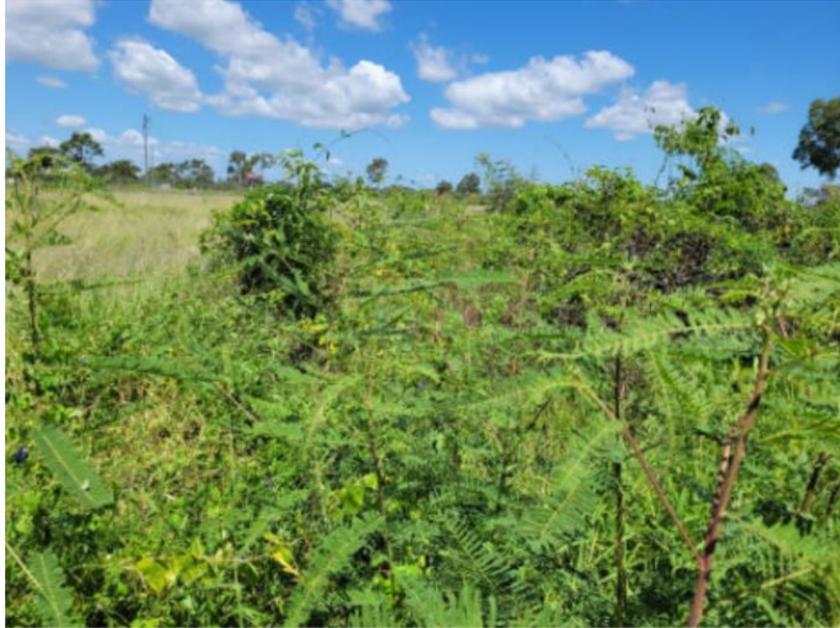
<b>WWM4</b>	146.835192	-19.59246	Not shown on mapping	<p><u>Bed and banks:</u></p> <ul style="list-style-type: none"> <li>- Defined top of bank is approximately 70 cm deep from top of bank and 4.5 m wide between top banks.</li> </ul> <p><u>Period of flow:</u></p> <ul style="list-style-type: none"> <li>- Potentially – Pooled water to 10cm depth.</li> </ul> <p><u>Flow adequacy:</u></p> <ul style="list-style-type: none"> <li>- Potential – sediment deposition of clay.</li> </ul> <p><u>Fish habitat:</u></p> <ul style="list-style-type: none"> <li>- Potentially - Waterway bed and banks become undefined within 5m upstream of assessment location.</li> </ul>	<p><i>Eclipta prostrata, Ludwigia octovalvis</i> and algal growth present in channel.</p> <p><i>Clitoria ternatea, Cryptostegia grandiflora</i> and <i>Heteropogon contortus</i> fringing channel.</p>

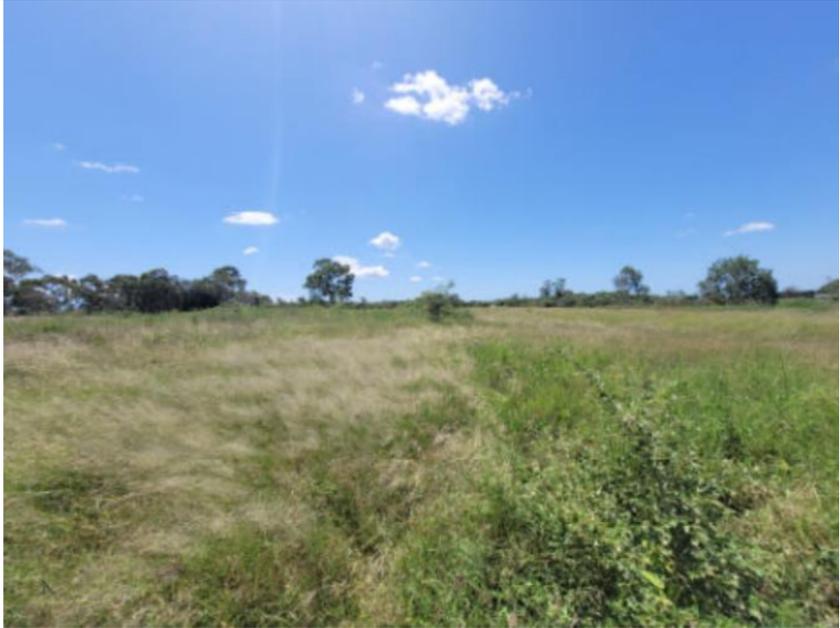
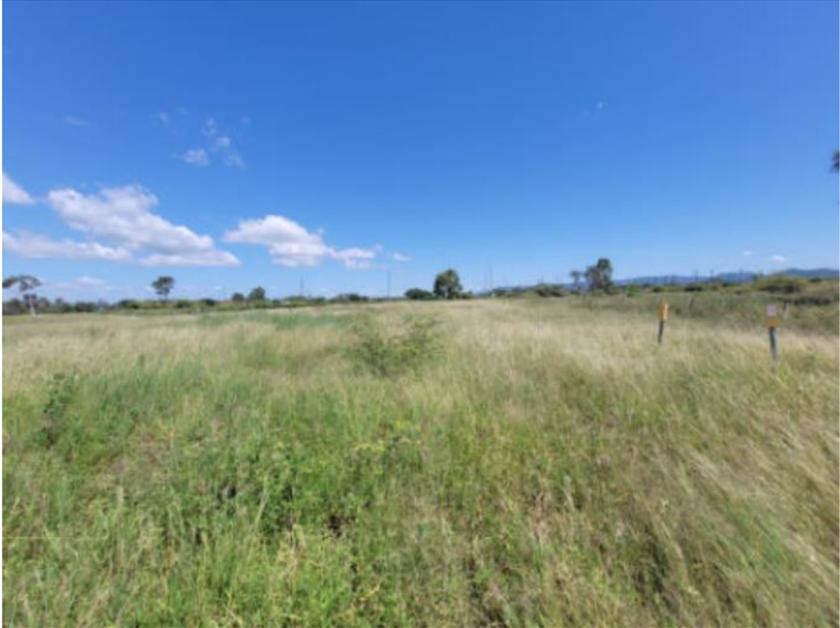
WWM5	146.8354	-19.592812	Not shown on mapping	<p><u>Bed and banks:</u></p> <ul style="list-style-type: none"> <li>- Defined top of bank is approximately 50 cm deep from top of bank and 8.55 m wide between top banks.</li> </ul> <p><u>Period of flow:</u></p> <ul style="list-style-type: none"> <li>- Potential – No evidence of flow in the form of vegetation snags or bank erosion, defined channel persist and clay deposition present in channel.</li> </ul> <p><u>Flow adequacy:</u></p> <ul style="list-style-type: none"> <li>- Potential – sediment deposition of clay.</li> </ul> <p><u>Fish habitat:</u></p> <ul style="list-style-type: none"> <li>- Yes – small fish were observed in pooled water upstream of the assessment location, at WWM2.</li> </ul>	<i>Alternanthera denticulate</i> growing amongst low grass cover.

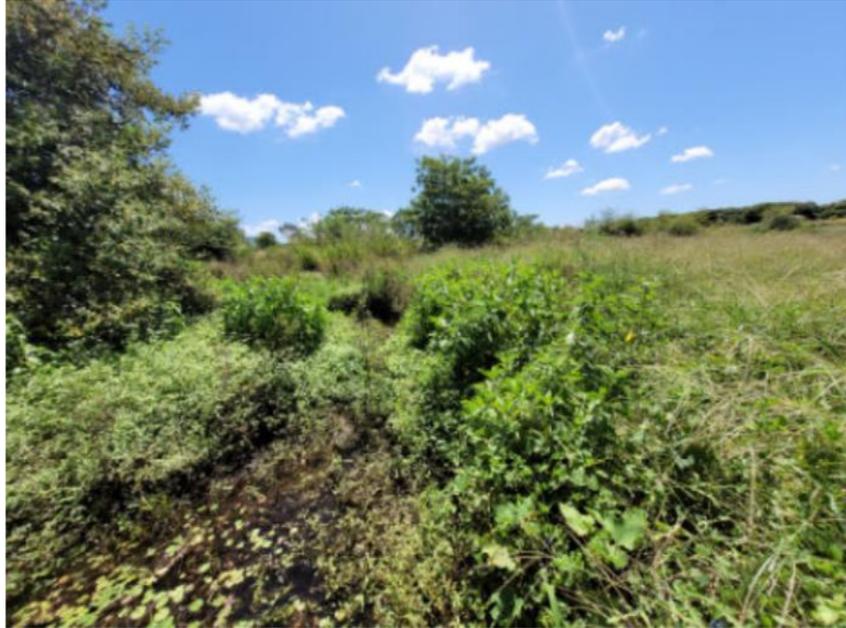
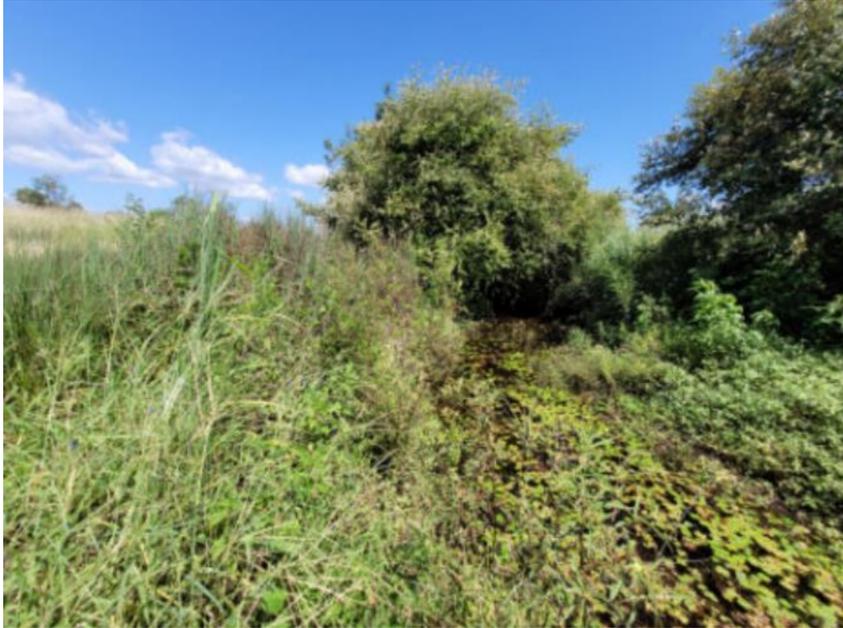
<b>WWM6</b>	146.834762	-19.591324	Not shown on mapping	<p><u>Bed and banks:</u></p> <ul style="list-style-type: none"> <li>- Yes - Defined top of bank is approximately 1.2 m deep</li> </ul> <p><u>Period of flow:</u></p> <ul style="list-style-type: none"> <li>- Potentially – pooled water present at time of survey.</li> </ul> <p><u>Flow adequacy:</u></p> <ul style="list-style-type: none"> <li>- Potentially – sediment deposition of clay.</li> </ul> <p><u>Fish habitat:</u></p> <ul style="list-style-type: none"> <li>- Yes – pooled water present at time of survey.</li> </ul>	<p><i>Marsilea mutica, Alternanthera denticulata, Potamogeton tricarinatus and Nymphoides crenata</i> growing in water pool.</p> <p><i>Ludwigia octovalvis, Alternanthera denticulata, Clitoria ternatea, Cyperus sp, and Heteropogon contortus</i> dominated mixed grasses present on banks.</p>
