RE: 49 Sixth Avenue East, South Townsville

Condition Report

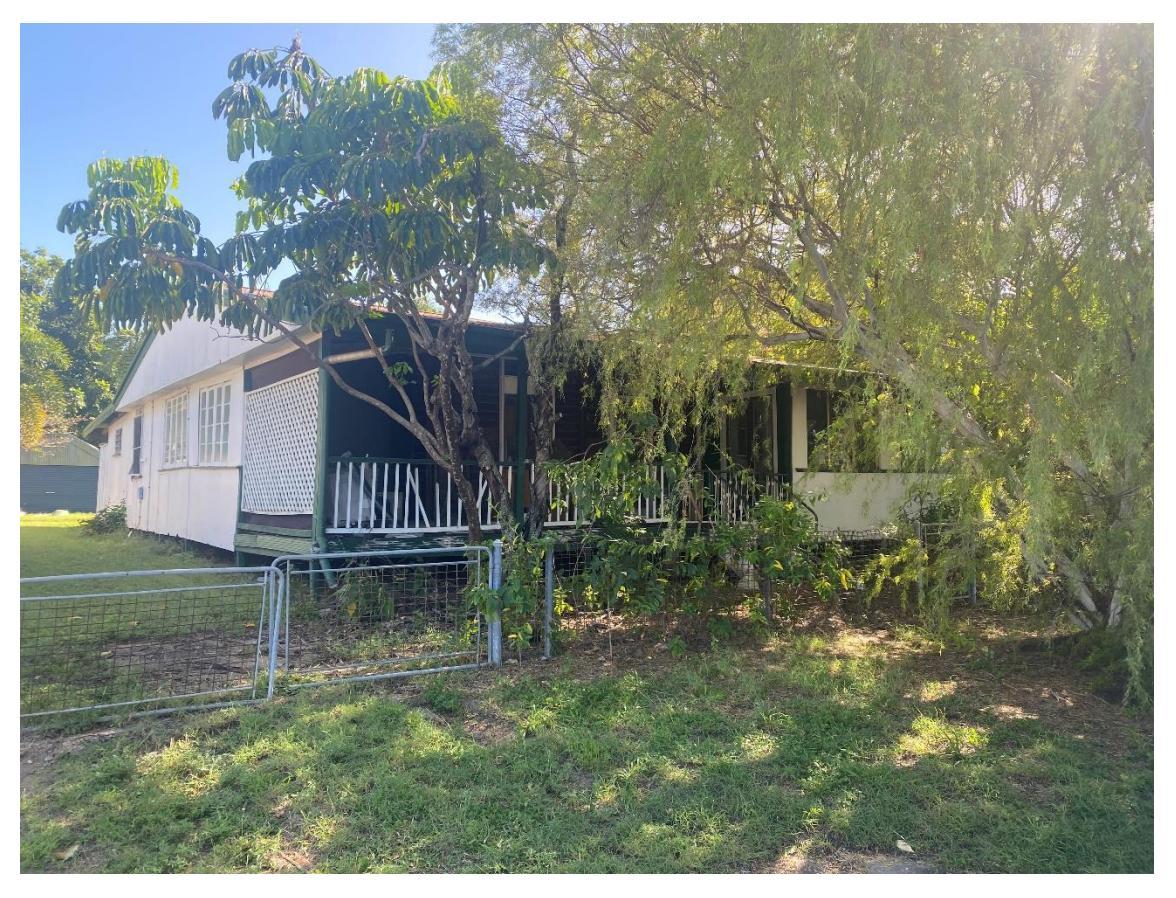
Image 1 – General view of the residential dwelling from the front of the property. The residential dwelling is timber framed construction on stumps.

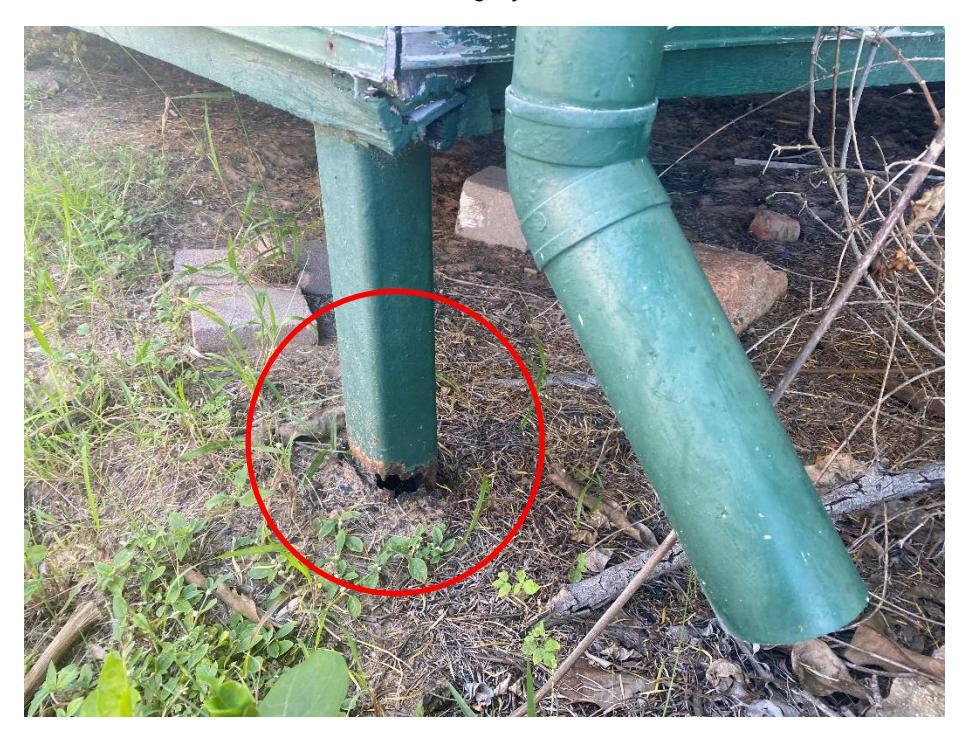
Steel stumps have been installed to the perimeter of the residence, presumably to replace original timber stumps. The steel stumps have severely corroded and in some cases have lost all their structural integrity.

Image 2 - Severely corroded steel stump.

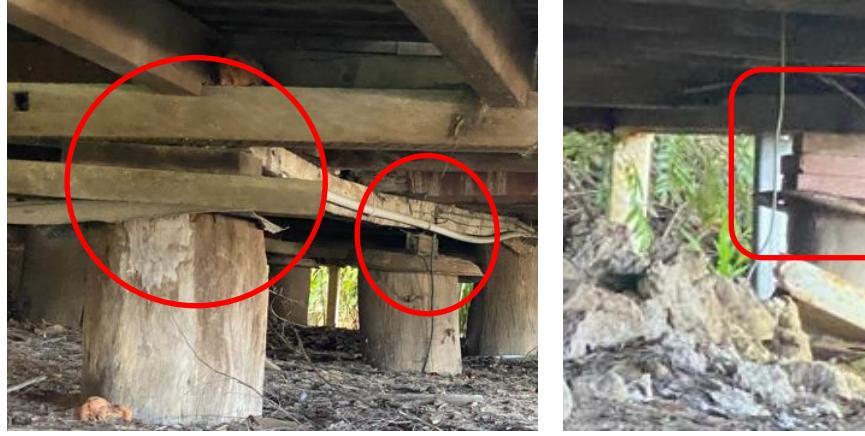
Timber stumps remained to the internal areas of the sub-floor. While they appeared to generally be in reasonable condition, it was noted that packing had been provided between the top of the stump and the underside of many of the bearers.

Image 3 – Packing from stump to bearer.

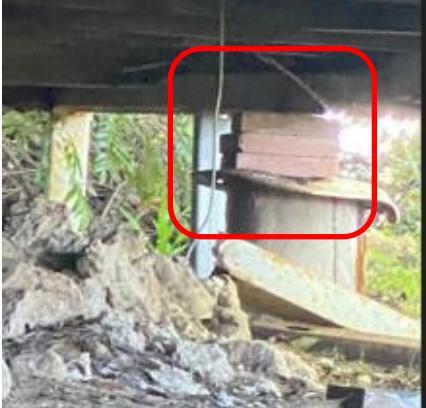
Image 4 – Packing from stump to bearer.

No tie down or connection of the bearers to the stumps was observed.

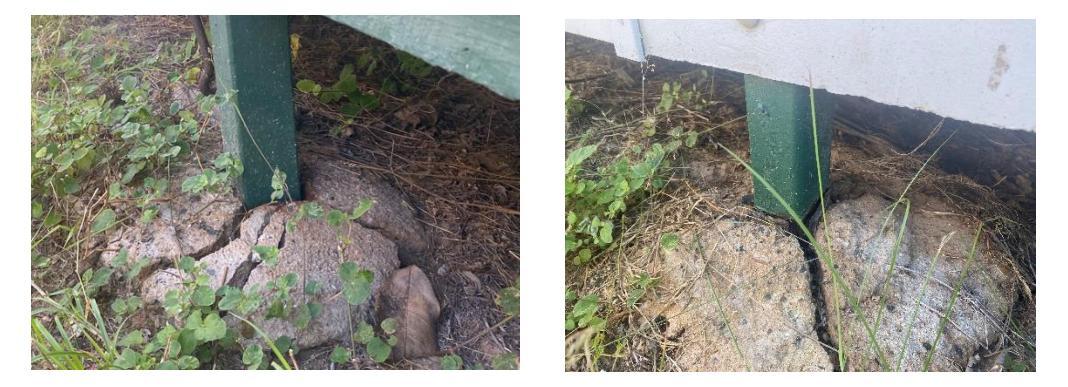
Concrete footing sizes could not be determined. Where domed concrete was provided to the steel stumps, the concrete had severely cracked. This allows moisture to enter and corrode the steel section below the top of the footing.

Image 5 & 6 – Severely cracked domed concrete at steel stumps.

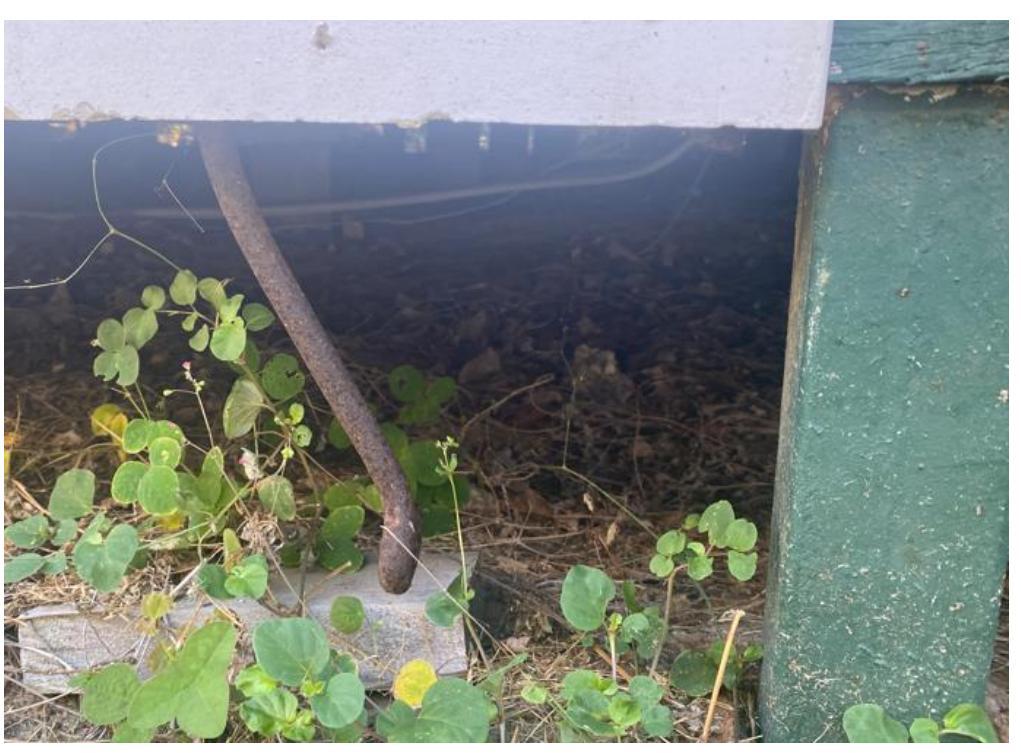
External tie down bars were not connected to the steel columns. These would have been originally connected to a larger timber stump.

Image 7 – Original tie down bar not connected to steel stump.

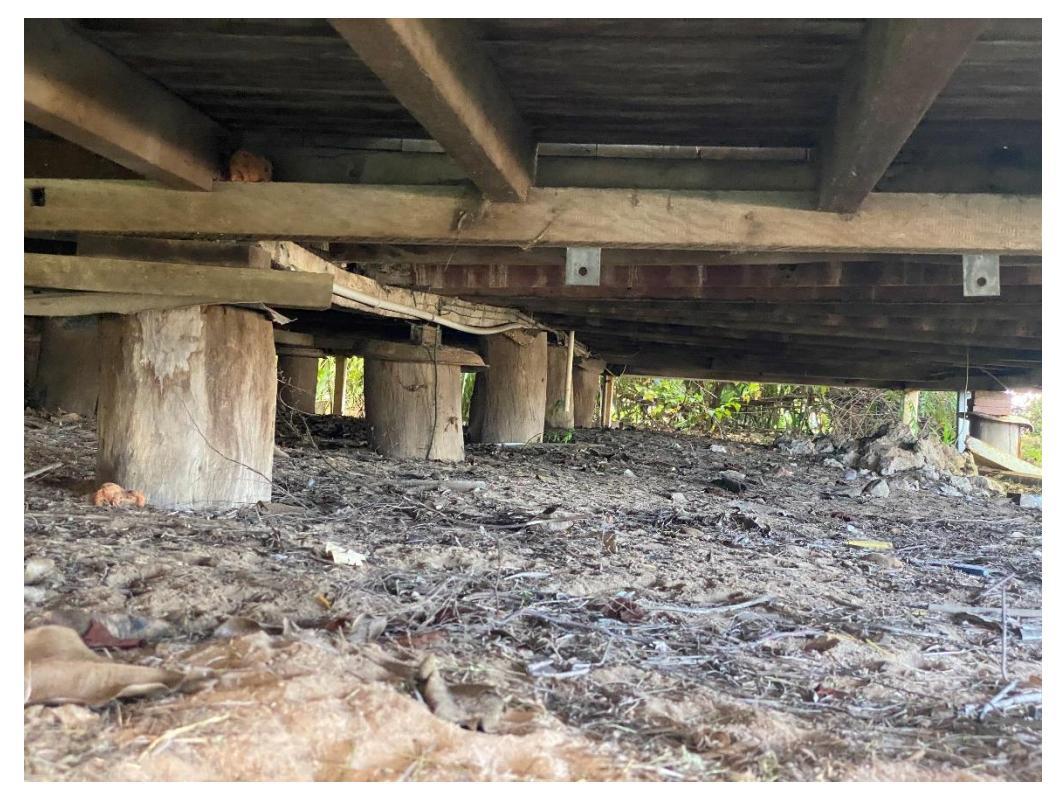
Timber bearers were observed to have significant sag. Preliminary assessment indicates these bearers are significantly undersized, resulting in excessive deflection.

Supporting timber stumps also to appear to have subsided significantly.

Image 8 – Bearer deflection and timber stump subsidence.

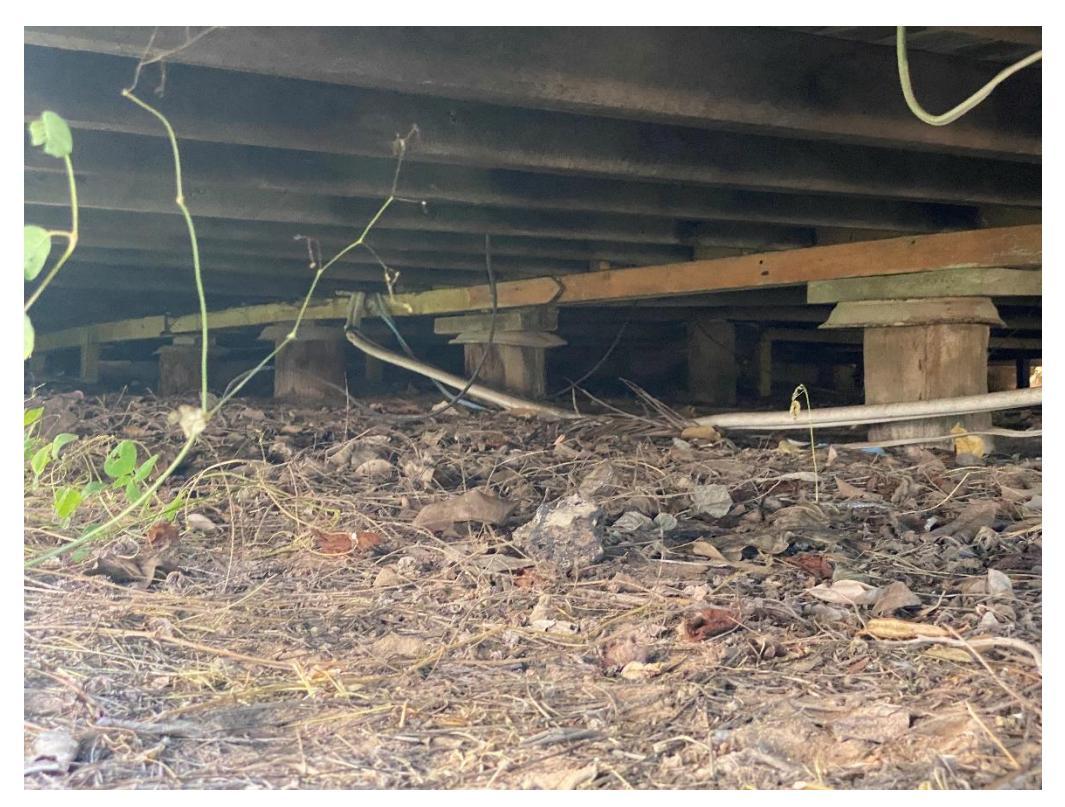
Image 9 – Bearer deflection and timber stump subsidence.

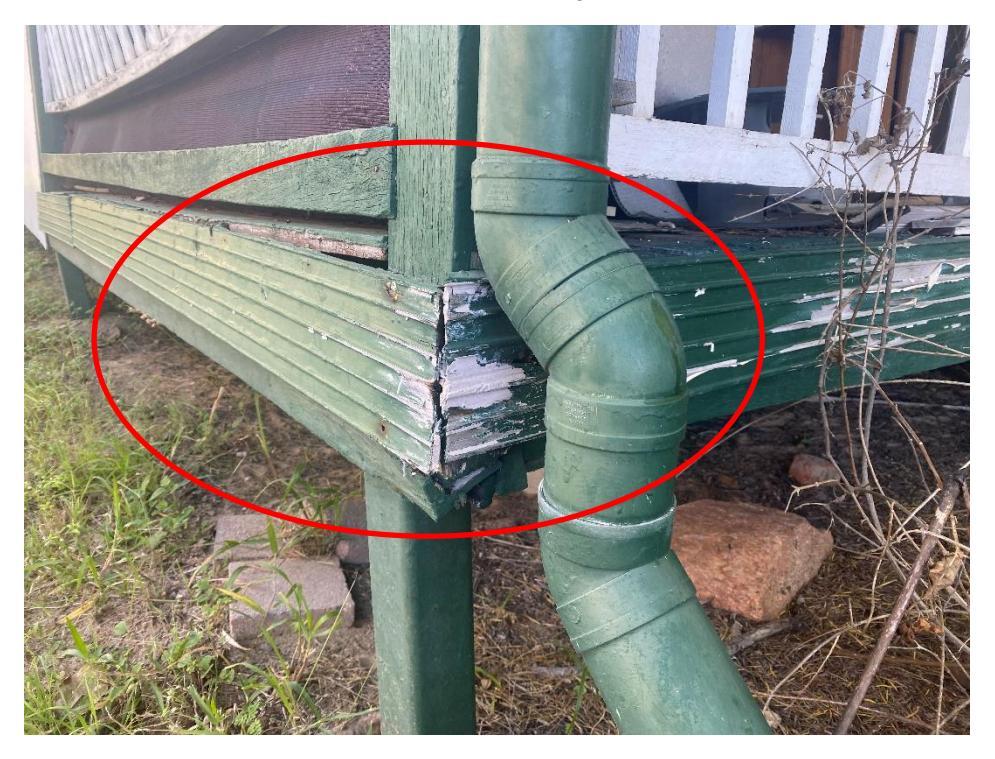
Timber fascias to the external decks are damaged and rotted.

Image 10 – Damaged and rotted deck fascias.

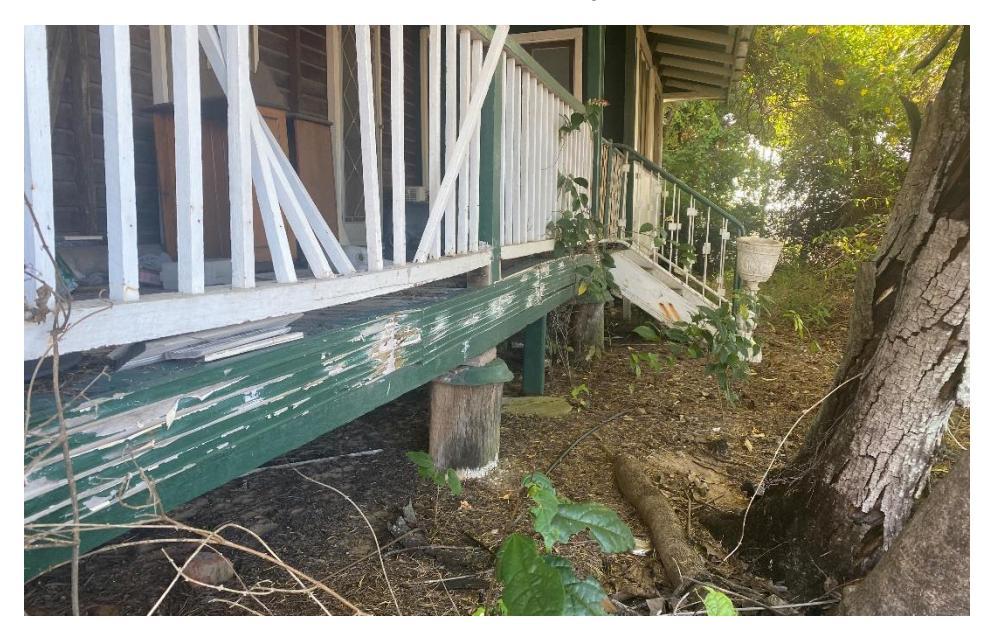
Balustrades to the external front deck are damaged.

Image 11 – Damaged balustrade.

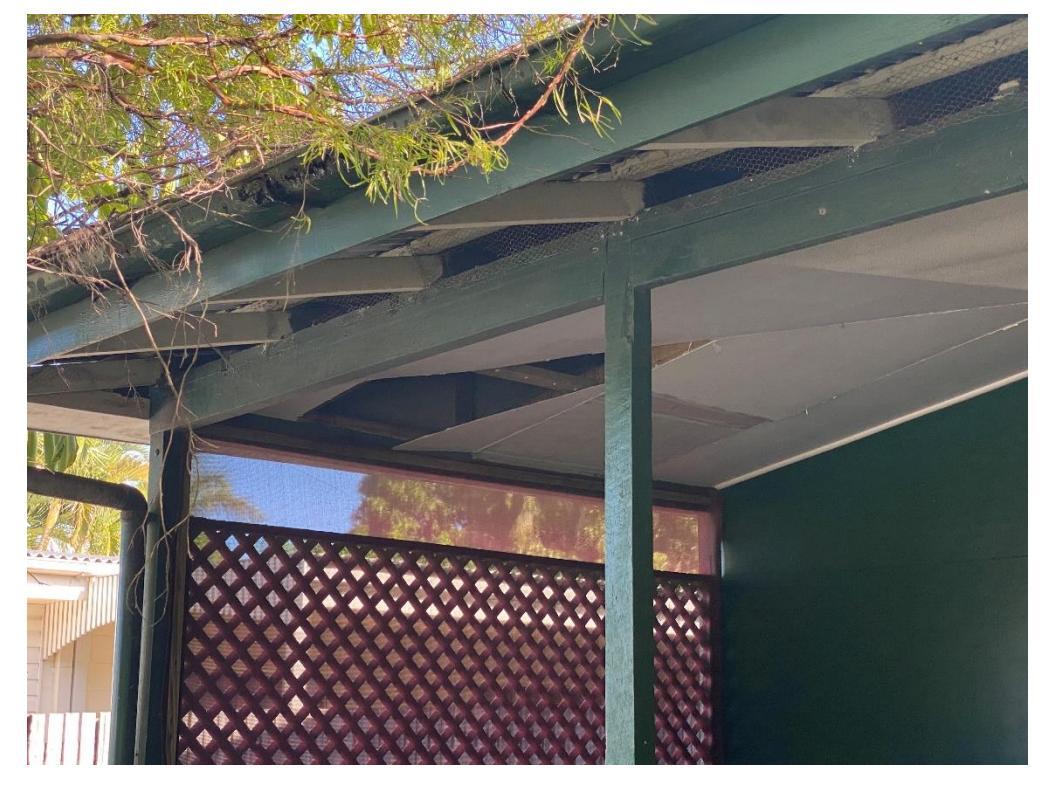
External ceiling linings were damaged and missing.

Image 12 – Damaged external ceiling.

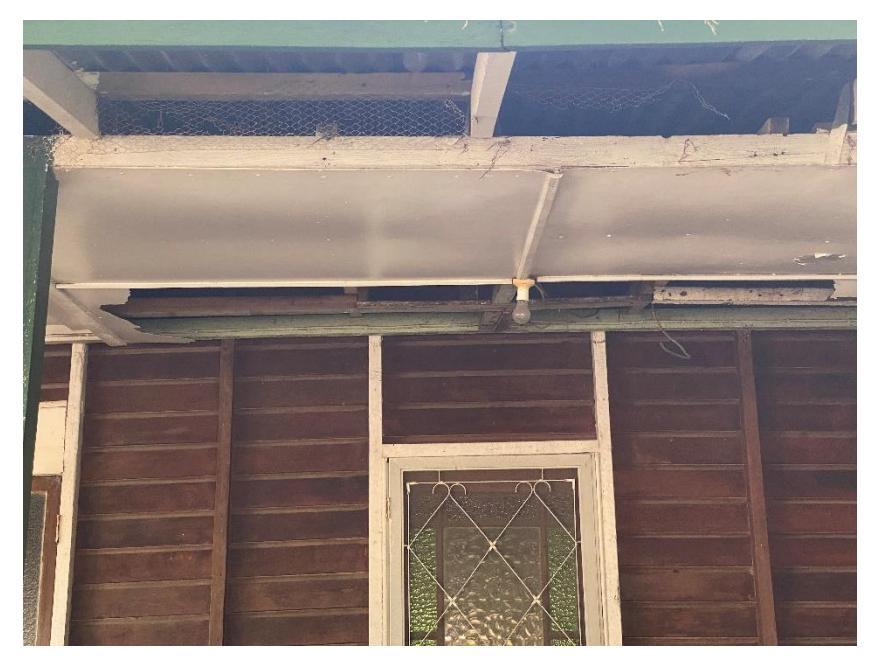
Where sheets have been dislodged and damaged, they remain unreplaced.

Image 13 – Damaged external ceiling.

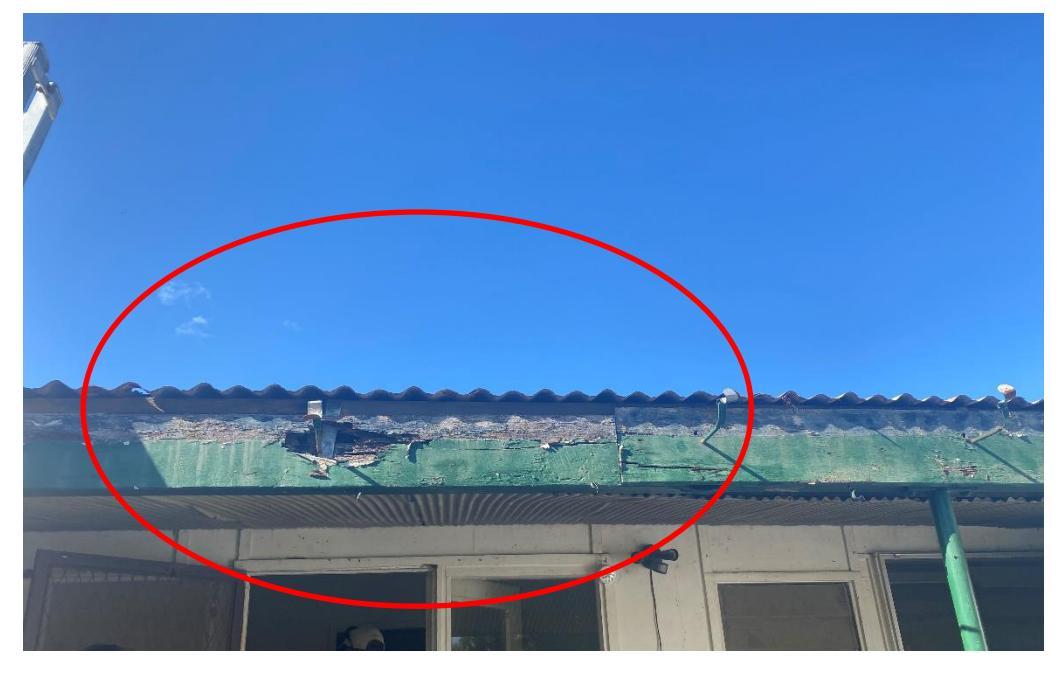
Fascias are damaged and rotted due to water damage.

Image 14 - Damaged and rotted roof fascias.

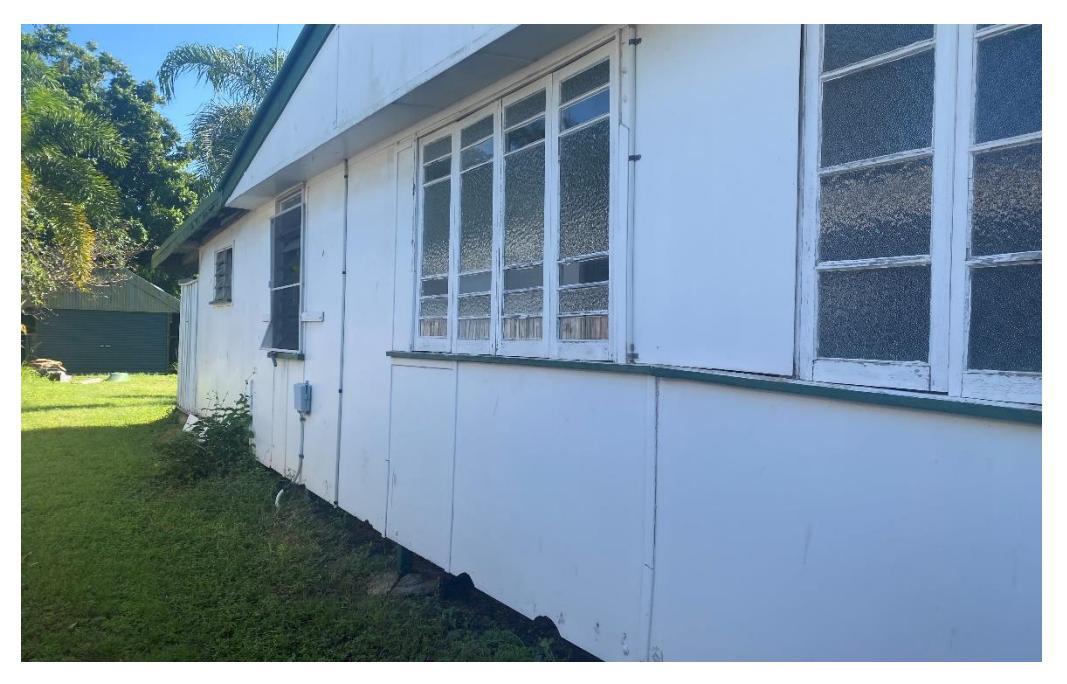
The external sheet cladding is damaged, and structure movement has resulted in gaps at sheet joints.

Windowsills were observed to not be level, indicating movement of the structure has occurred due to footing and/or timber stump subsidence.

Image 15 – Damaged external cladding and general building movement.

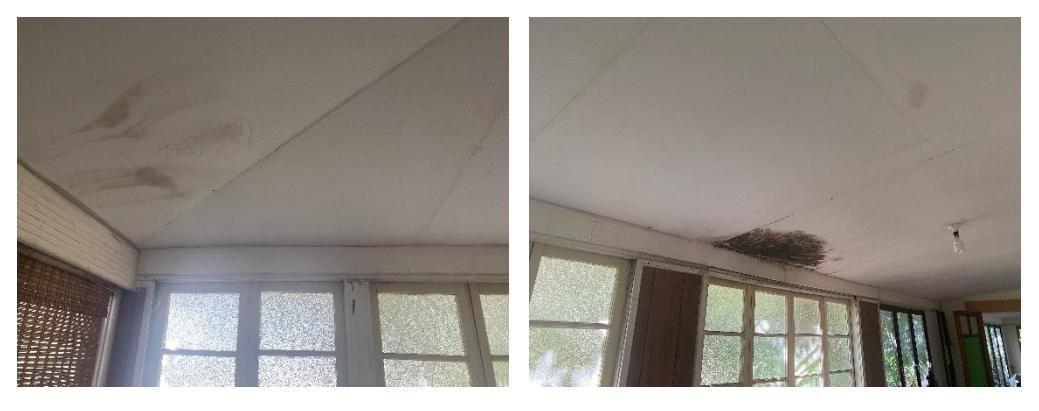
Mould to ceilings was observed in numerous locations, indicating numerous roof leaks.

Image 16 – Mould to ceiling.

Image 17 – Mould to ceiling.

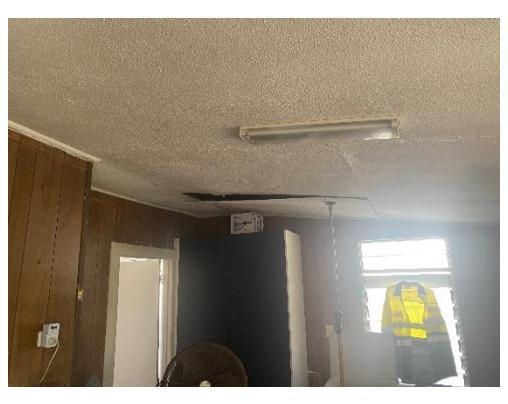
Ceilings had sheeting coming away from their supports in several locations.

Image 18 - Damage to ceiling.

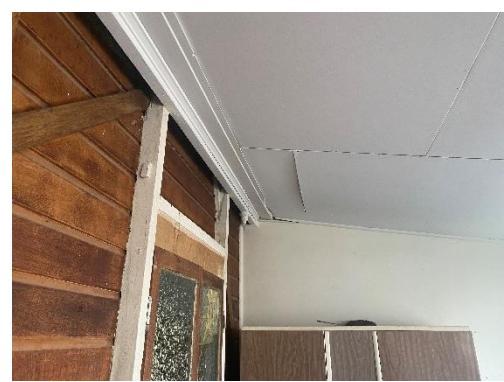
Image 19 - Damage to ceiling.

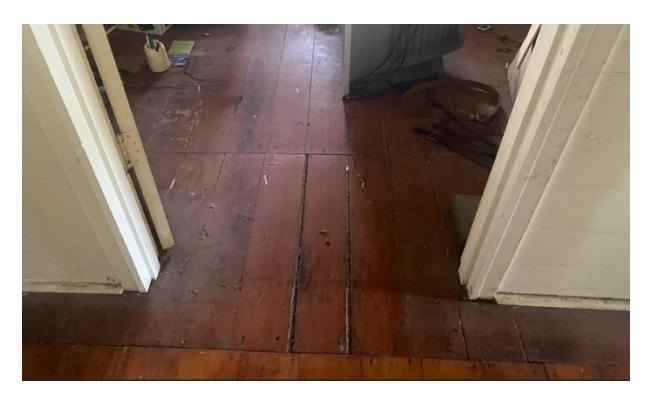
Walking through the residence, it was noticeable that floors sloped significantly in areas and exhibited excessive bounce in numerous locations. This was due to the bearer sag and subsiding timber stump issues noted previously.

Image 20 – Area where floor sloped.
