CUNGULLA SHORELINE EROSION MANAGEMENT PLAN

TOWNSVILLE CITY COUNCIL

Project :	Cungulla Shoreline Erosion Management Plan
Document Title :	Final Report
Client :	Townsville City Council
Document Code :	12-713qld-pobrp
First Issue Date :	22 October 2012

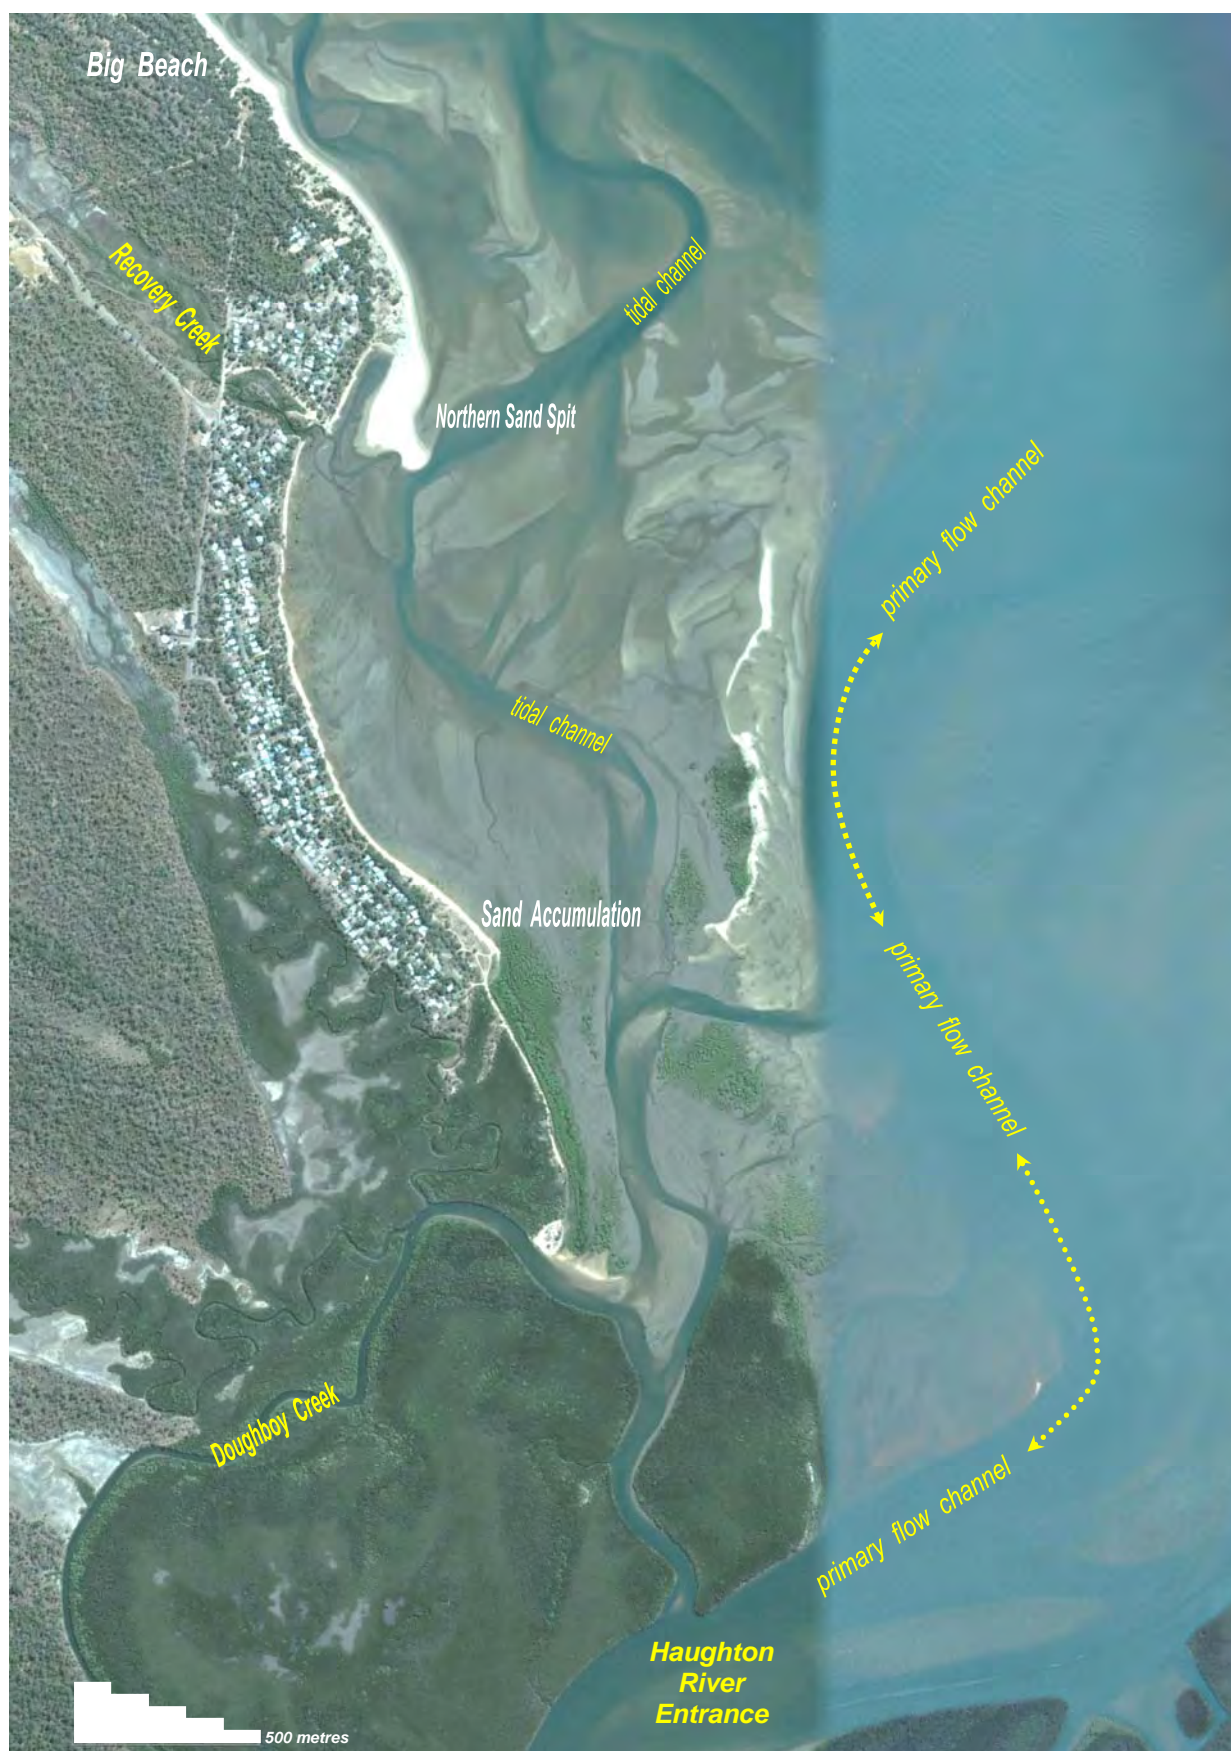
Figure 1.2 : Cungulla Coastal Reach

Figure 1.2 shows the setting of the Cungulla foreshore within a more local context.

There are a number of topographic and geomorphological features evident in this figure which are referred to in later chapters of this report. The most relevant of these being:

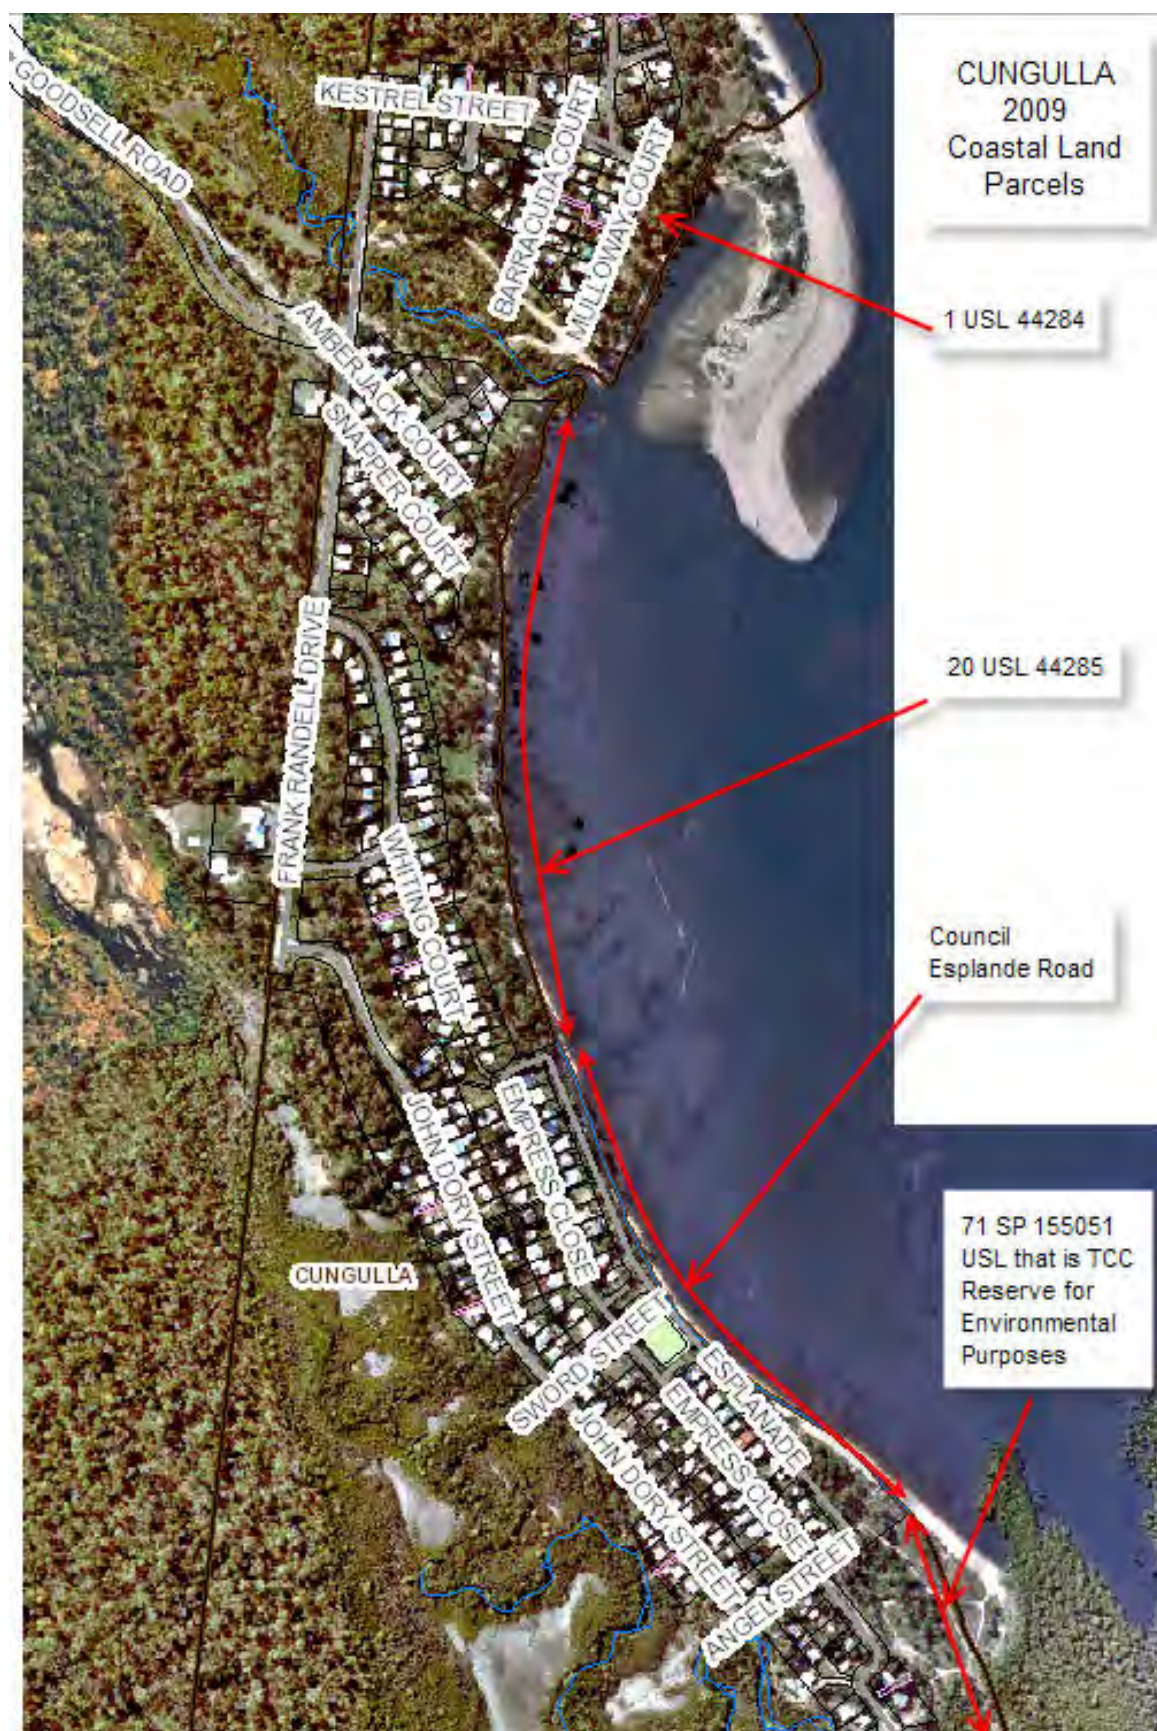
Figure 1.3 : Foreshore Land Parcels
(superimposed on a 2009 aerial photograph)

The nature of land tenure along the foreshore of Cungulla is an important consideration when assessing appropriate erosion mitigation options. As shown in Figure 1.3, most of the foreshore consists of Unallocated State Land (USL), except for an approximately 700 metre long section that is designated as a Council Esplanade. This Esplanade runs parallel to Empress Close and is located on the seaward side of properties fronting Empress Close.

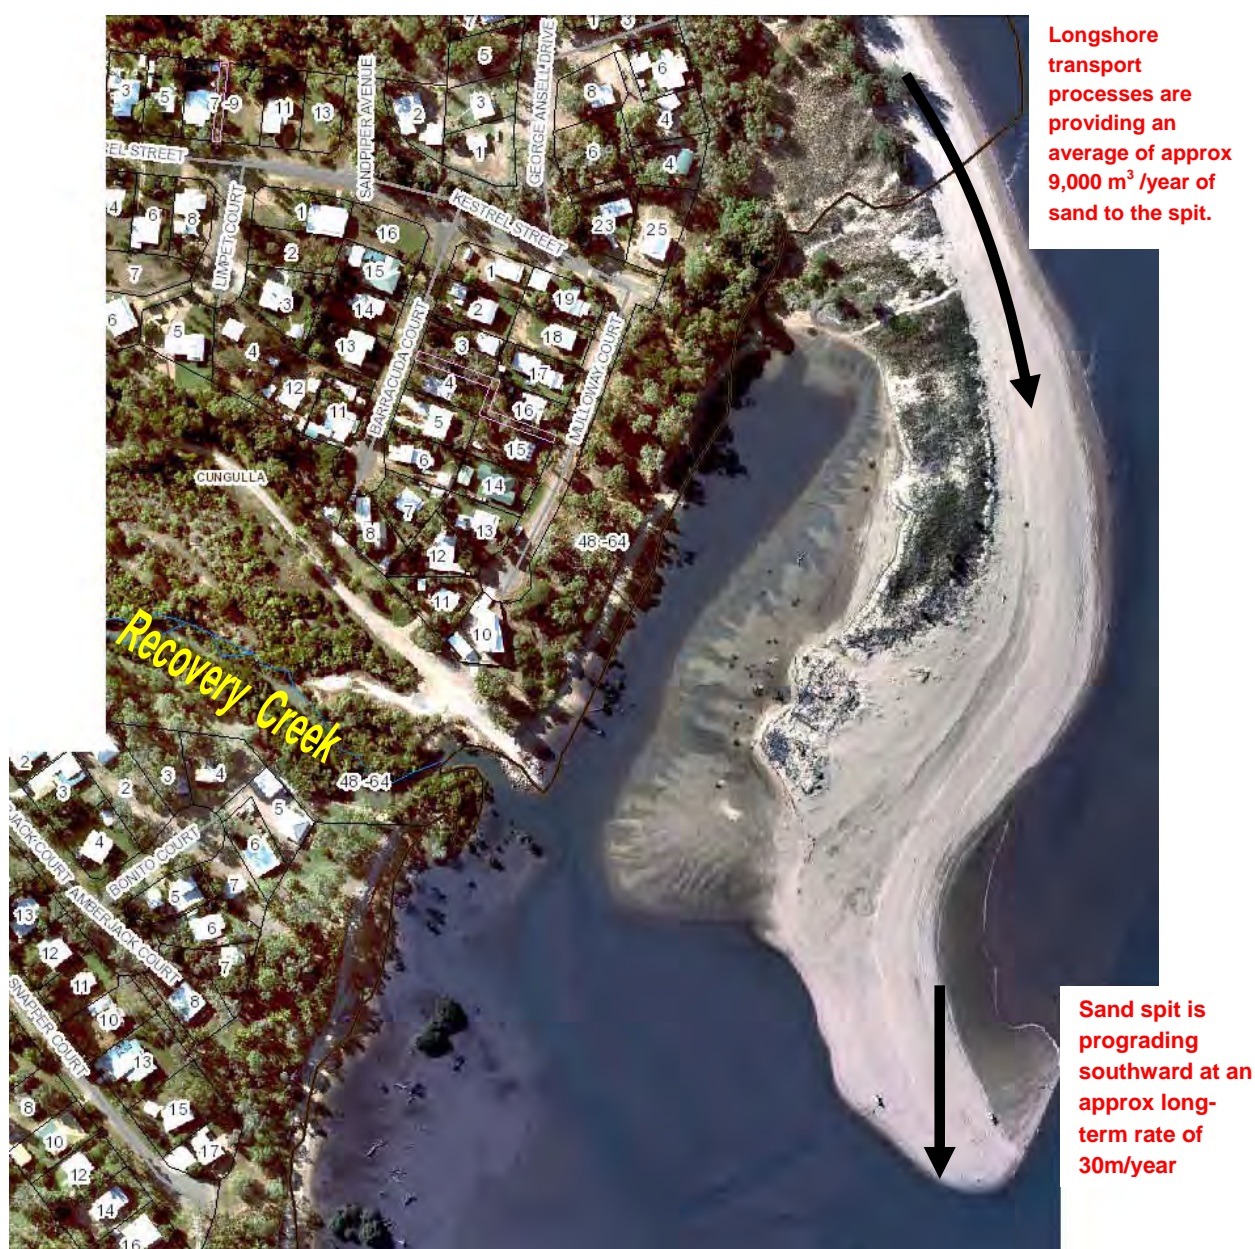
Figure 2.3 : Locale of the northern sand spit

The northern end of the Cungulla coastal reach and the sand spit are shown on Figure 2.3. In the years between the surveys of December 1996 and July 2012, approximately 140,000m³ of sand has been supplied to the spit from the foreshores of Big Beach further to the north. This indicates that the spit is growing at a rate of around 9,000m³ each year.

There is no northern sand spit evident in aerial photographs taken prior to 1961. However in those times, the offshore tidal channel was located very close to the beach along the northern end of Cunggulla - particularly north of Recovery Creek where the channel was virtually along the toe of the beach slope (refer to 1961 photograph in Appendix A). It is likely that the spit was prevented from forming by the ebb tide flow in this nearshore channel.

This steady offshore migration of the channel has enabled the sand spit to grow at an estimated average rate of 9,000 m³/year since 1996. Its southern tip has moved southward some 470 metres since then, ie. advancing approximately 30 m/year. This growth and southern migration of the spit is expected to continue into the future. However due to the variability of future annual / seasonal conditions and prevailing wave climate, actual rates in any one year could differ markedly from this average which has been determined over approximately 15½ years.

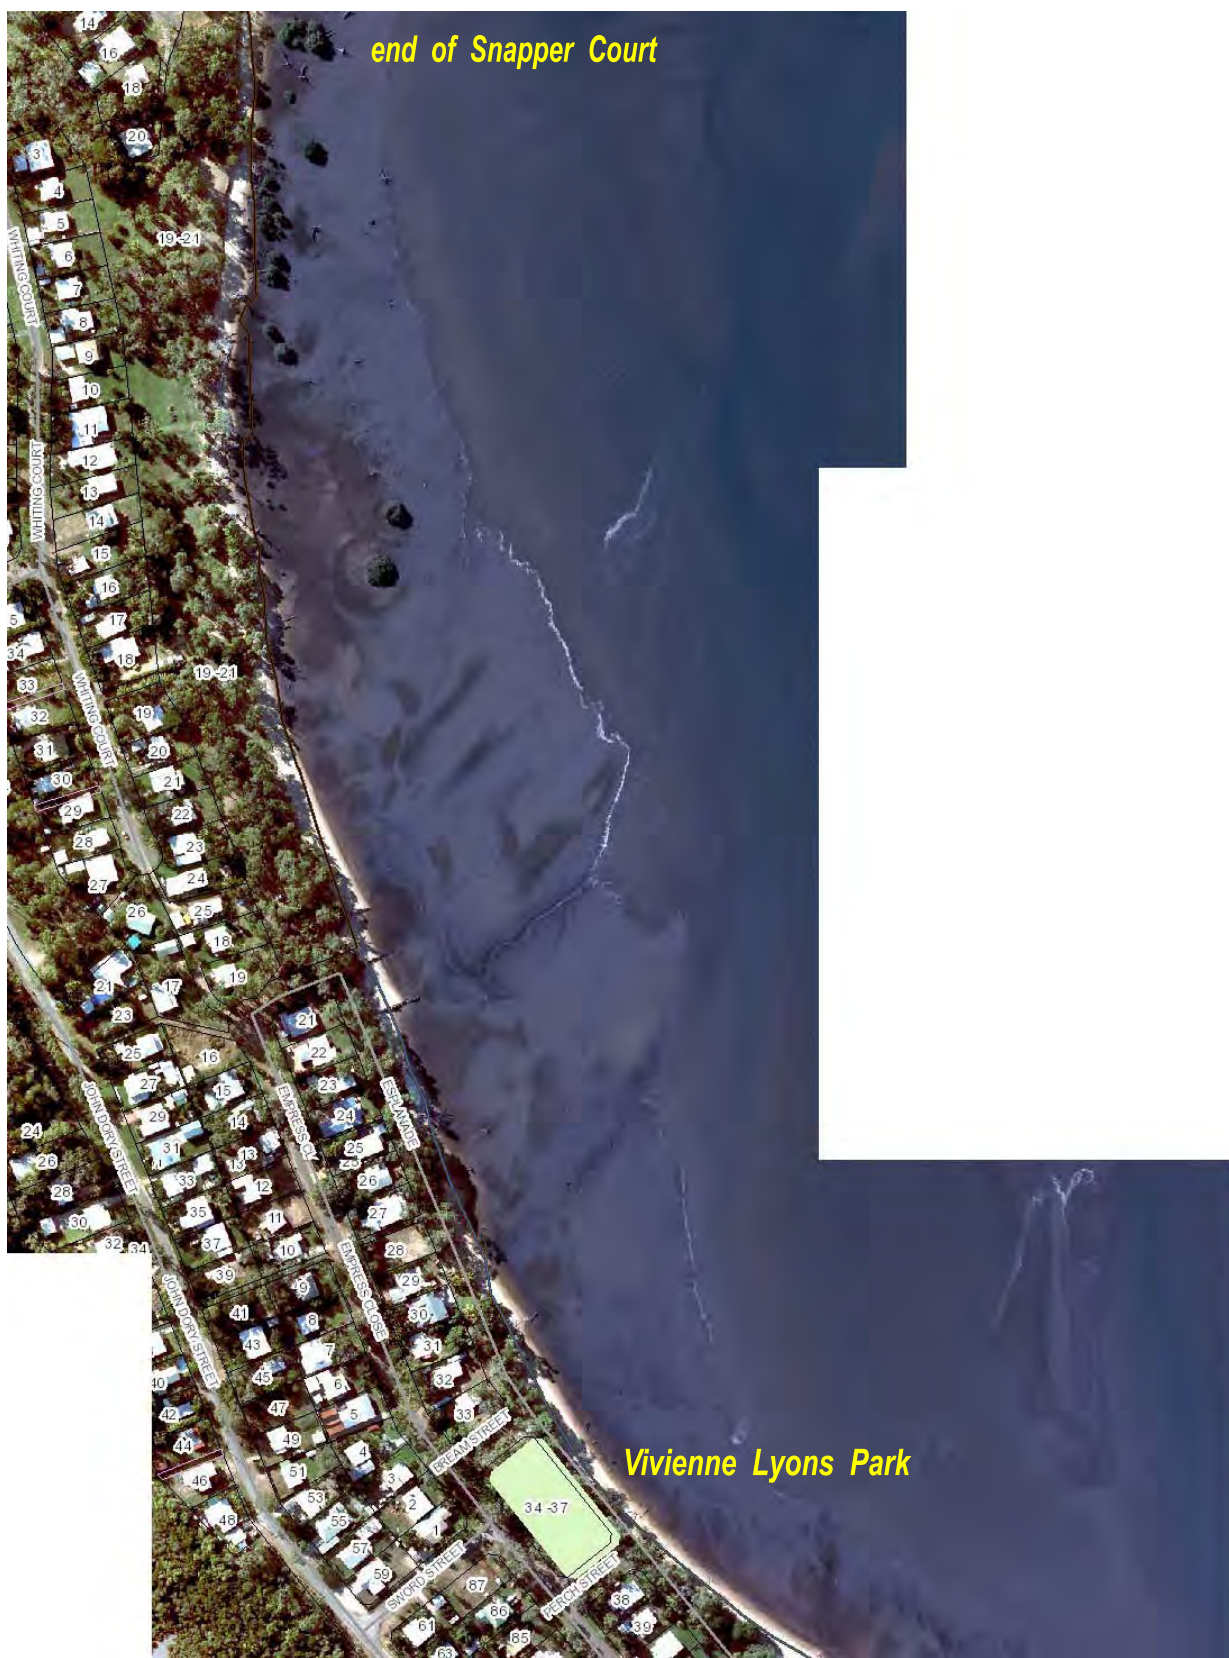
Figure 2.4 : Locale of the central section of Cungulla

Further south along the ocean frontage to Empress Close, private dwellings are quite close to the shoreline and it is along this section of foreshore that there has been considerable effort applied by landowners to protect their assets by ad hoc foreshore protection measures.

In coming years there will continue to be strong erosion processes. These will significantly threaten the structural integrity of the ad hoc protection works along these various properties. As is the case elsewhere along the Cungulla foreshore, some of the individual protection works exacerbate the erosion problems of neighbouring properties due to their inappropriate design and construction. Future years will see increasing need of significant repair and/or replacement of these ad hoc works, along with increasingly adverse impacts on adjacent properties.

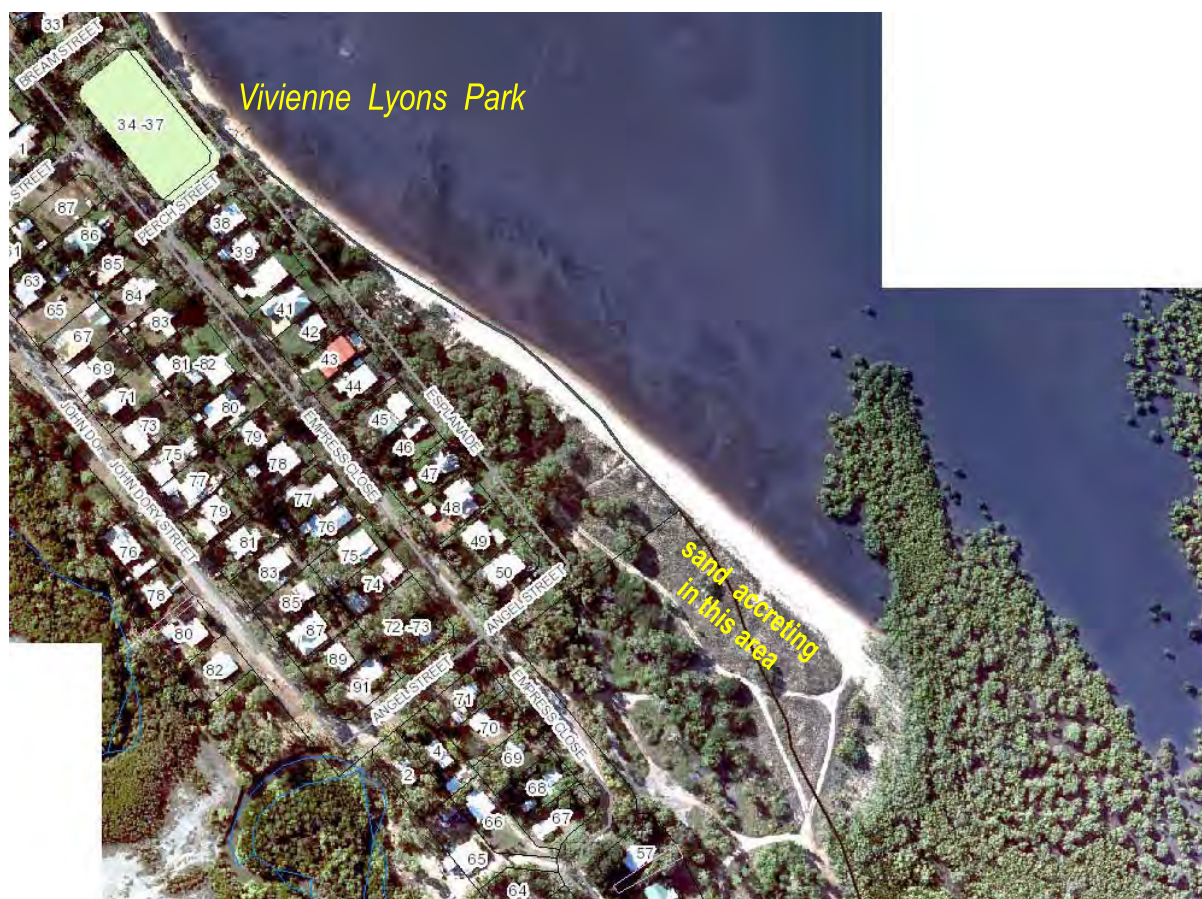
Figure 2.5 : Locale of the southern section of Cunggulla

The extensive offshore sand shoals of the nearby Houghton River Entrance result in a reduced wave climate along this section of foreshore. The expanding areas of offshore mangroves also act to reduce the wave energy (and hence sand transport capability) along this local shoreline.

It is expected that this area will continue to accrete, although the rate at which it will do so will depend upon the amount of sand on the foreshore of central Cunggulla that becomes freely available to be moved by waves. Armouring of the central area - either by continuing ad hoc protection works (which will require increasing repair/replacement efforts by landowners) or by a more appropriately designed and constructed seawall structure - will result in lower accretion rates

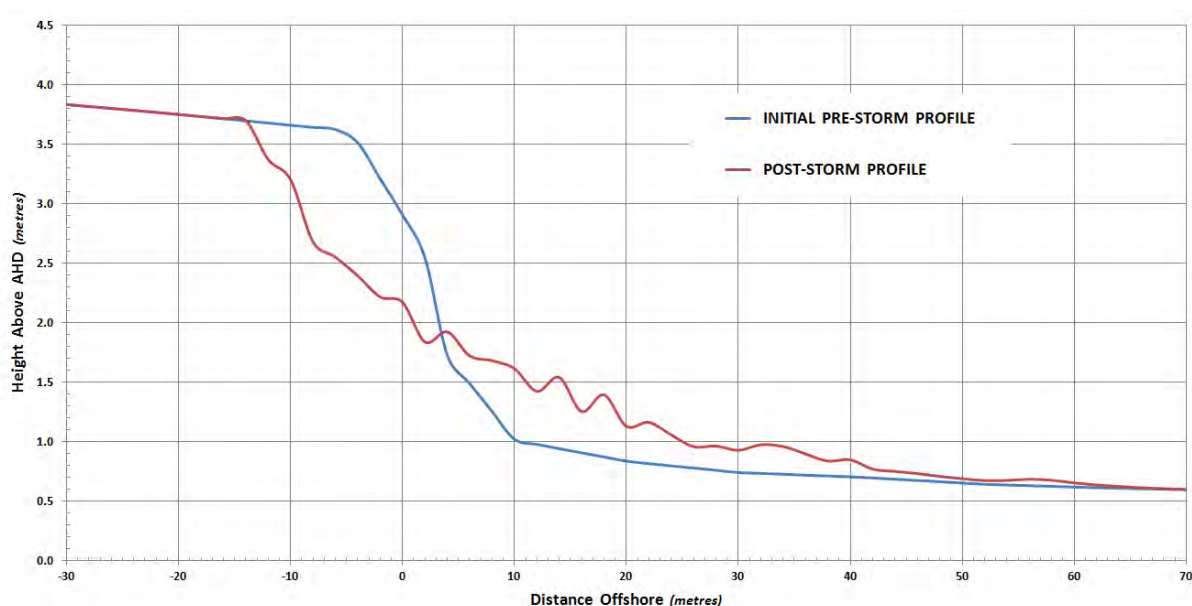
Figure 2.6 : Predicted Beach Response (at CUN-07) for 100 year ARI Event

A 100 year ARI event will result in around 10 metres recession of the shoreline. As can be seen, sand is typically eroded from the upper beach area, generally from above RL+1.5m AHD. This sand is then deposited offshore of the toe of the beach, thereby flattening the beach slope. This typical cross-shore erosion process occurs along the entire Cungulla shoreline during severe storms/cyclones.

During events greater than around 200 year ARI, there is considerable overwash of the Cunggulla foreshore. This phenomenon occurs when the storm tide builds during the cyclone to be so great that waves no longer dissipate their energy directly on the beach slope or on any dunes - ocean water levels are such that the waves wash over the beach slope since it is substantially submerged.

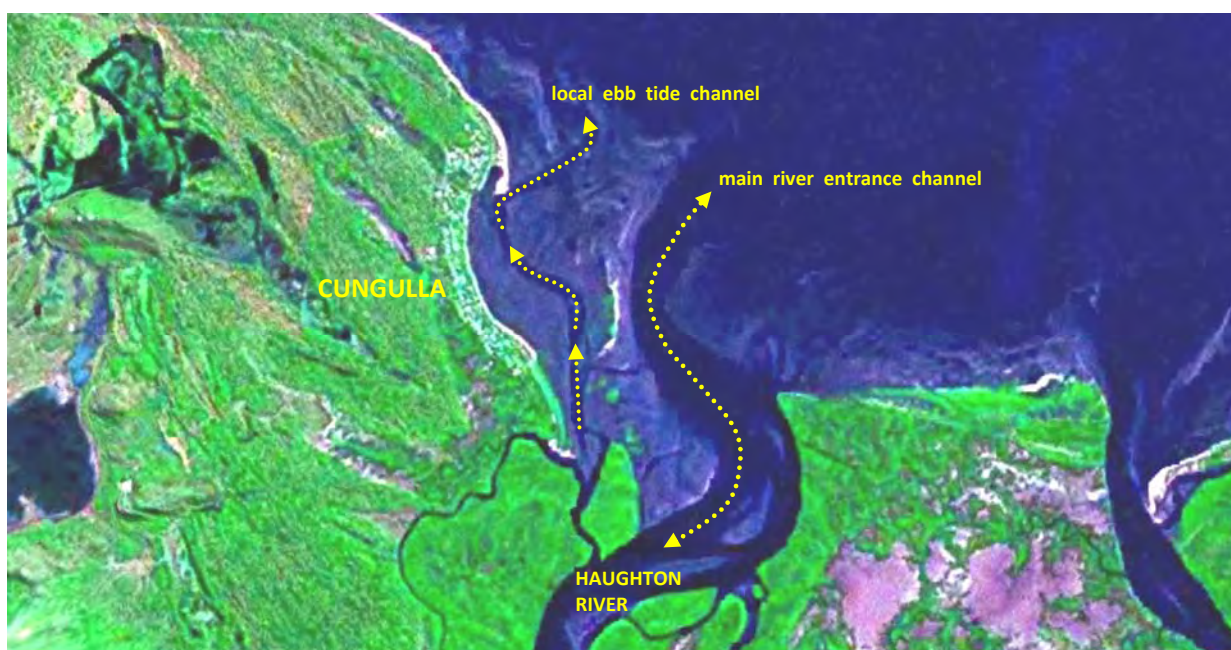
Figure 2.7 : Satellite image showing local tidal channels

This nearshore channel acts mainly as an ebb (outgoing) tidal channel. Changes to the alignment of the ebb tide channel are evident in the series of historical aerial photographs presented in Appendix A to this report.

An investigation of beach erosion processes reported by Hopley & Rasmussen in 1996 identified the significant effect that this channel has had on beach processes of the Cungulla coastal reach.

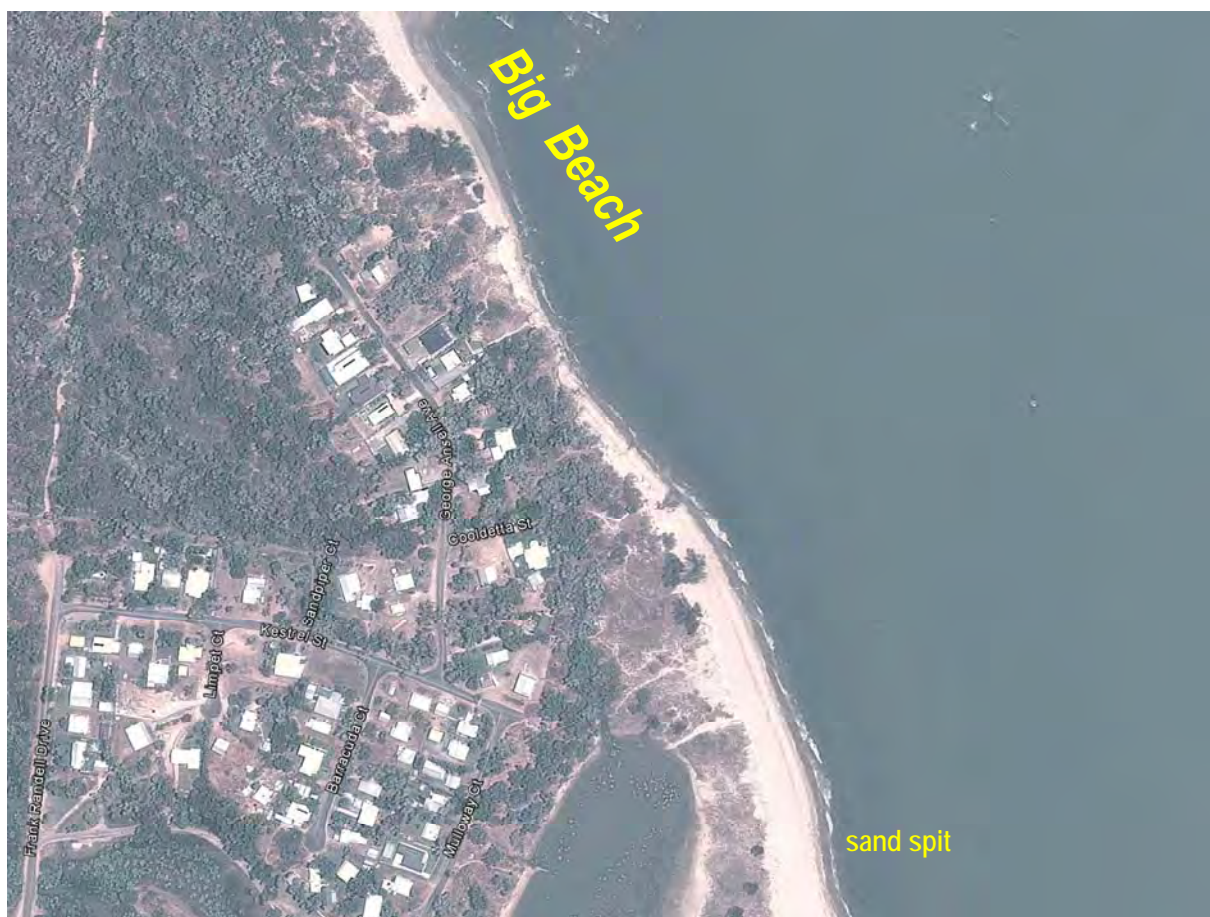
Figure 4.1 : Southern end of Big Beach

This particular foreshore has been experiencing erosion in recent years - primarily as a consequence of storms and cyclones. The shoreline has receded approximately 60 metres since 1998. The erosion has removed much of the foredunes that existed seaward of the high primary dune along this section of coast. A significant amount of erosion occurred as a consequence of TC Yasi in February 2011 - with an erosion scarp extending into the toe of the primary dune at many locations.

Nevertheless there still remains a significant buffer between the private property boundaries and the erosion scarp. The distance from the scarp to seaward property boundaries is variable, but at its narrowest is still some 42 metres to a property off George Ansell Avenue. This buffer consists of the very high primary dune system, which is typically more than 8 metres in height.

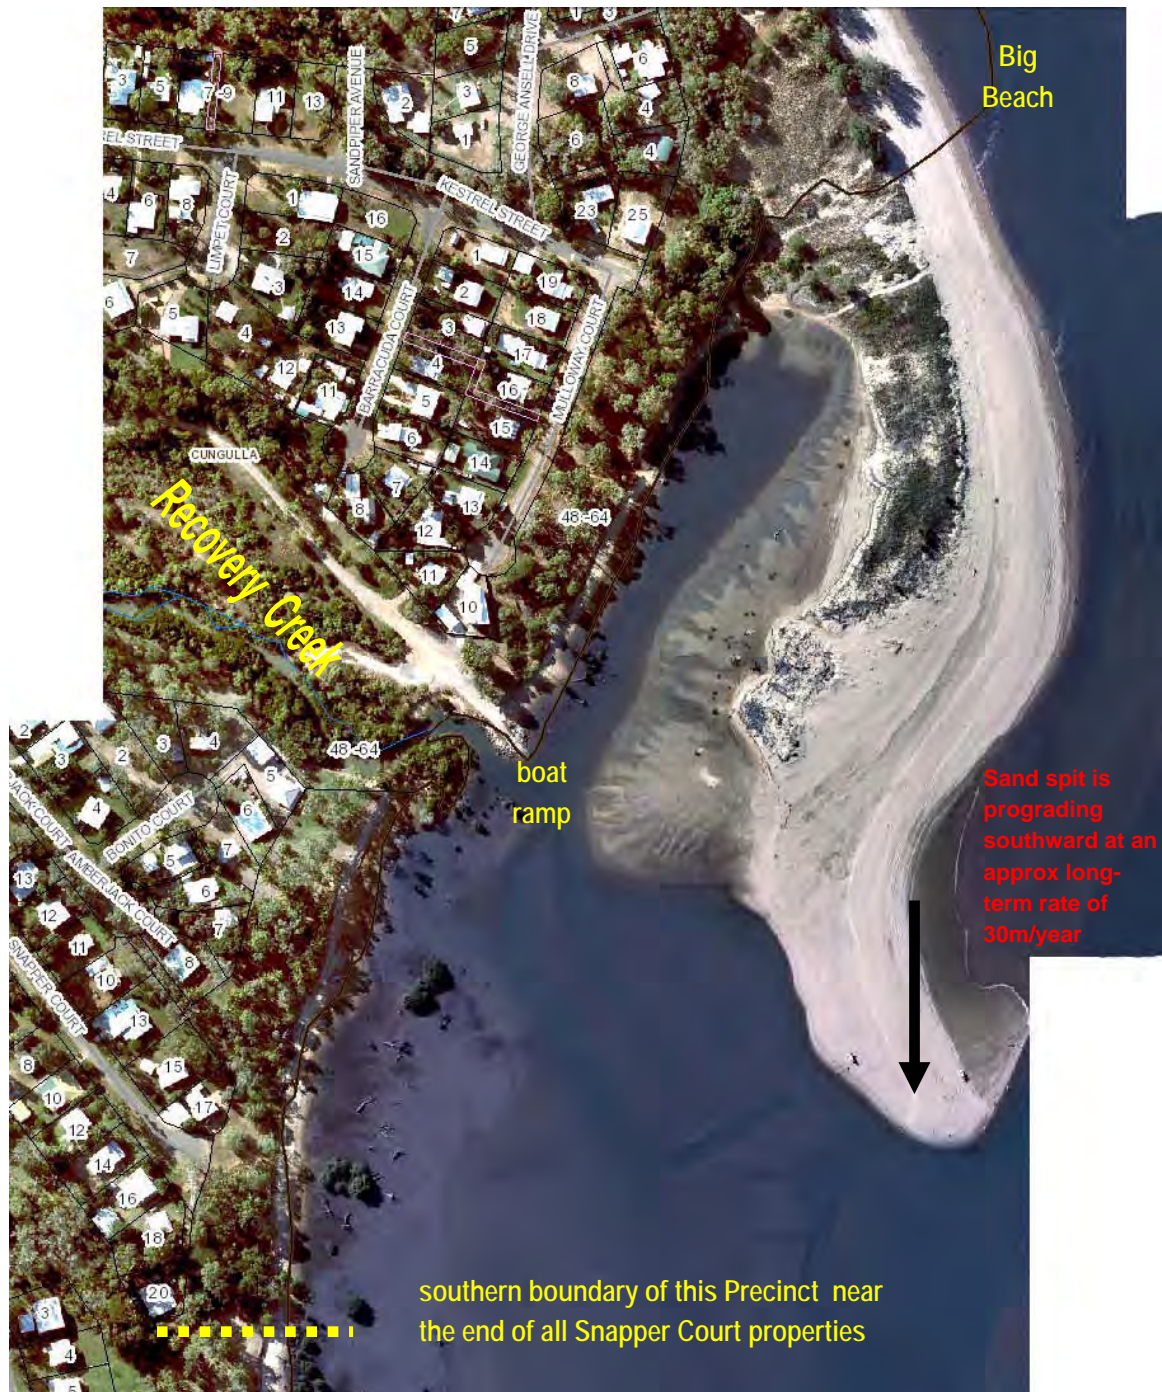
Figure 4.2 : Northern Precinct on the Cunggulla foreshore

The Northern Precinct is that section of the Cunggulla foreshore which is in the lee of the northern sand spit. It encompasses the entire foreshore north of Recovery Creek (ie. opposite Mulloy Court) and extends from Kestrel Street, down to the southern-most end of all Snapper Court properties. The overall extent of the precinct is depicted in Figure 4.2.

The northern sand spit is growing due to some 9,000 m³ of sand being supplied to it on average each year by longshore sand transport processes; with its tip moving southwards at an average rate of 30 metres each year. Consequently the Northern Precinct can be considered as gradually expanding (and therefore the Whiting Court Precinct is contracting). This needs to be appreciated when formulating appropriate erosion mitigation measures for this location.

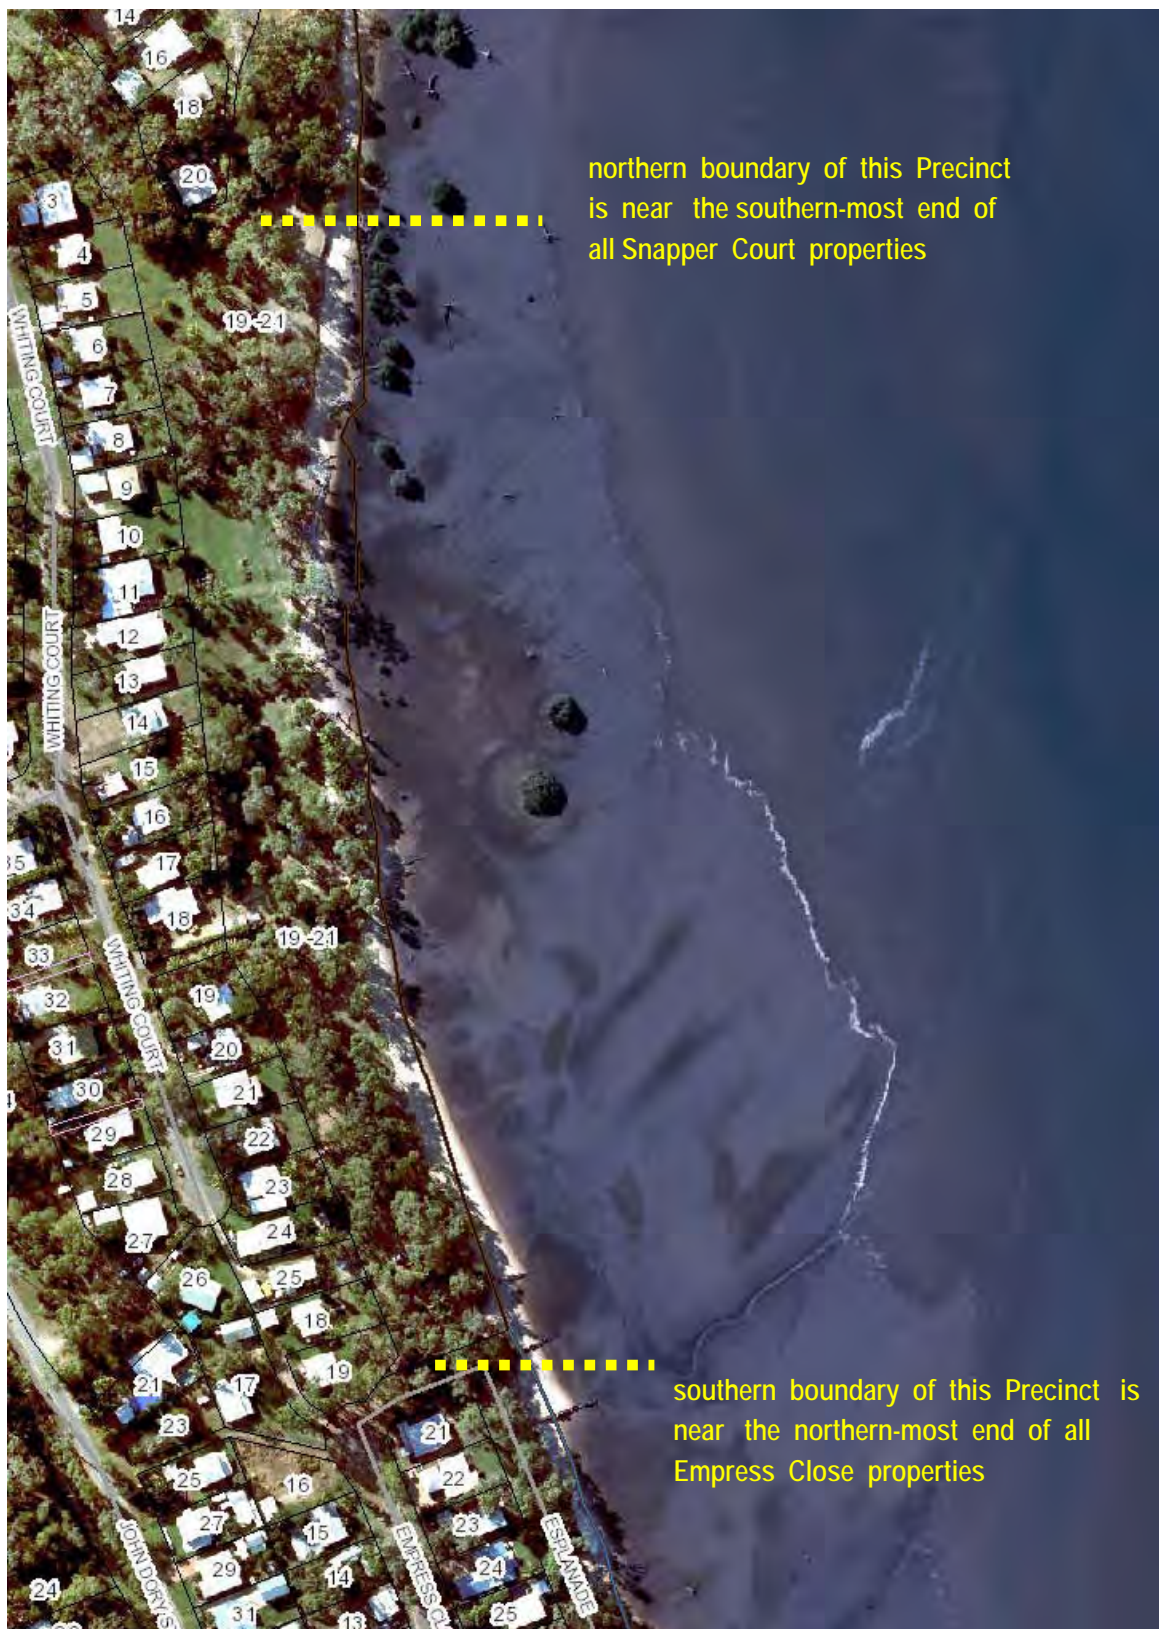
Figure 4.3 : Whiting Court Precinct on the Cungulla Shoreline

In summary, there is no need to currently implement any erosion protection along this Whiting Court Precinct of the Cungulla foreshore. Nevertheless it is recommended that the future width of the natural buffers along the Whiting Court Precinct be monitored by survey on at least an annual basis.

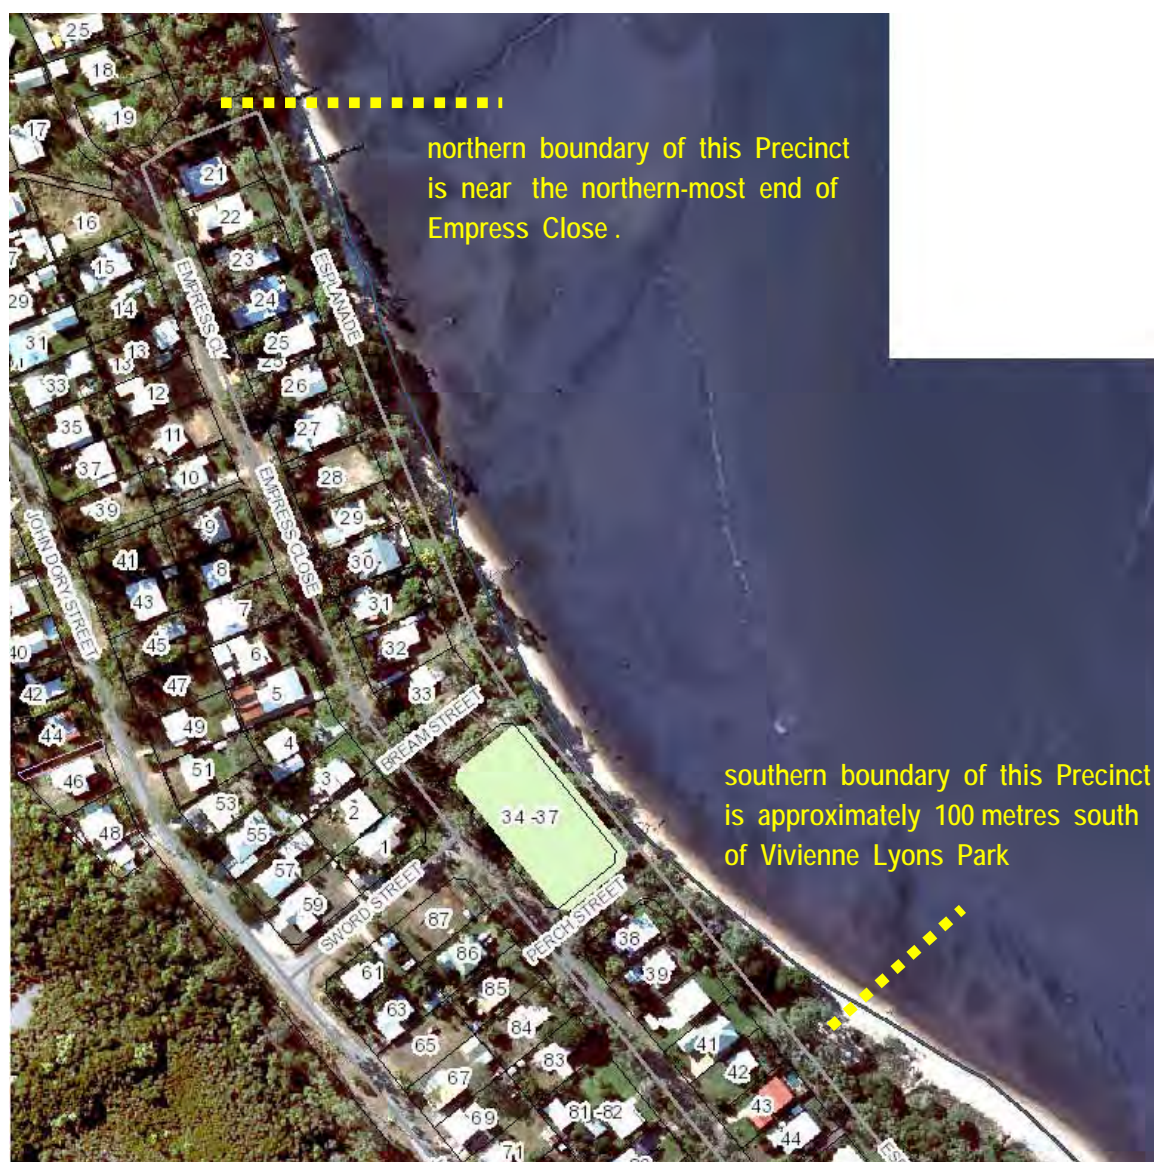
Figure 4.4 : Central Precinct on the Cunggulla Shoreline

The shoreline has encroached into the foreshore Esplanade along a section of this precinct, with private property boundaries within only a few metres of the shoreline.

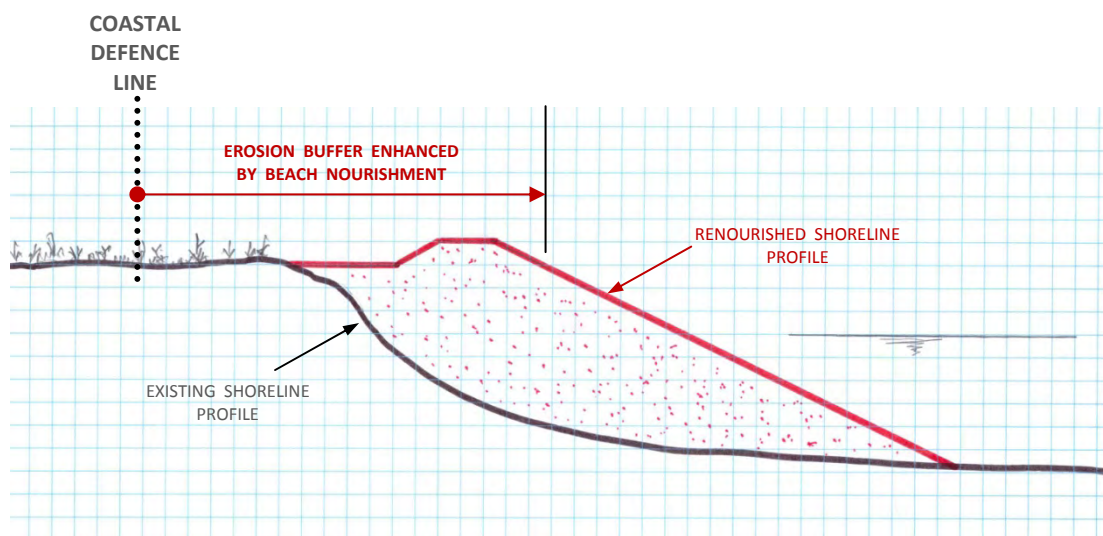
Figure 4.5 : Typical initial beach nourishment profile

Assuming a Coastal Defence Line along the line of the existing foreshore erosion, then this will require the placement of around 15,000 m³ of sand on the approximately 585 metre long Central Precinct.

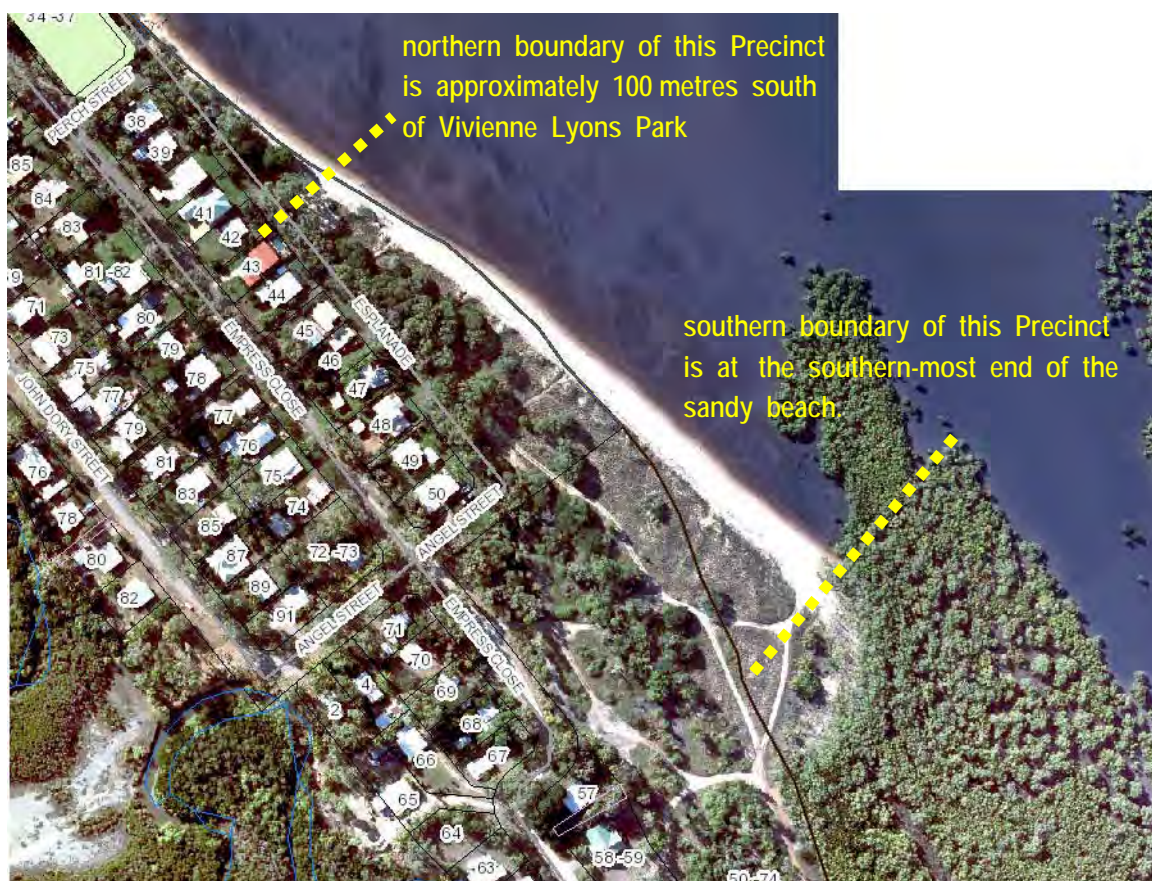
Figure 4.7 : Southern Precinct on the Cungulla Shoreline

The Southern Precinct is the approximately 330 metre long section of the Cungulla foreshore which extends from a location 100 metres south of Vivienne Lyons Park towards the large stand of mangroves at the southern-most end of the township. It includes private properties along the southern-most end of Empress Close.

Figure 4.7 shows the extent of the precinct.

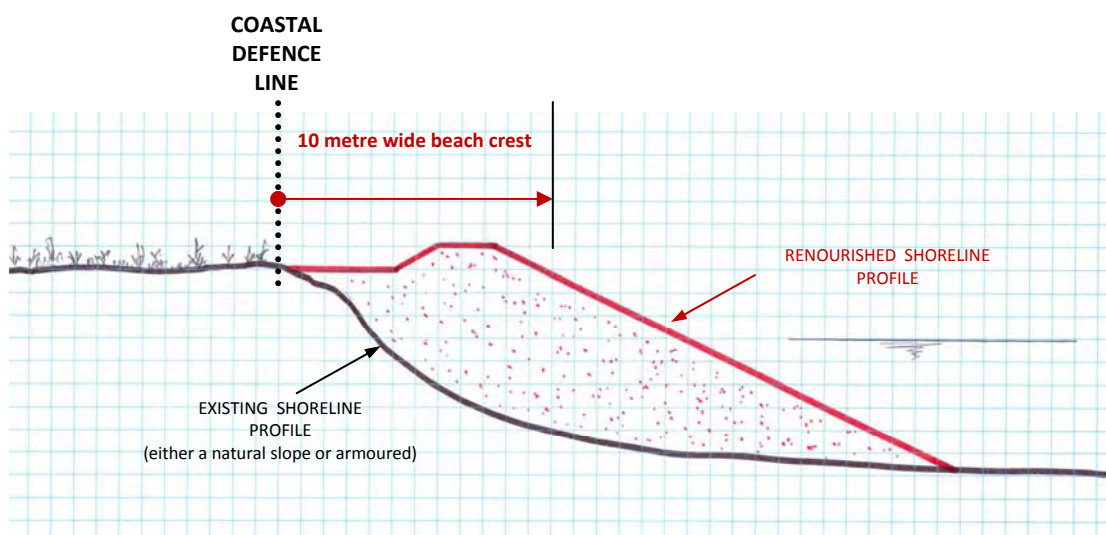
Figure 5.1 : Recommended Initial Nourishment Profile

Whilst it is acknowledged that the location of a Coastal Defence Line on the Cunggulla foreshore is a matter for stakeholders, for the purposes of illustrating and quantifying works under this Shoreline Erosion Management Plan a location along the top of the existing sandy beach and/or the crest of ad hoc protection works has been adopted. The general arrangement is illustrated in Figure 5.1.

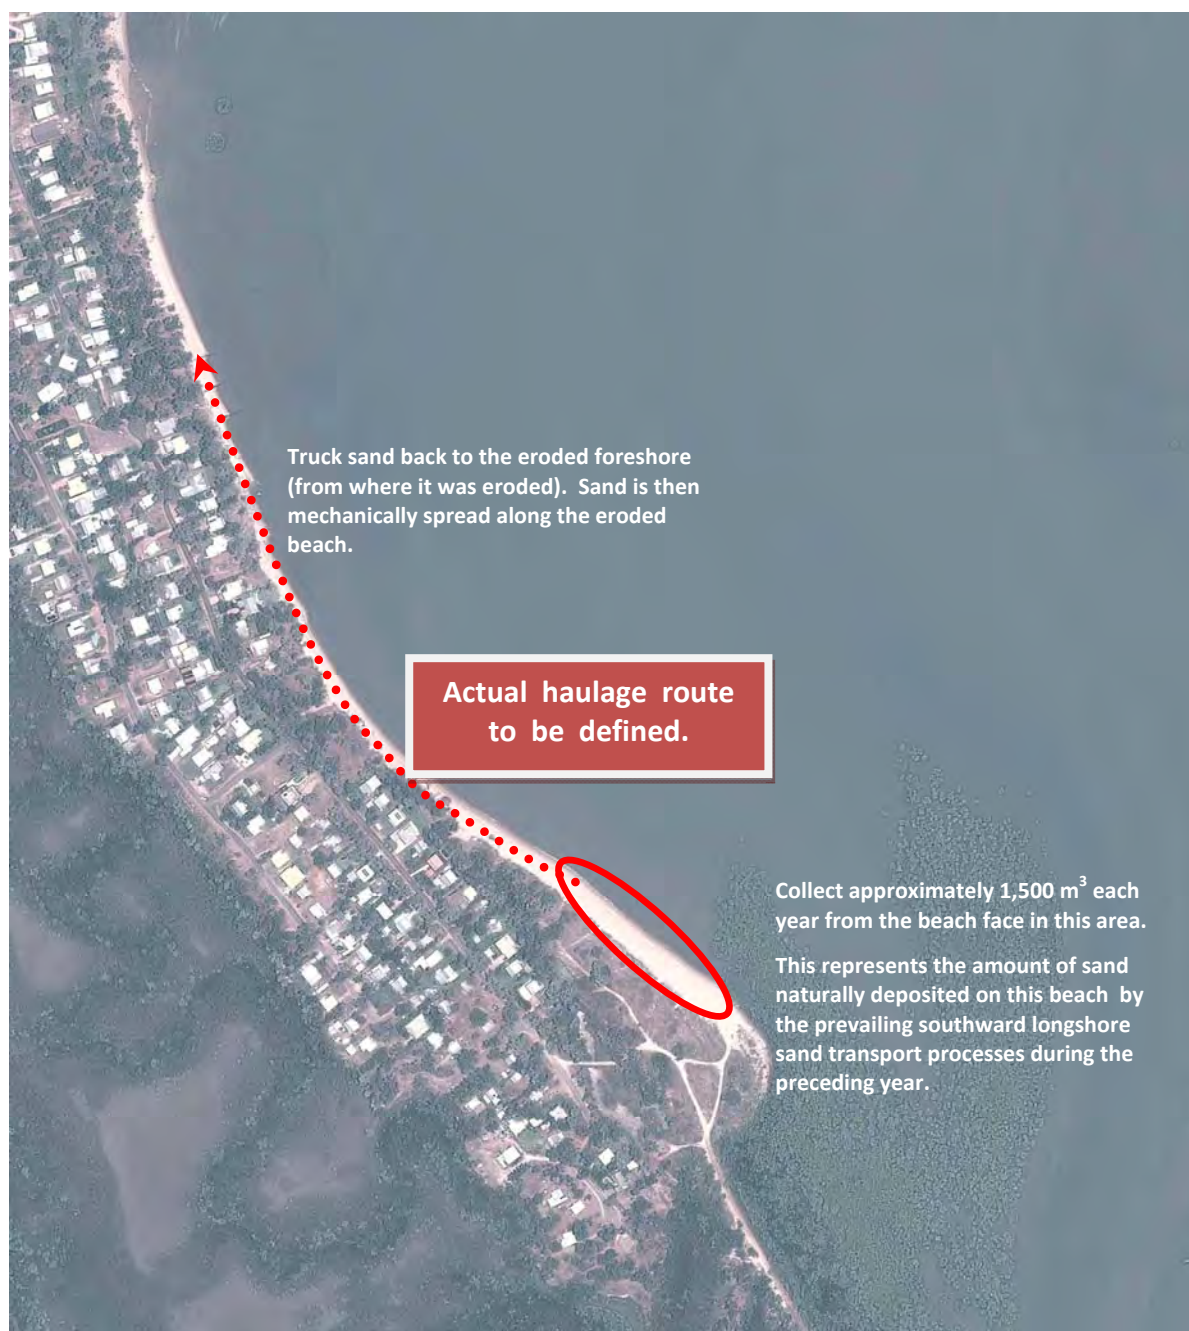
Figure 5.2 : Proposed back-passing of sand from southern accumulation area

This backpassing essentially “recycles” the sand back onto the eroding beach. The sand volumes are moderate and the haul distances are short, it therefore provides a very cost-effective scheme for sustaining the erosion buffer on the updrift beach. It is also very flexible and can be easily tailored to suit the variable nature of longshore sand transport rates, and any emerging effects of future climate change.
