CUNGULLA SHORELINE EROSION MANAGEMENT PLAN

TOWNSVILLE CITY COUNCIL

Project :	Cungulla Shoreline Erosion Management Plan
Document Title :	Final Report
Client :	Townsville City Council
Document Code :	12-713qld-pobrp
First Issue Date :	22 October 2012

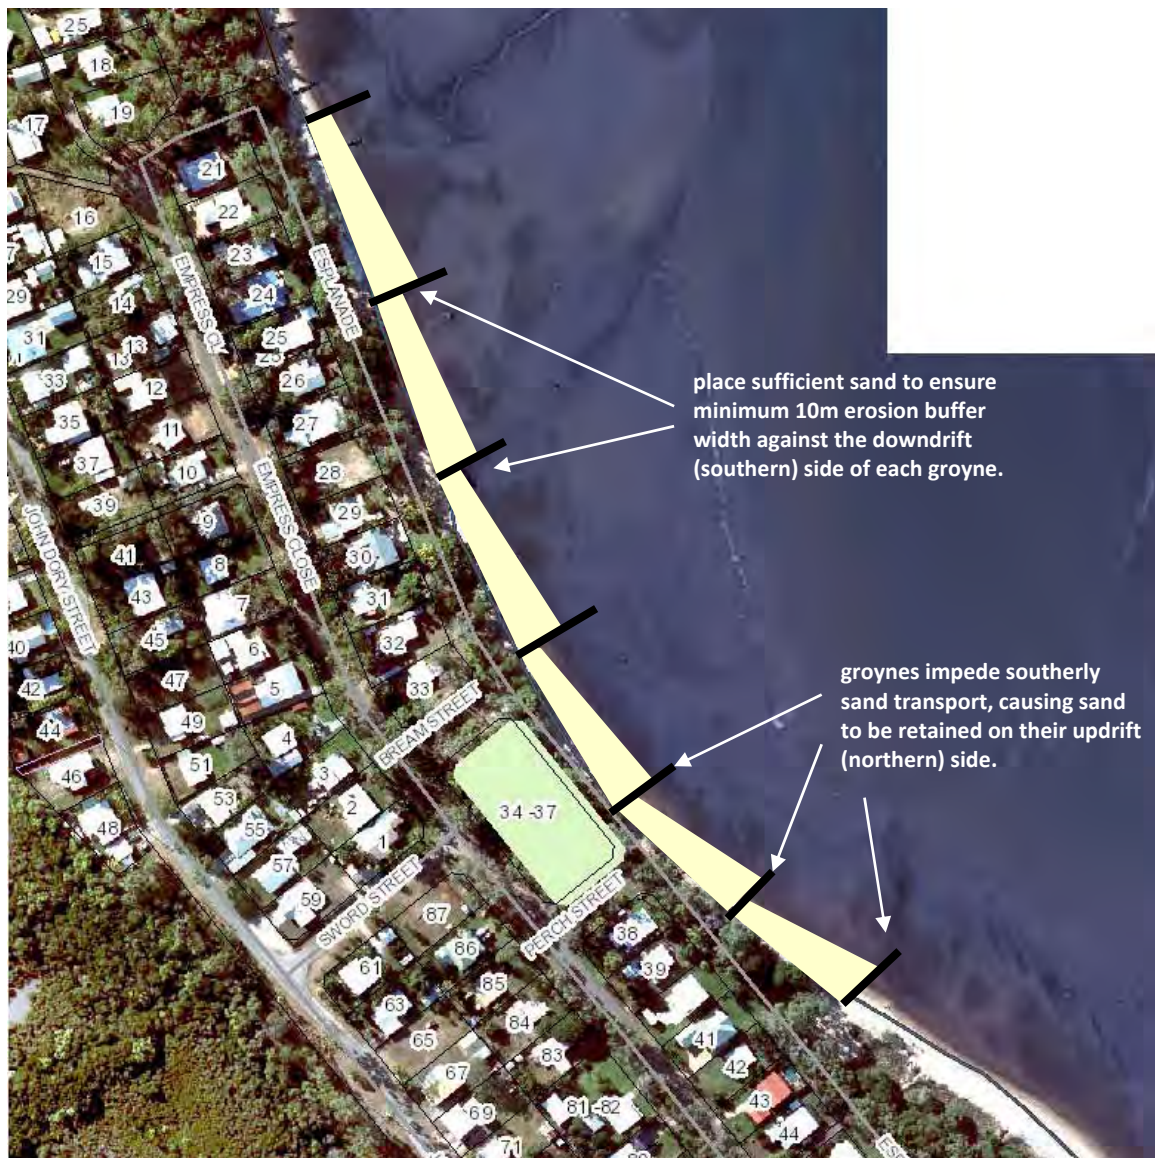
Figure 5.3 : Proposed groyne field to retain buffer

Instead of recharging the buffer regularly by backpassing, groynes could be constructed across the foreshore to impede the longshore transport of sand out of the buffer. The concept is illustrated on Figure 5.3. However the number, length and positions of groynes shown on this figure are estimates only based on desk-top study of stable beach compartments. Detailed coastal process modelling would be required as part of final engineering design to determine these issues specifically.

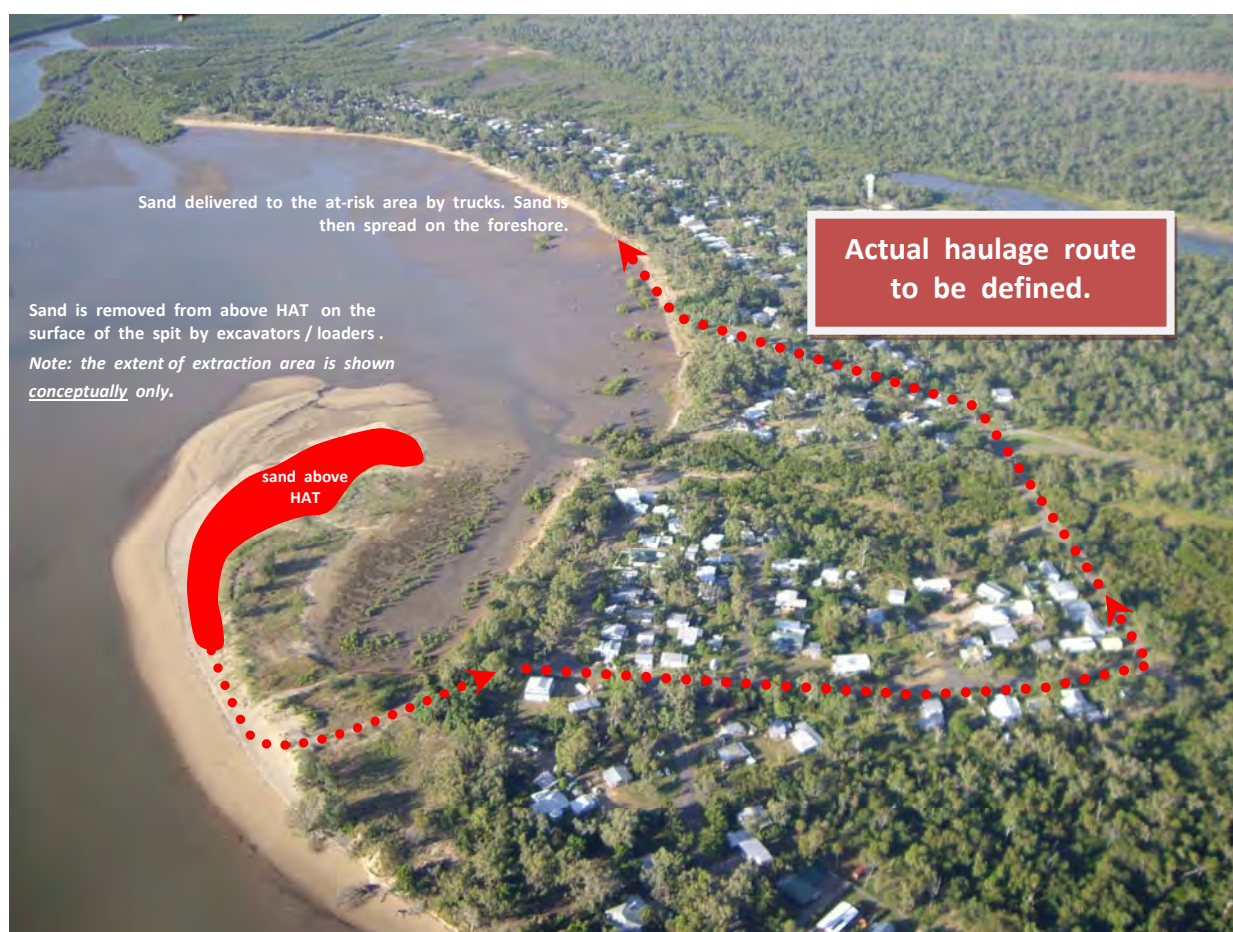
Figure 5.4 : Potential sand sourcing methodology

The proposed sand sourcing methodology is illustrated conceptually in Figure 5.4. It entails using conventional earth-moving equipment such as excavators and front-end loaders to extract the sand from the surface of the spit and load it into trucks. These trucks would then deliver this sand to the downdrift foreshore fronting Cungulla.

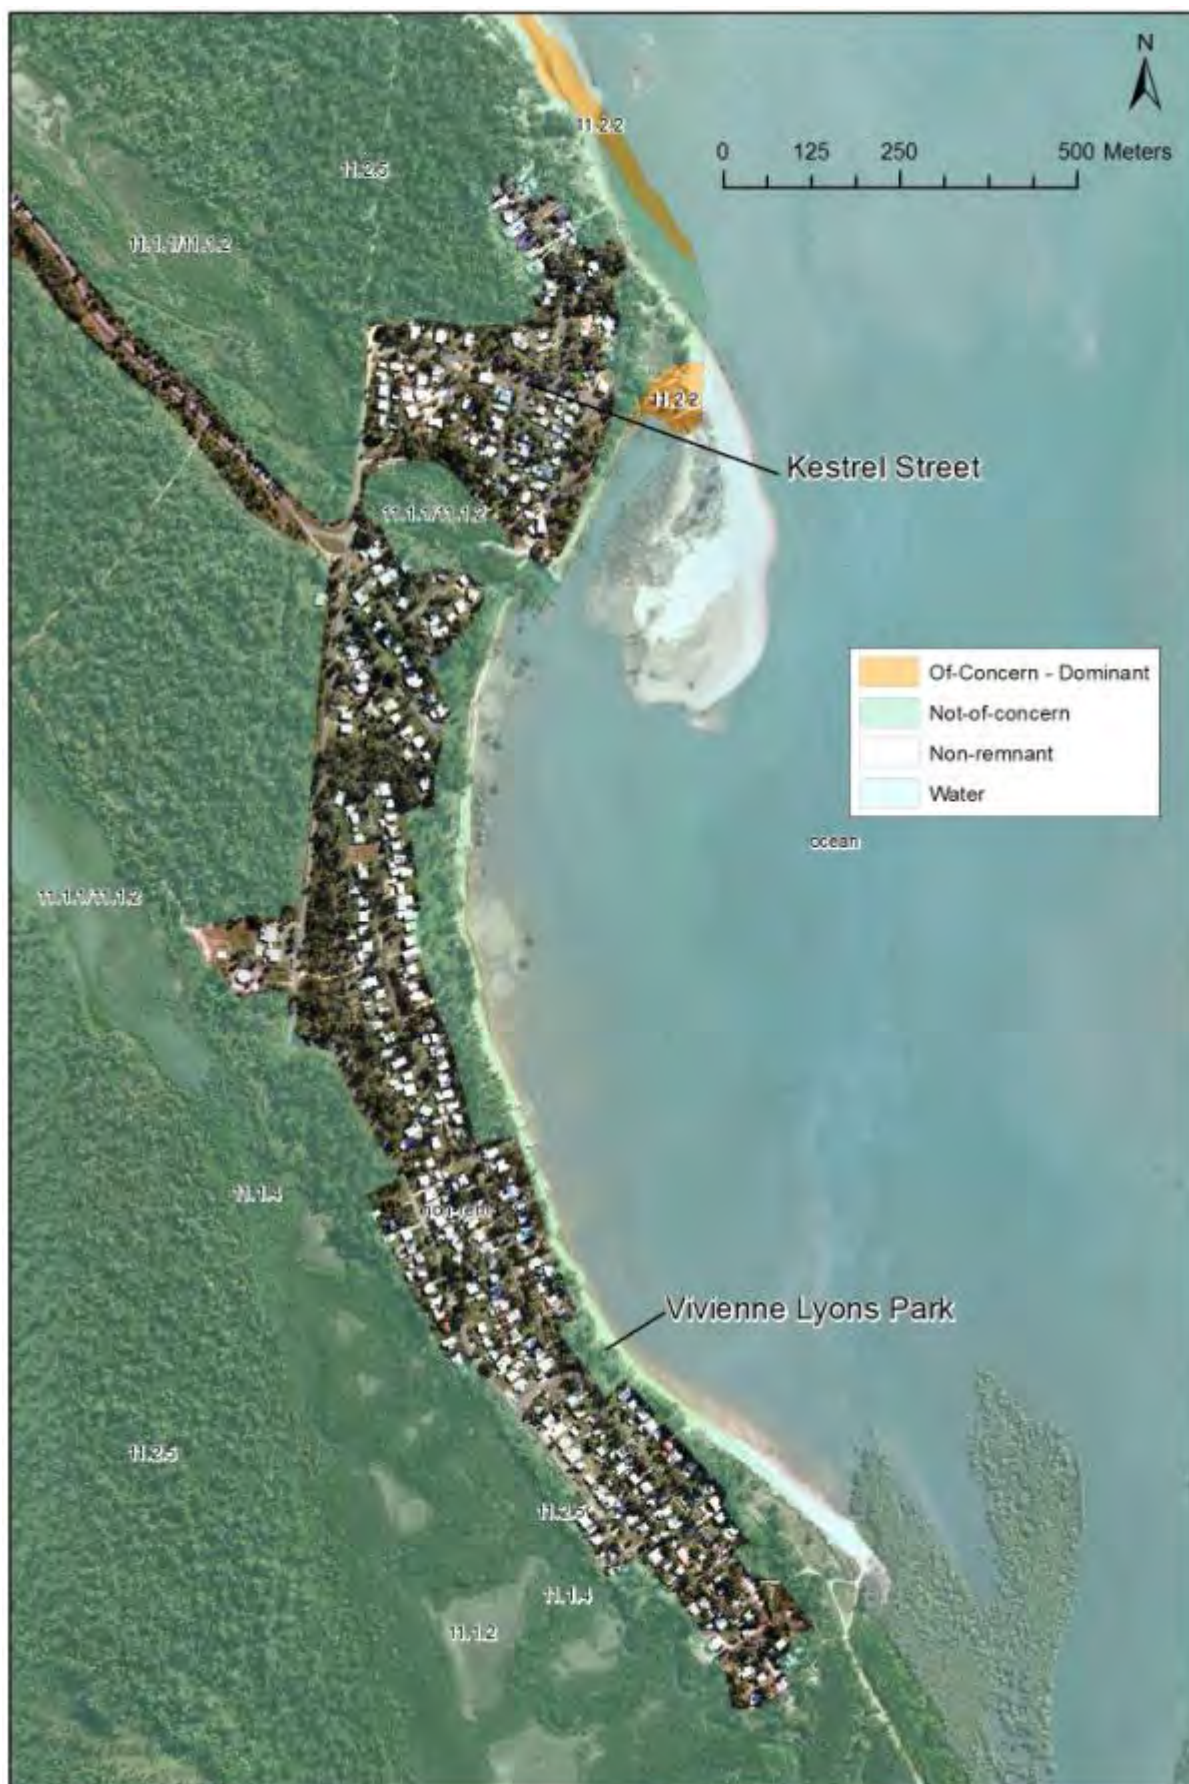
Figure 6.1 : Regional Ecosystem mapping for Cungulla Foreshore

The foreshore from Kestrel Street to just south of Vivienne Lyons Park is highly modified with low to no dune height, limited native foreshore vegetation, numerous weed species and has piles of rocks, tyres, tree trunks, green waste, bricks and building debris littering the foreshore. As illustrated in Figure 6.1, the Regional Ecosystem for this area is mapped as *11.2.5 Corymbia-Melaleuca woodland complex of beach ridges and swales*.

The regional ecosystem for this area is mapped as *11.2.5 Corymbia-Melaleuca (Moreton Bay Ash-Tea Tree) woodland complex of beach ridges and swales* and *11.2.2 Complex of Spinifex sericeus (Spinifex), Ipomoea pes-caprae (Goat's foot vine) and Casuarina equisetifolia (She Oak) grassland and herbland on foredunes*. It is pertinent to note that the latter vegetation community is classed as *Of Concern*. A regional ecosystem is listed as *Of Concern* if:

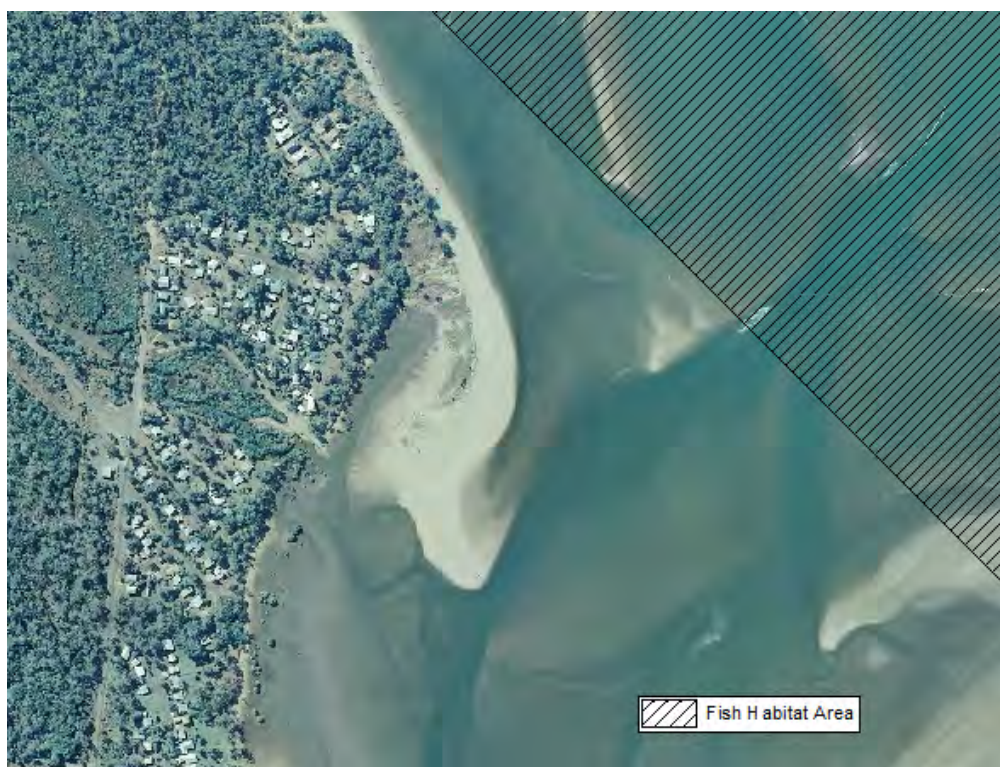
Figure 7.1 : Designated Fish Habitat Area in relation to Cunggulla

It is unlikely that the proposed activities will directly impact on marine plants, but if disturbance is unavoidable, a development application under the *Sustainable Planning Act* (referred to previously), will need to be referred to the Department of Agriculture, Fisheries and Forestry. Figure 7.1 shows that Cungulla is not within the Fish Habitat Area.

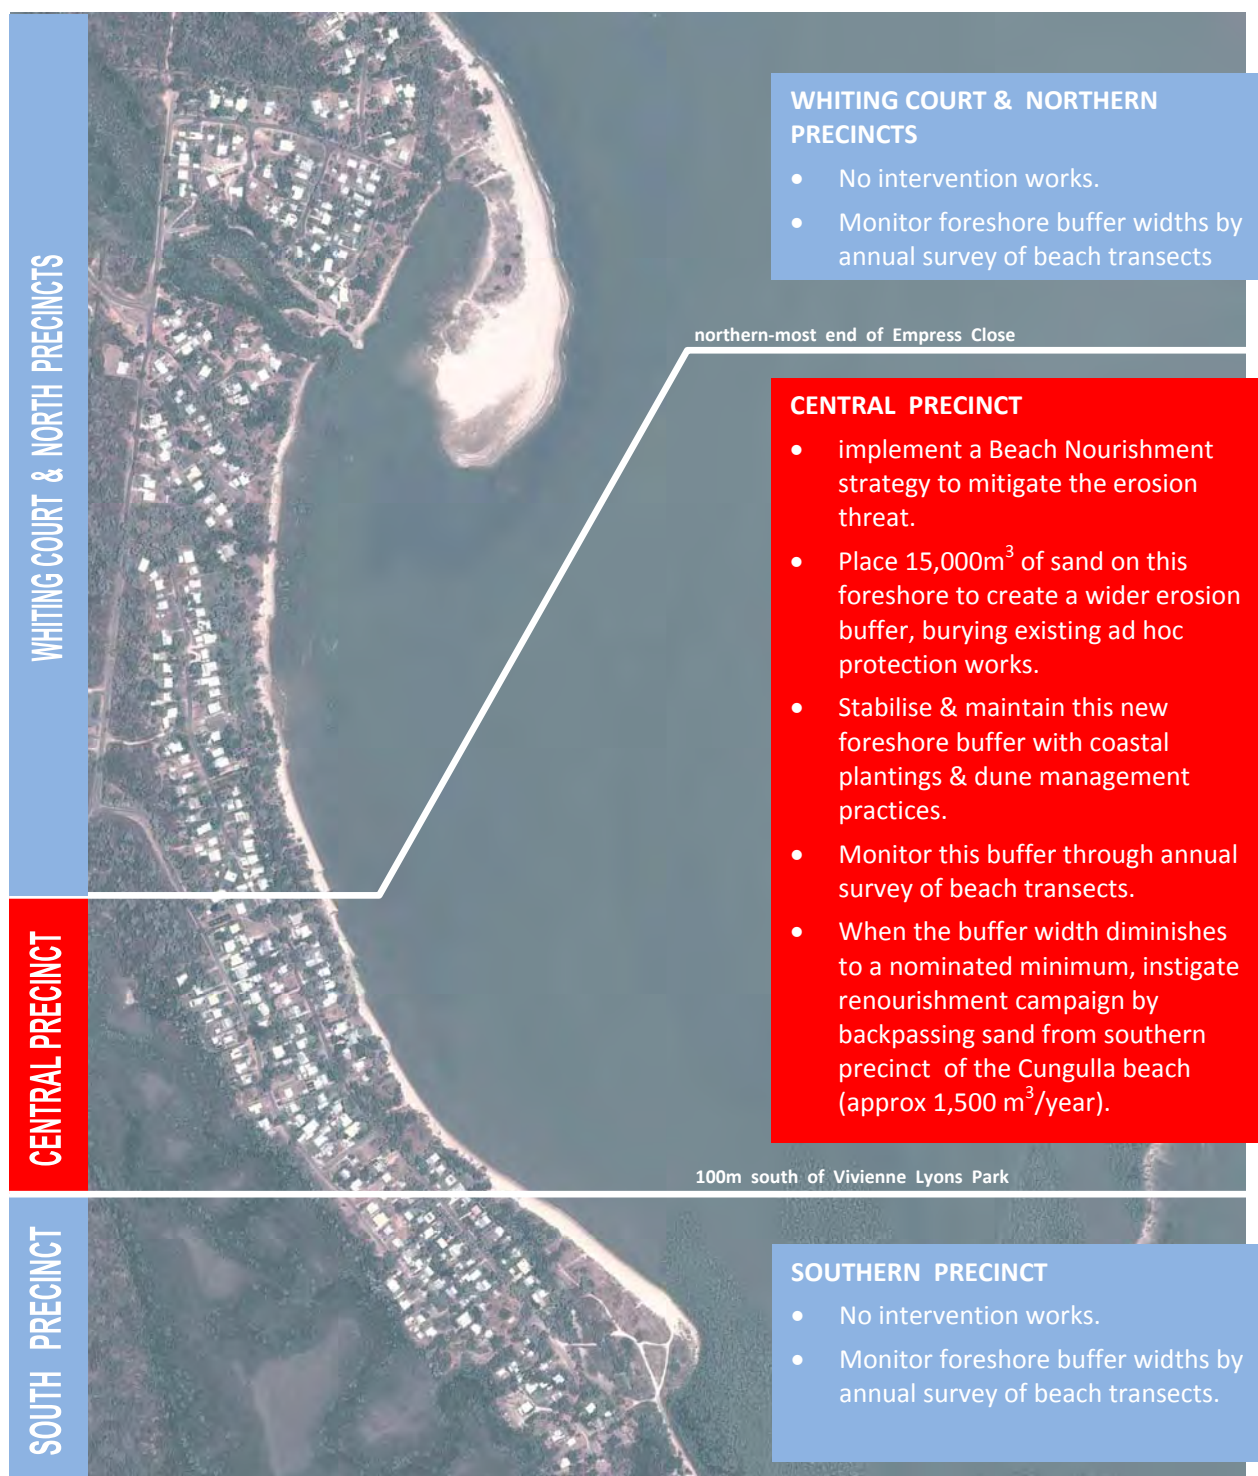
Figure 8.1 : Recommended Shoreline Erosion Management Strategy

- The estimated cost of initial beach nourishment to create the necessary erosion buffer along the at-risk foreshore along the northern end of Empress Close is \$475,000. This is based on sourcing 15,000m³ of sand from existing commercial sand extraction operations in the region; and placing it on the foreshore along the northern end of Empress Close.
- Given that the buffer will be gradually depleted by longshore sand transport processes, it will be necessary to recharge the erosion buffer by periodic placement of additional sand by backpassing. The timing of these backpassing campaigns will be determined by actual depletion rates as measured from annual surveys, however the long-term average annual cost is estimated at \$20,000.
