INVESTIGATION OF TC CHARLOTTE IMPACTS IN THE TOWNSVILLE AREA

Systems Engineering Australia Pty Ltd

TITLE	<i>Investigation of TC Charlotte Impacts in the Townsville Area</i>				
Client	Townsville City Council				
Contract	P/O D/217802	Name	Storm Tide Support		
SEA Job No.	J0813	Document ID:	PR001	Rev:	B
Prepared by:	B A Harper	Approved by:	B A Harper		
Custodian:	B A Harper	Signature:	B A Harper Date: 05/03/2009

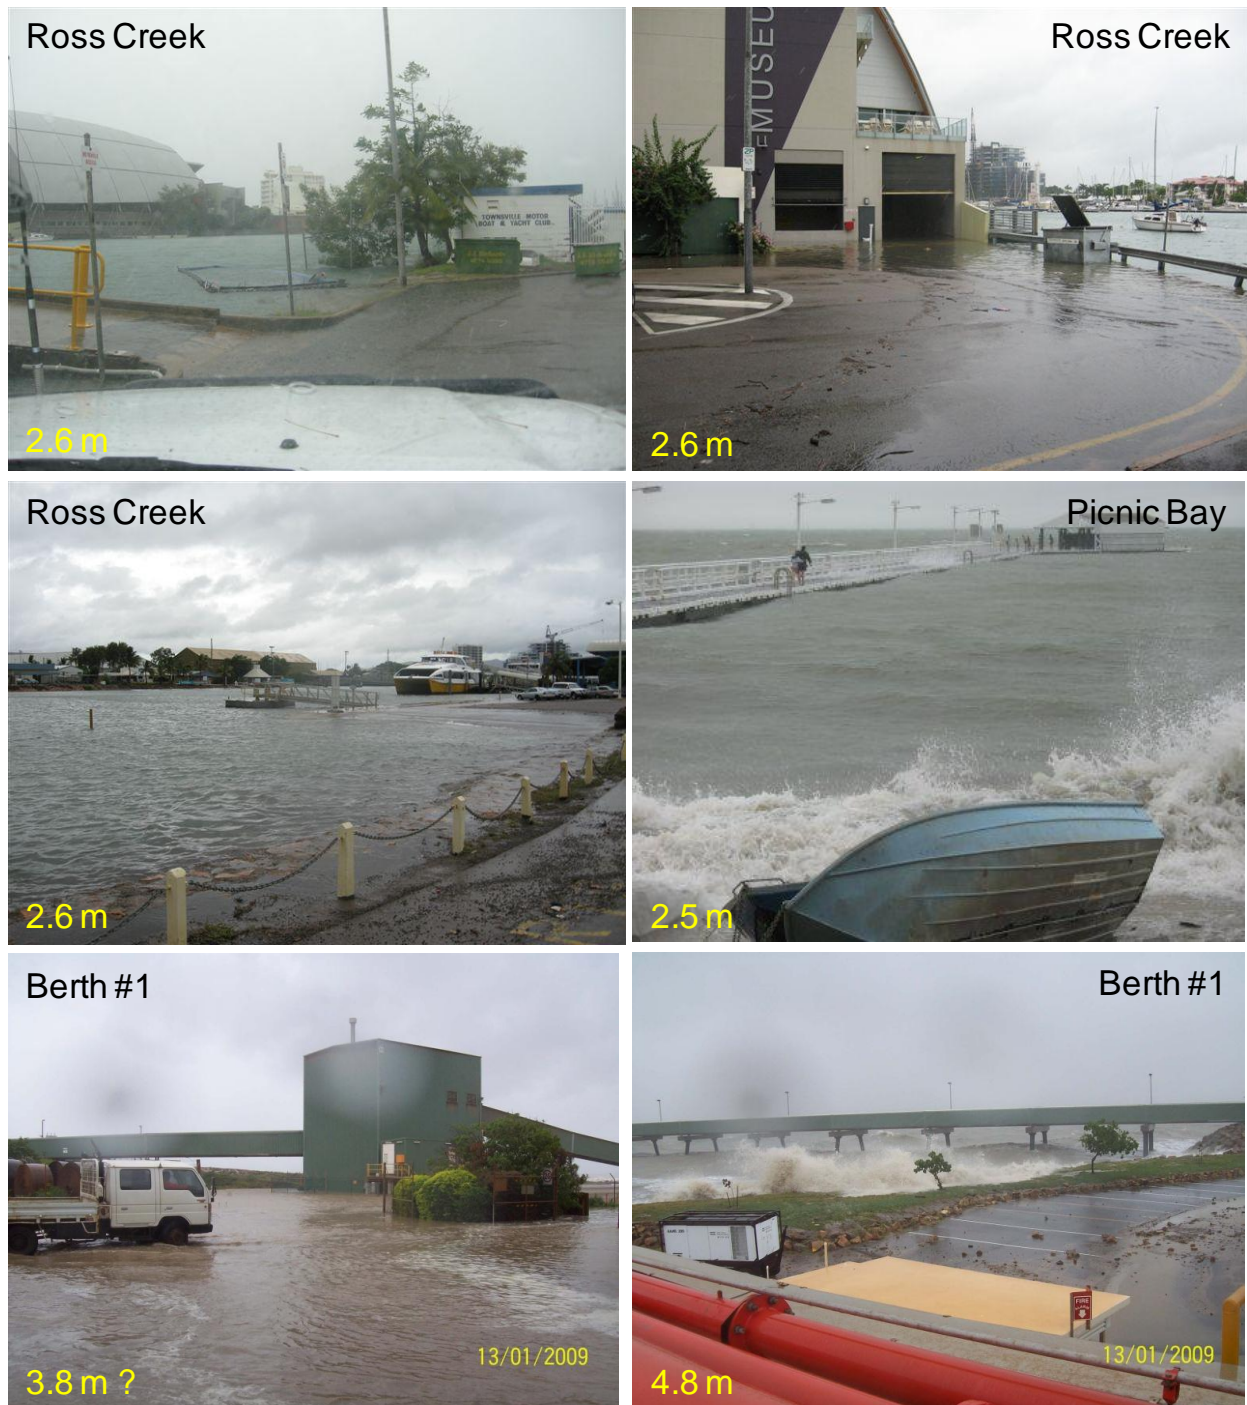
Figure 5 Selected water levels Ross Creek, Harbour and Picnic Bay.

In Figure 5, the Ross Creek levels are consistent with the nearby tide gauge maximum (refer Figure 10 also). The Picnic Bay level is slightly lower but consistent with the expected slight tidal attenuation relative to the Harbour. The Harbour levels are considerably higher and the ponding evident may be due to poor drainage in that vicinity or perhaps some wave setup affecting the drain tailwater. The debris line at the car park is amongst the highest levels found in the region, indicating added wave setup and runup at the exposed rubble-mound revetment.

A large number of photographs taken during the event were made available from Council sources (principally beach inspectors) and others, a selection of which are shown in Figure 5 through Figure 7 for illustration. The water levels, where indicated, have been inferred from Council's TIM system or surveyed levels. The exact timing of the images is unknown but generally is understood to be near the time of high tide on the 13th.

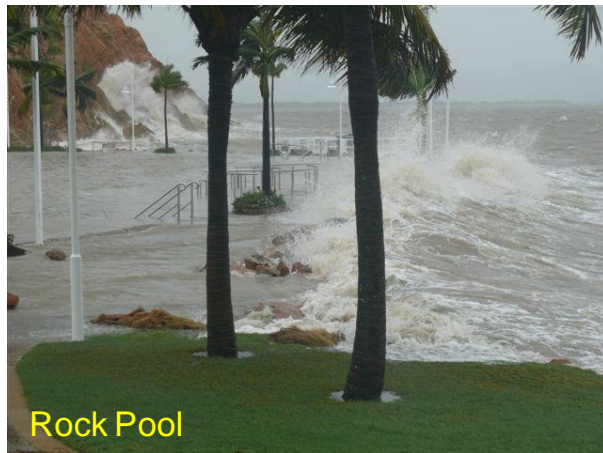
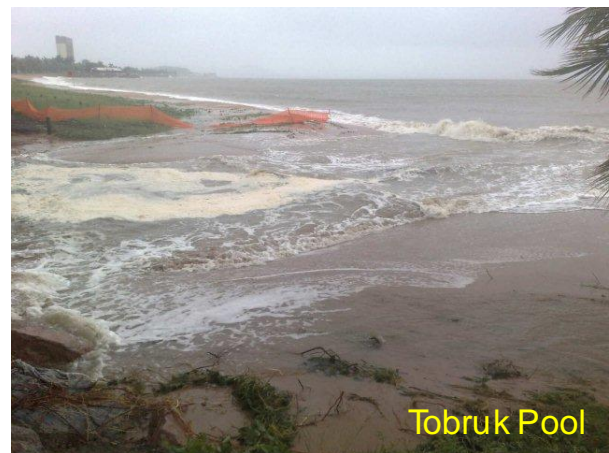
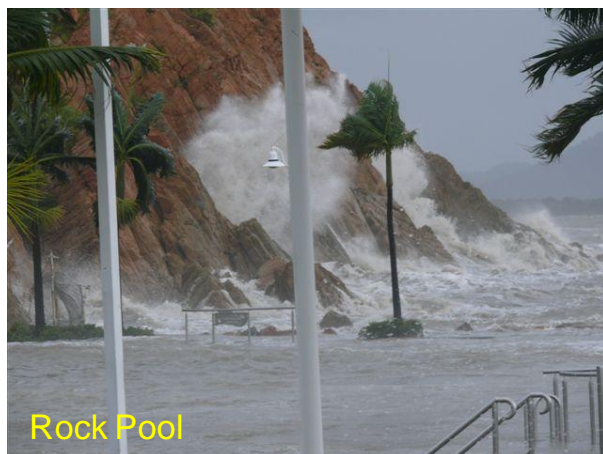
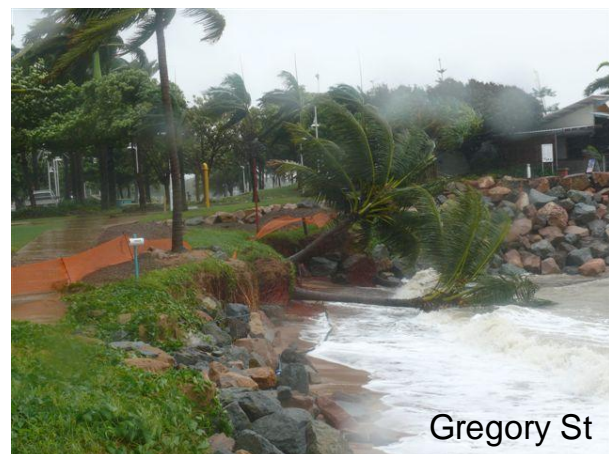
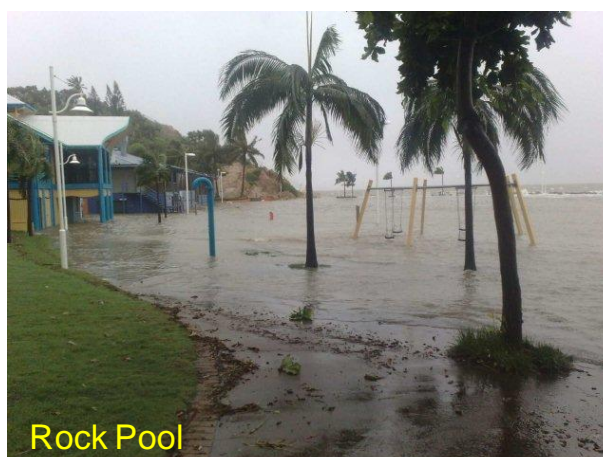
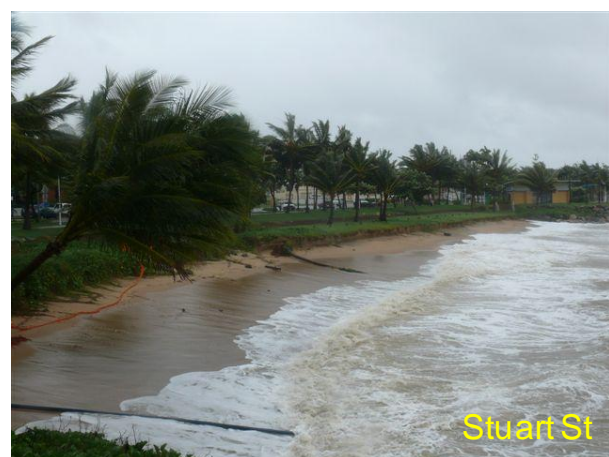
Figure 6 Selected beach impacts along The Strand.

In Figure 6, wave effects on top of the elevated levels eroded portions of the beaches, mainly on the southern side of the revetment headlands. At the Rock Pool, wave setup and runup was significant and dislodged some armour stone, depositing it in the enclosure. The ground levels of the life saving club and restaurants were inundated and appear to have been the highest stillwater levels in the area.

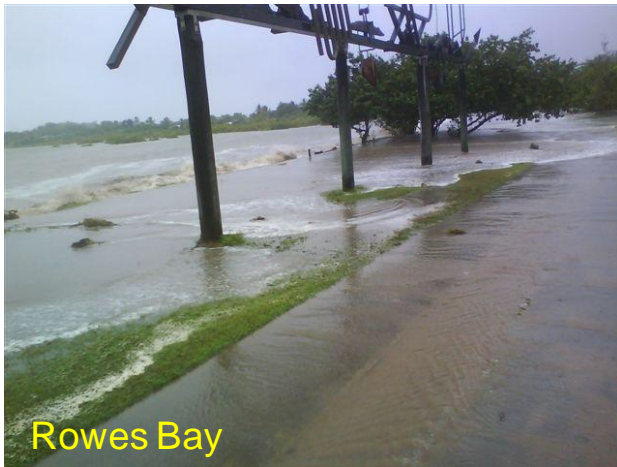
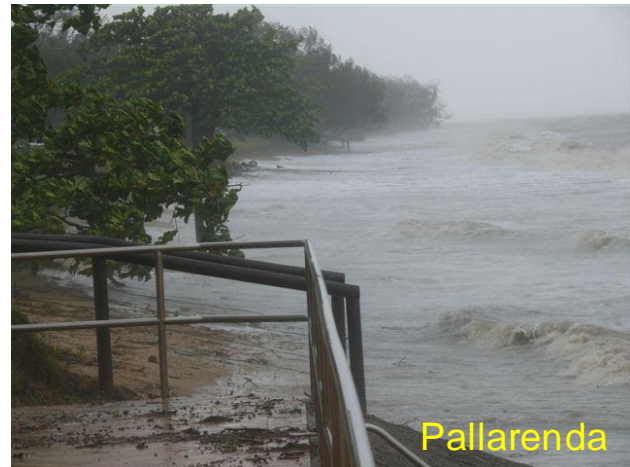
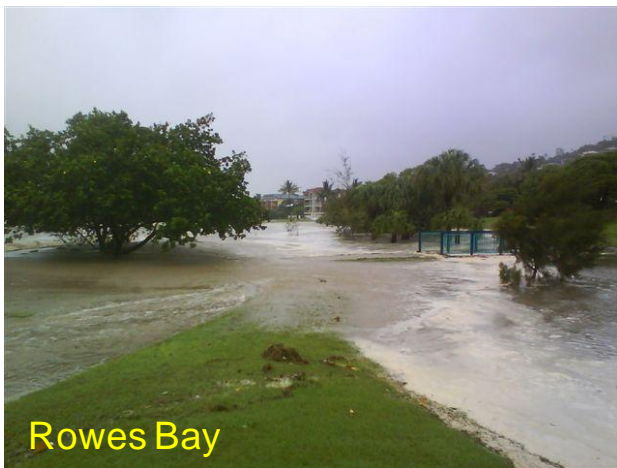
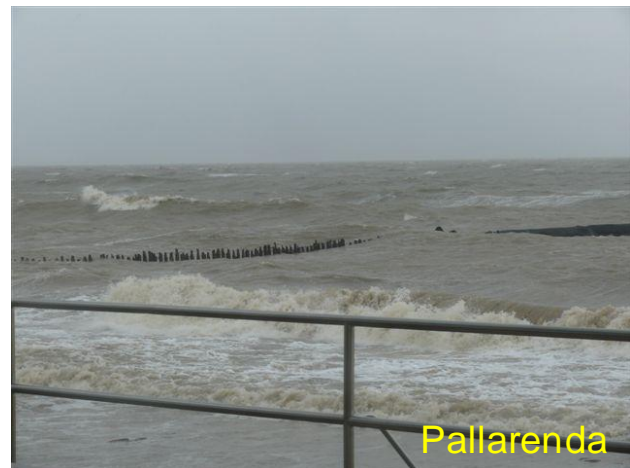
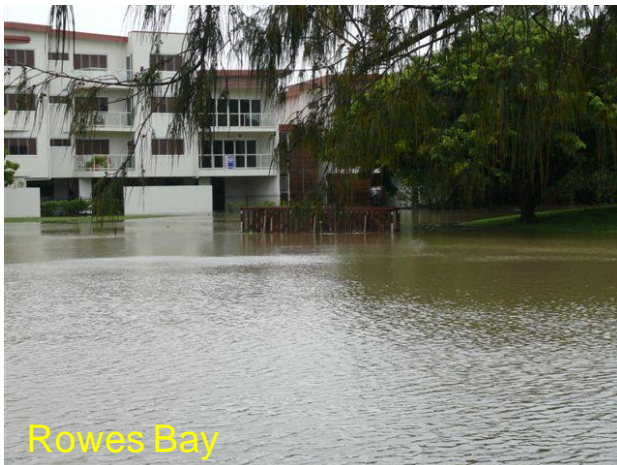
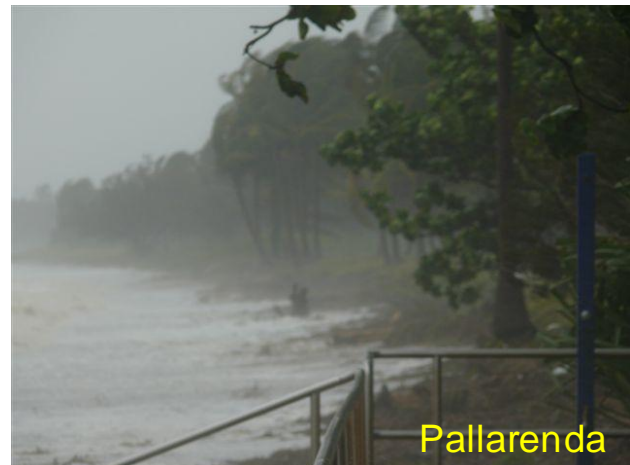
Figure 7 Selected beach impacts Rows Bay and Pallarenda.

In Figure 7, properties near Rowes Bay / Belgian Gardens were affected and Soroptimist Park was overtopped. The Pallarenda foreshore was also impacted (these photos apparently taken on 14/01).

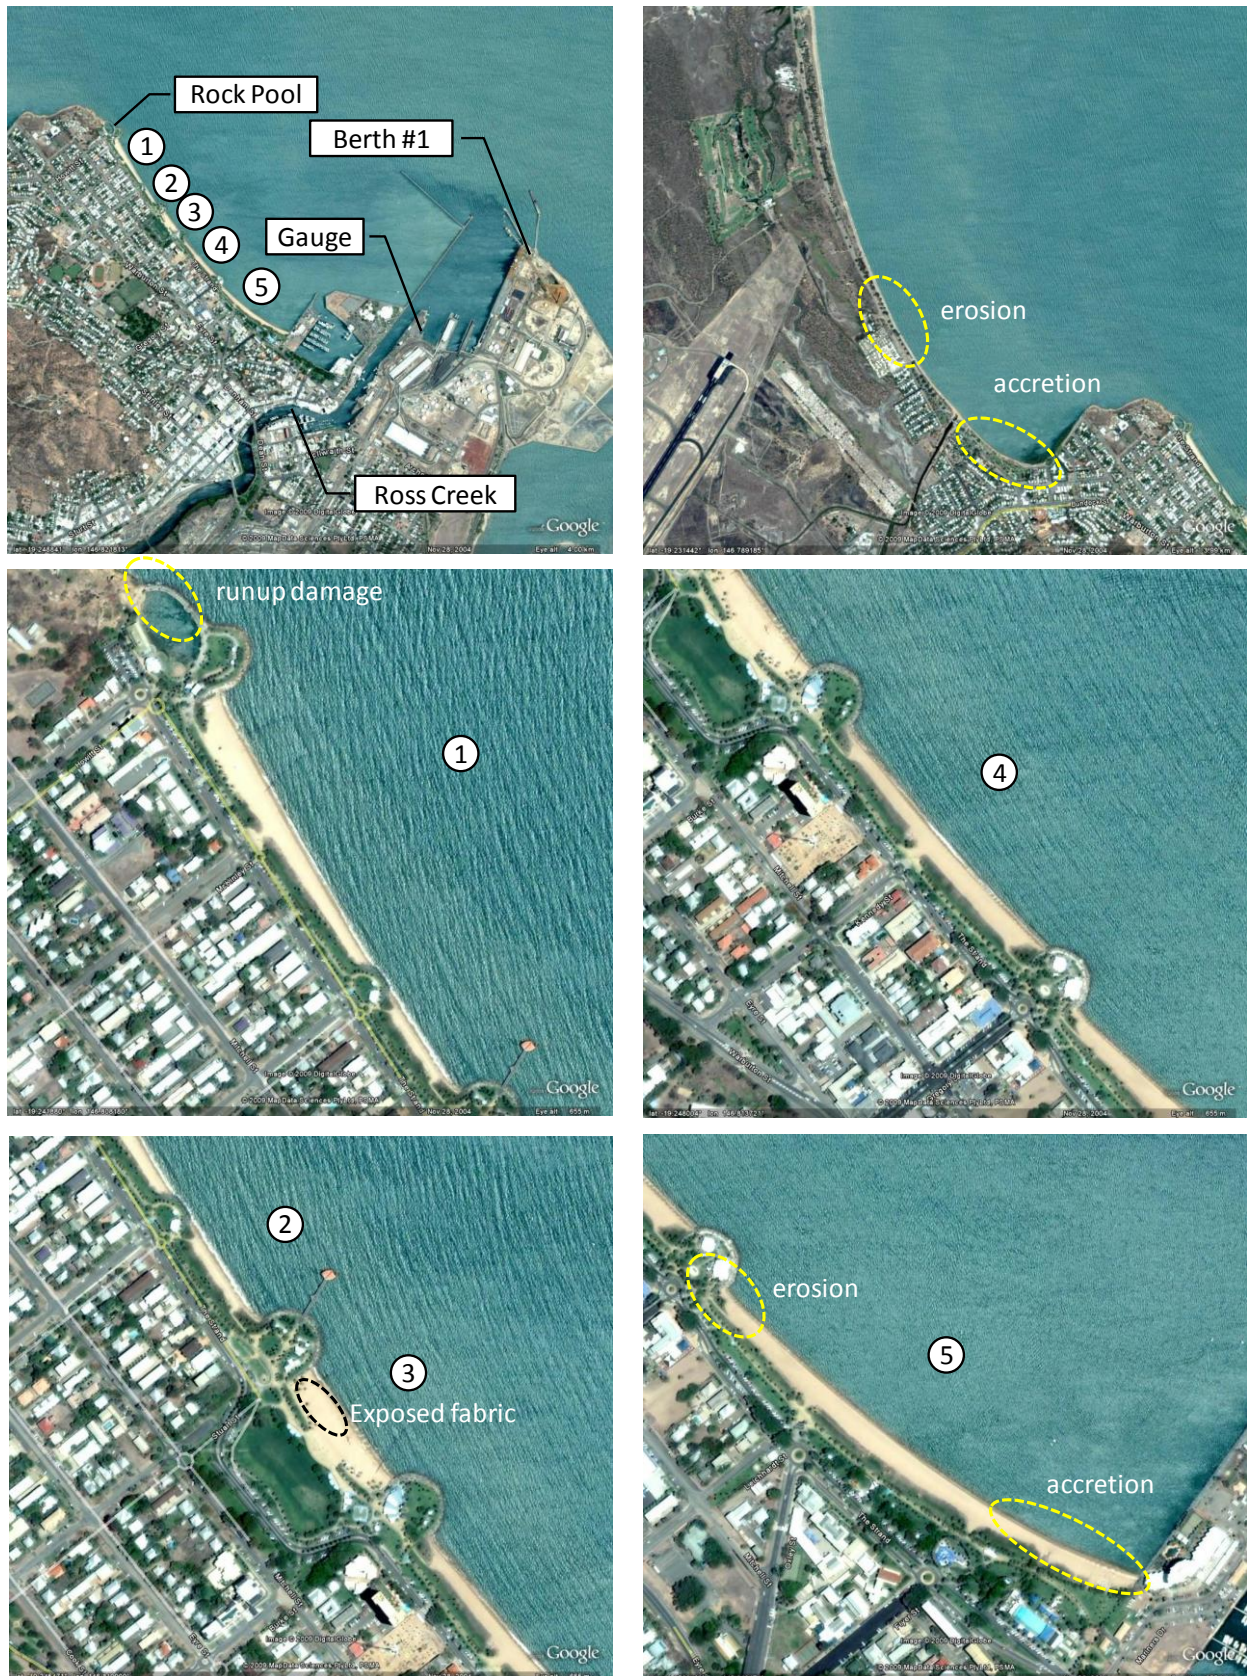
Figure 10 Surveyed areas of The Strand and Rows Bay.

Examples of the site inspection and survey work are given in Figure 10 through Figure 12. Figure 10 provides a key diagram for The Strand beaches and indicates typical areas suffering erosion (normally northern corners) or accretion (normally southern corners), consistent with the angle of wave attack. Effects along beaches 1 through 4 were similar, with evidence of lee sheltering from the harbour breakwater at the southern end of beach 5. Erosion occurred at the abutment of each headland revetment as a result of concentrated wave energy and was often greatest on the more exposed southern sides. All floating swimming enclosures appeared undamaged, albeit clogged by seagrass flotsam and sand. The Kissing Point rock pool suffered superficial damage and scour.

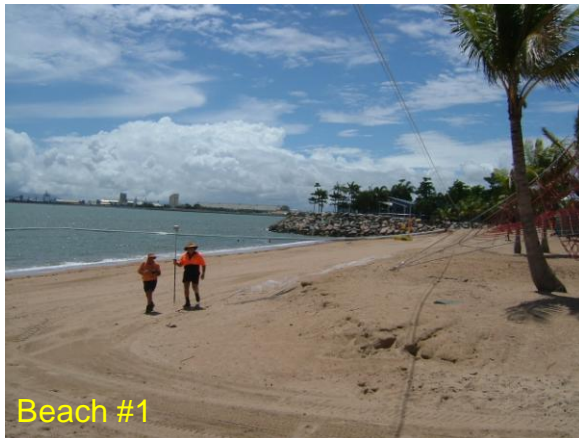
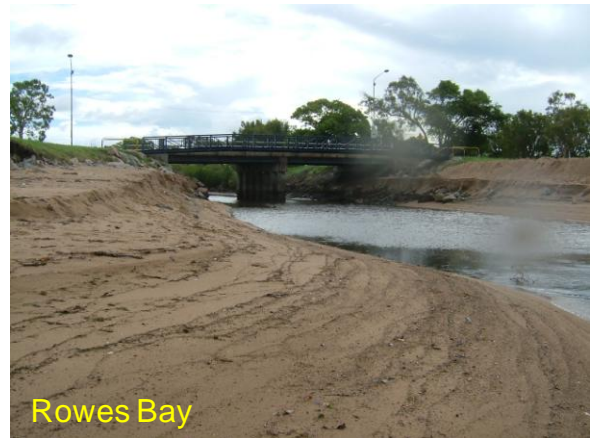
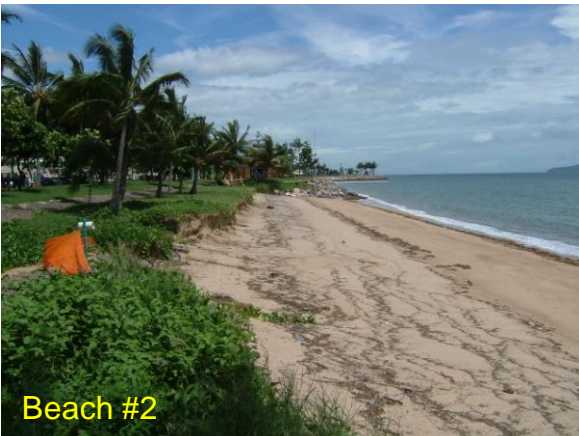
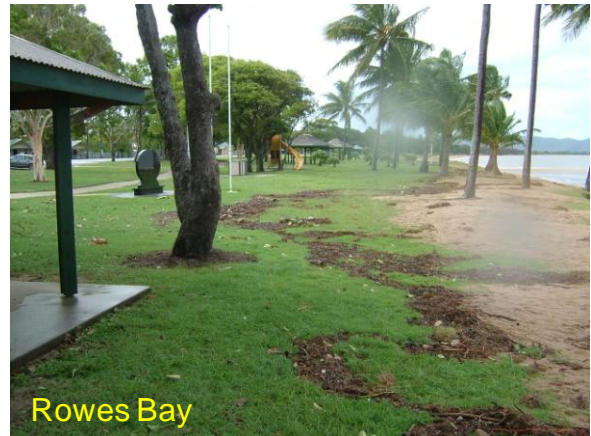
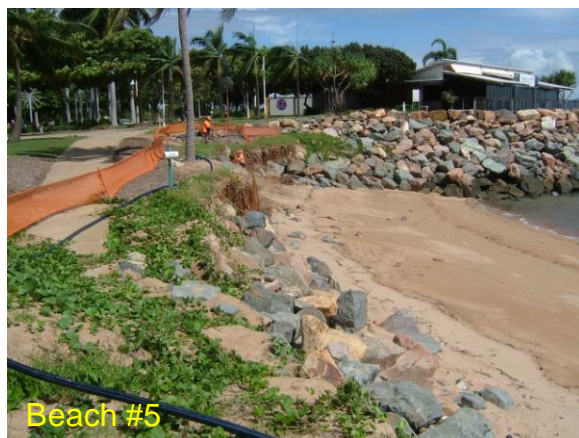
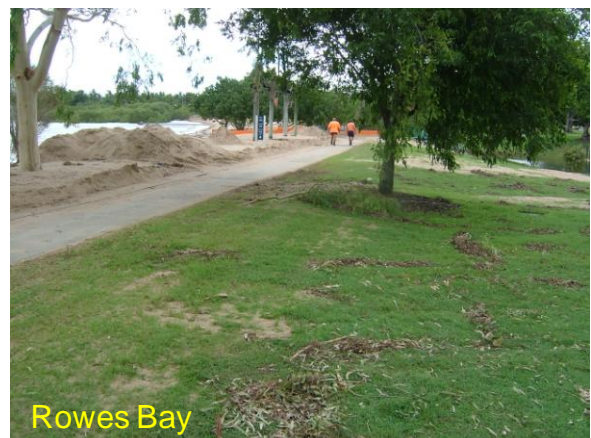
Figure 11 Site inspections The Strand and Rowes Bay.

The site inspection confirmed widespread upper beach sand depletion (scarps plus some exposure of geofabric), some bank erosion at revetment abutments and rock displacement, damage to landscaping, deposition of sand in some southern corners and destruction of beach access infrastructure.

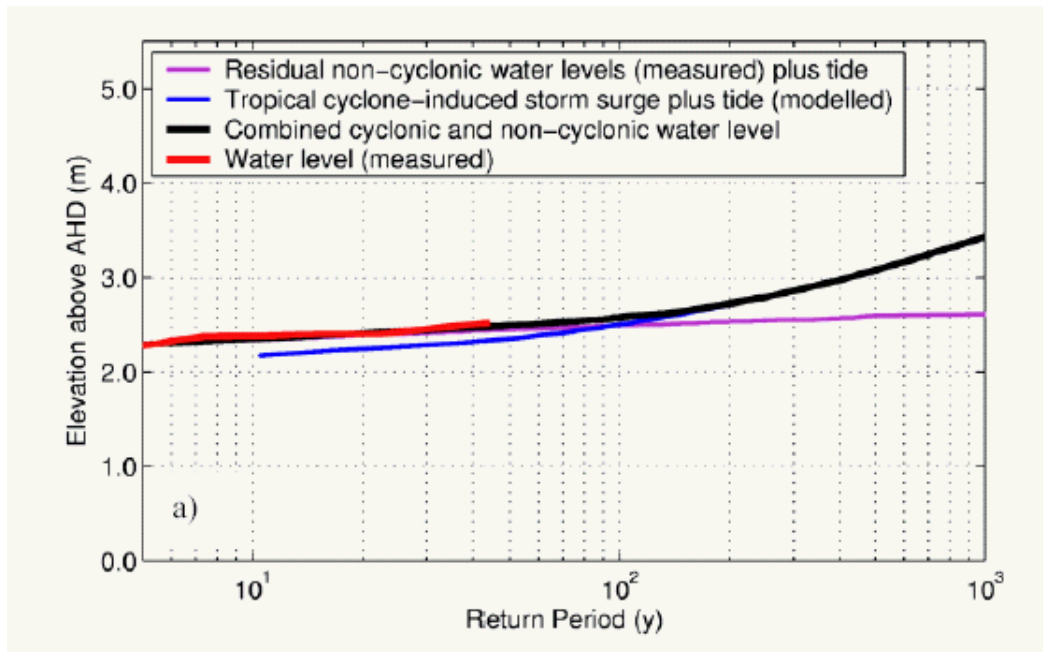
Figure 14 Cyclonic and non-cyclonic analysis for Townsville from Hardy et al. (2004)

However, in the Queensland Climate Change Study (Hardy et al. 2004), some consideration was given to these types of events and a specific case study was included for Townsville as an example. An analysis was undertaken of the residual water levels from the Townsville tide gauge over a 44 year period, specifically excluding times when tropical cyclones were known to have been active in the area. While this would also tend to exclude events like TC *Charlotte*, it remains somewhat representative of this type of phenomenon. The resulting water levels then represented situations when “other” types of weather events had influenced the total water level. This was then sampled in a statistical model and randomly combined many hundreds of times with real tide records for a period of 250 years. In this way a “non-cyclonic” tide plus surge water level return period curve was obtained, which extended from slightly above HAT to merge with the “cyclonic” return period line at about the 200 year return period. The “cyclonic” and “non-cyclonic” probability curves were then appropriately merged, as shown in Figure 14 (part of §Fig 16 from Hardy et al. 2004). No wave setup analyses are available for this situation.

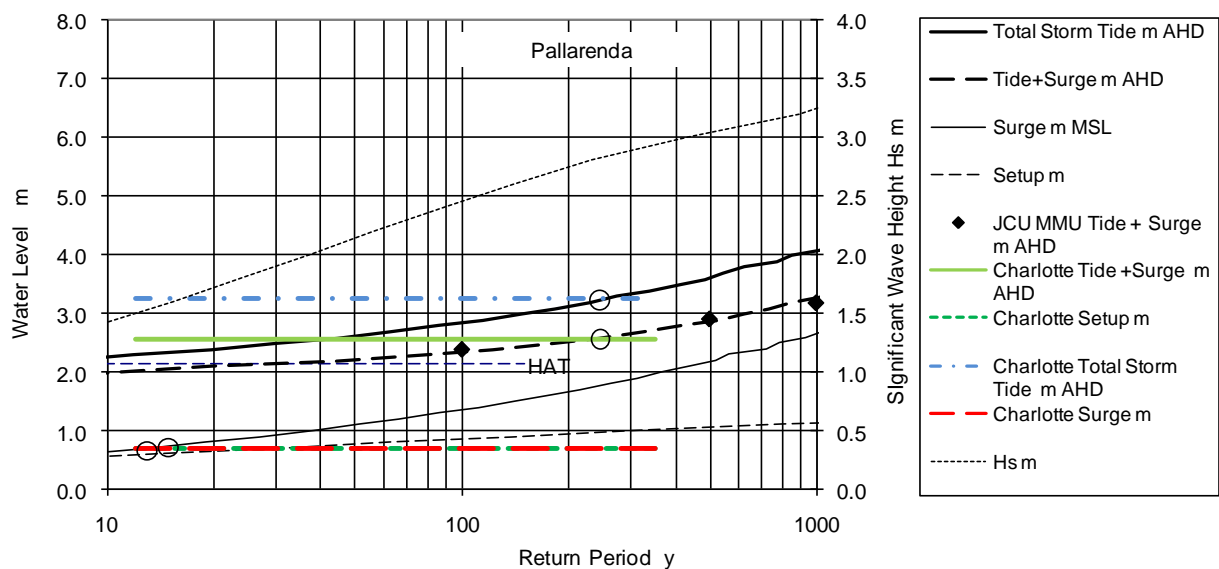
Figure 15 Comparison with cyclonic-only analysis for Townsville from GHD (2007)

In any case, the data for *Charlotte* can be usefully compared with the results from the GHD study, as shown in Figure 15 for Pallarenda as an example. This shows the GHD/SEA predicted “cyclonic only” levels and also the Hardy et al. (2004) “cyclonic only” results for this location, which are quite similar. Overplotted on this are the various water levels for *Charlotte* obtained from this investigation and the approximate intersection with “cyclonic” return periods (open black circles). This shows that the *Charlotte* wave setup and storm surge are relatively low return period events in a “cyclonic” situation, but the tide + surge and total water levels are relatively rare even for “cyclonic” conditions, being in excess of a 200 year average Return Period.

By allowing for the slight raising of the return period curves as per the Hardy et al. (2004) analyses for “combined non-cyclonic and cyclonic”, this indicates a total water level probability of about one in 200 years for this unusual *Charlotte* “pseudo-cyclonic” event.
