Landsdown Eco-Industrial Precinct, Woodstock

Ecological Assessment Report: Week Two

Job Number: VS0366

06/10/2022

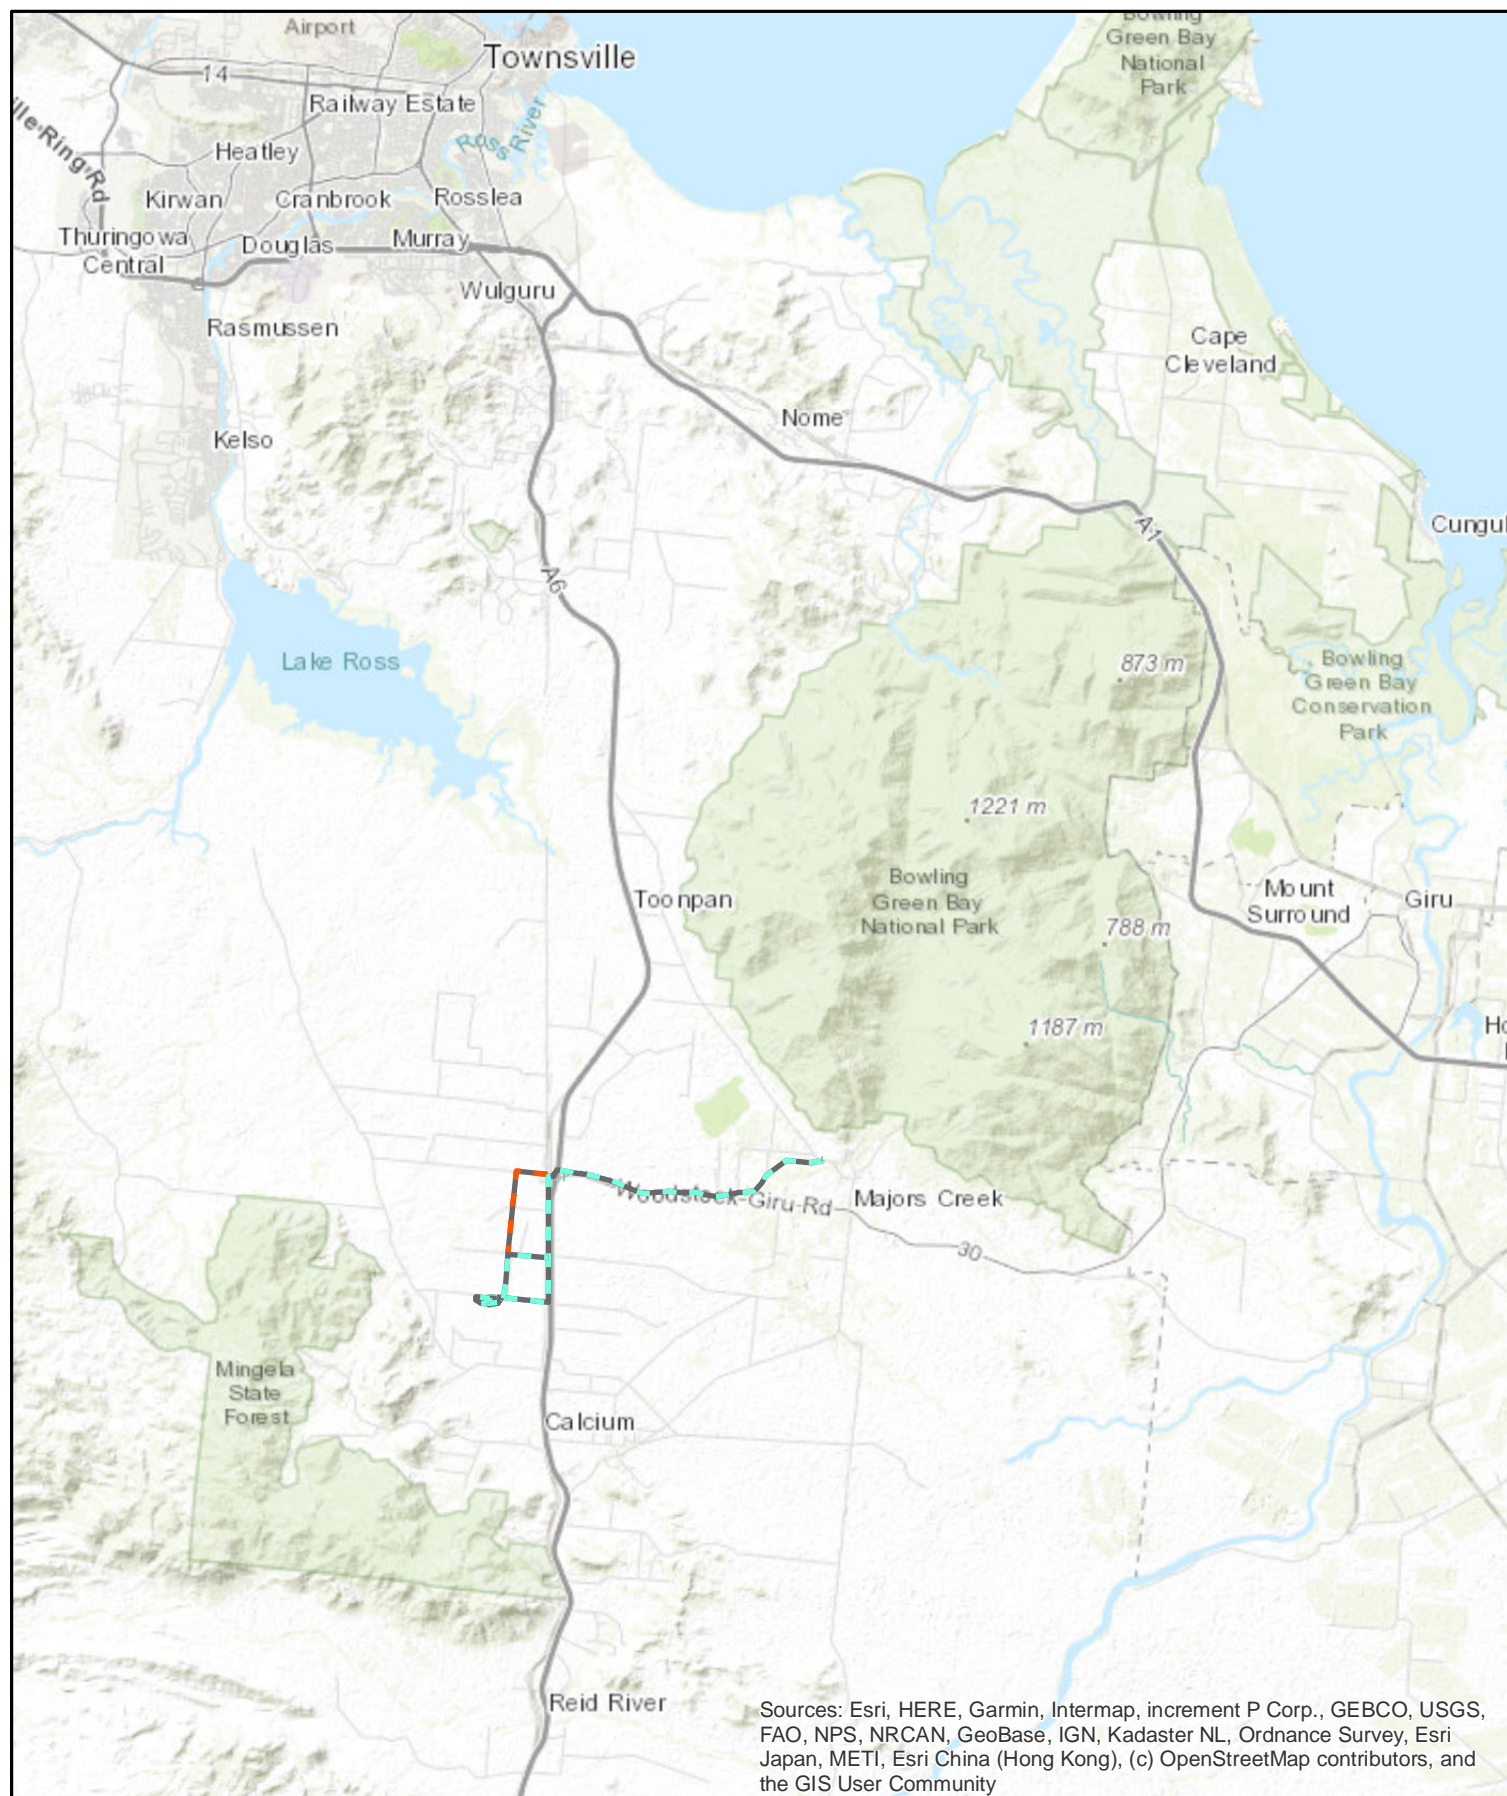
Figure 1: Site Context

2 Site Context

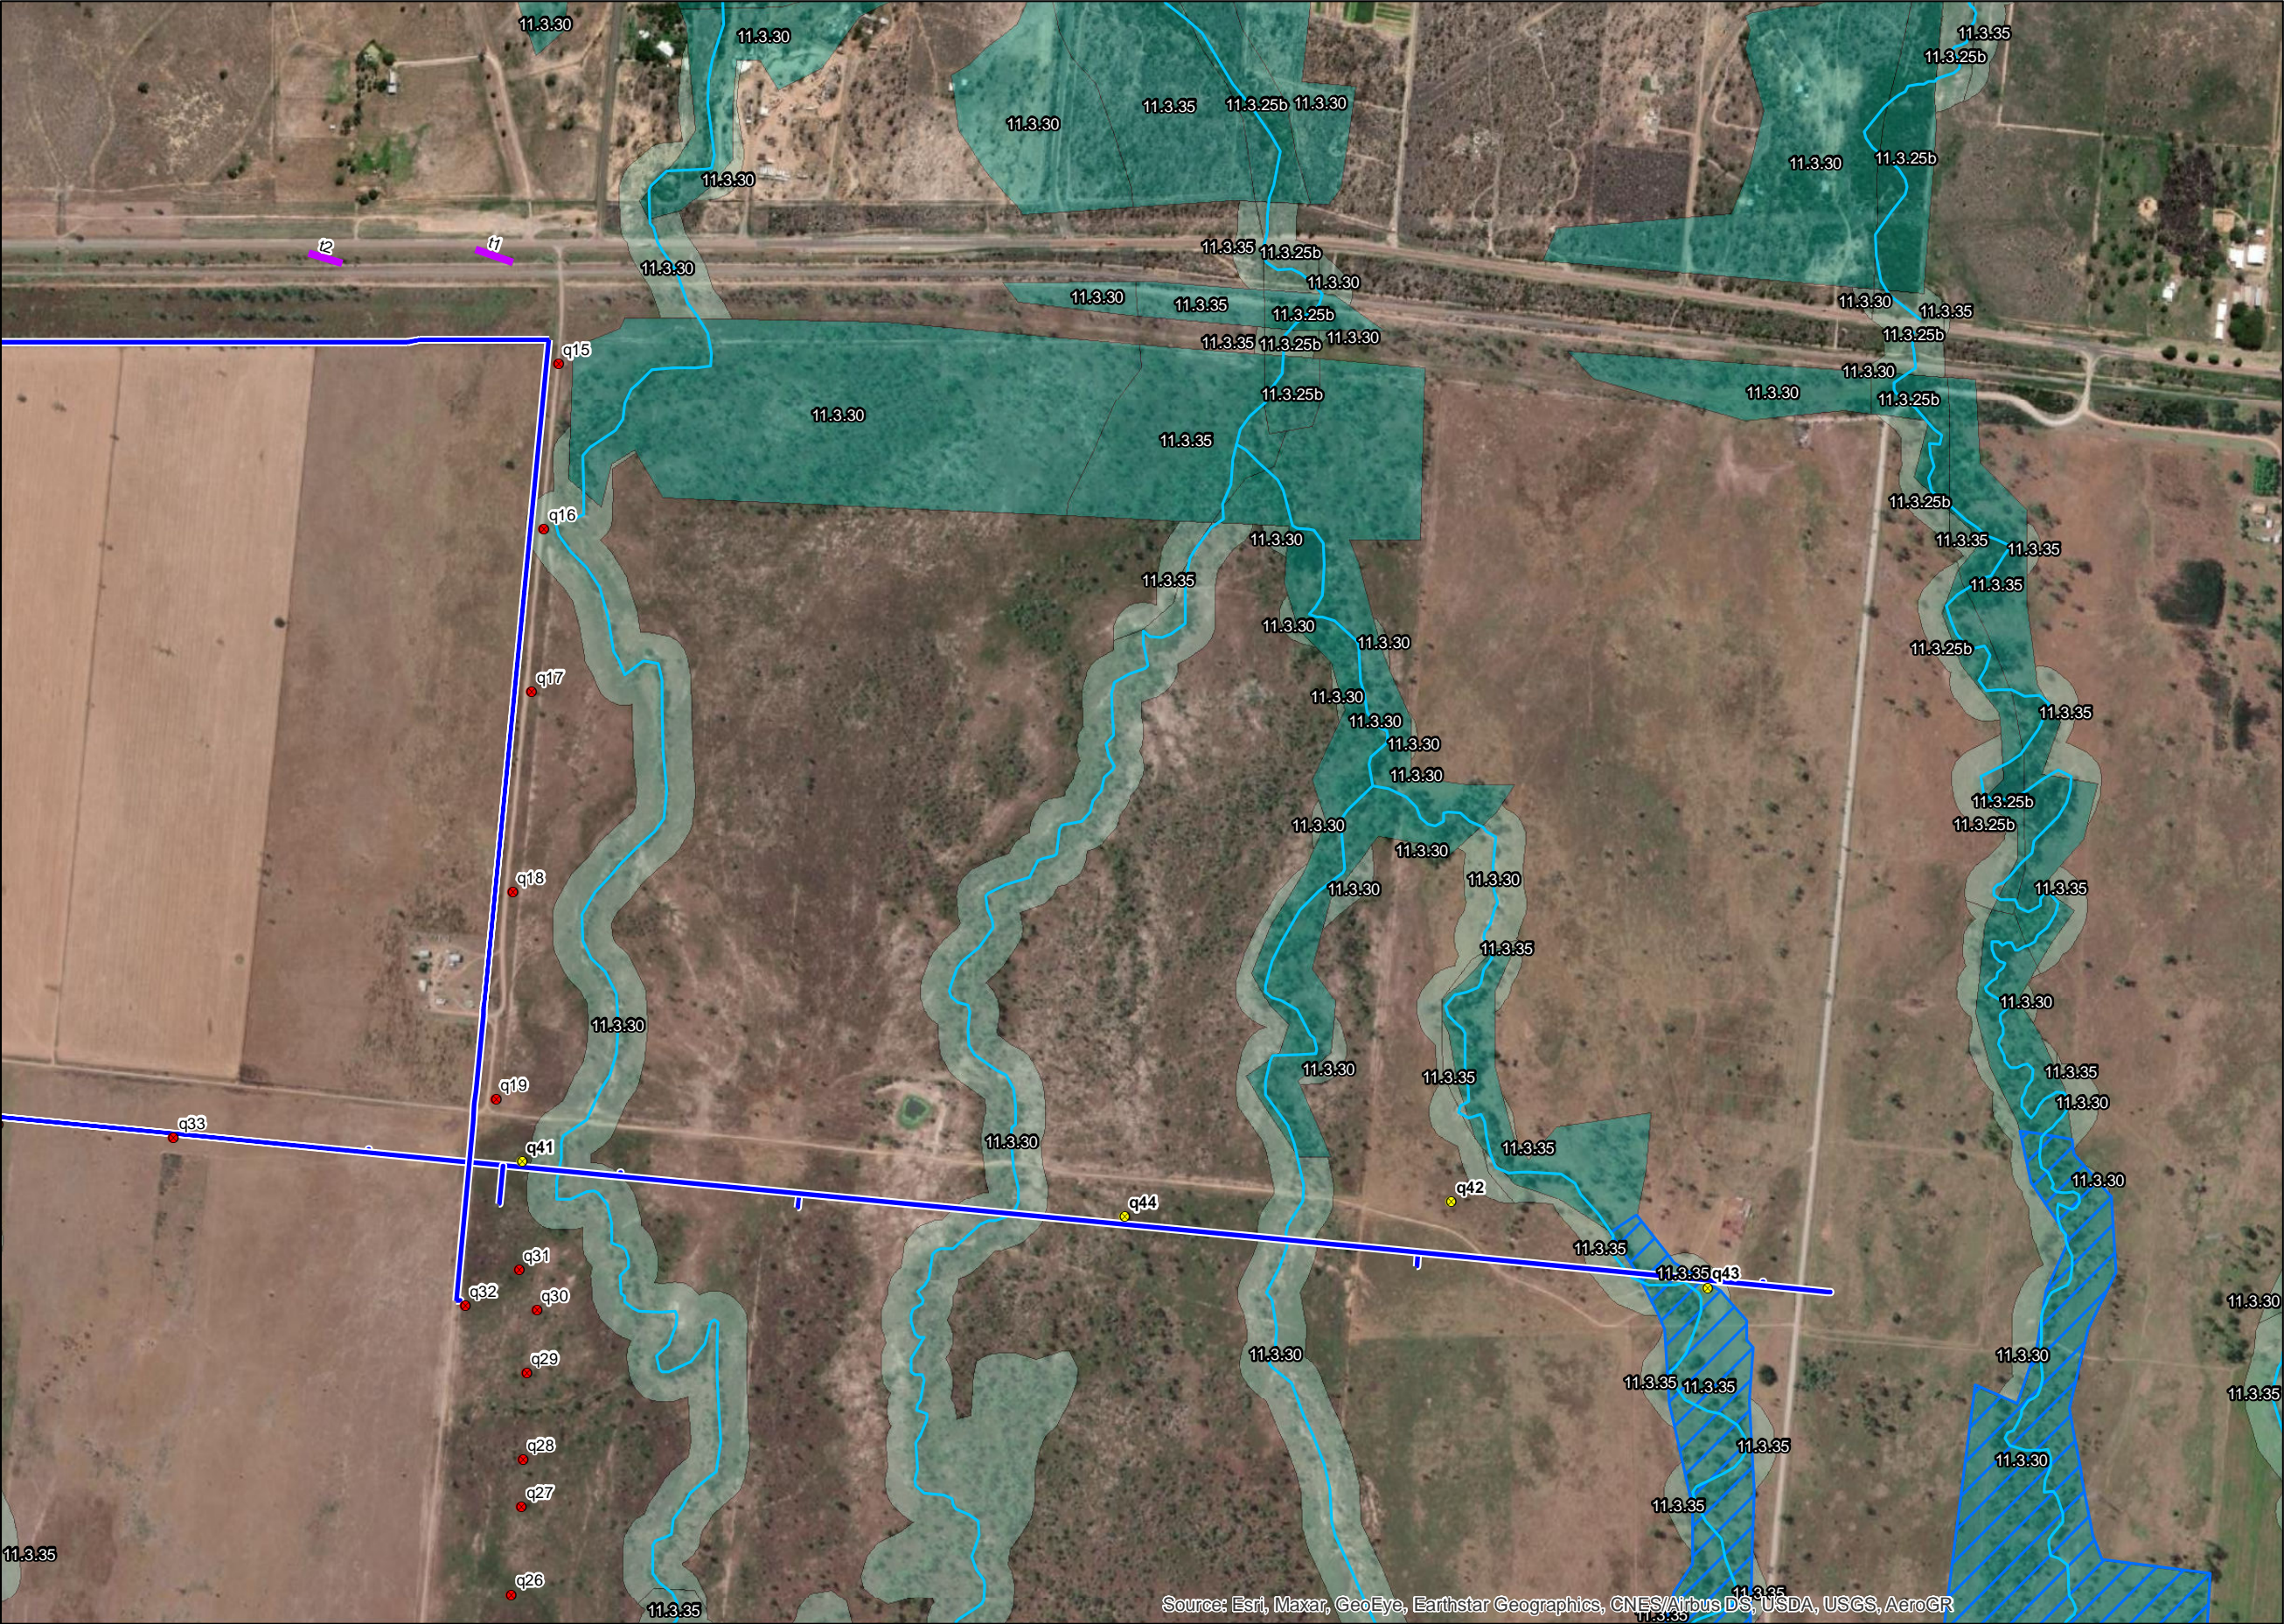
Plan 2: Regional Ecosystems

Refer to **Plan 2** for locations of these surveys.

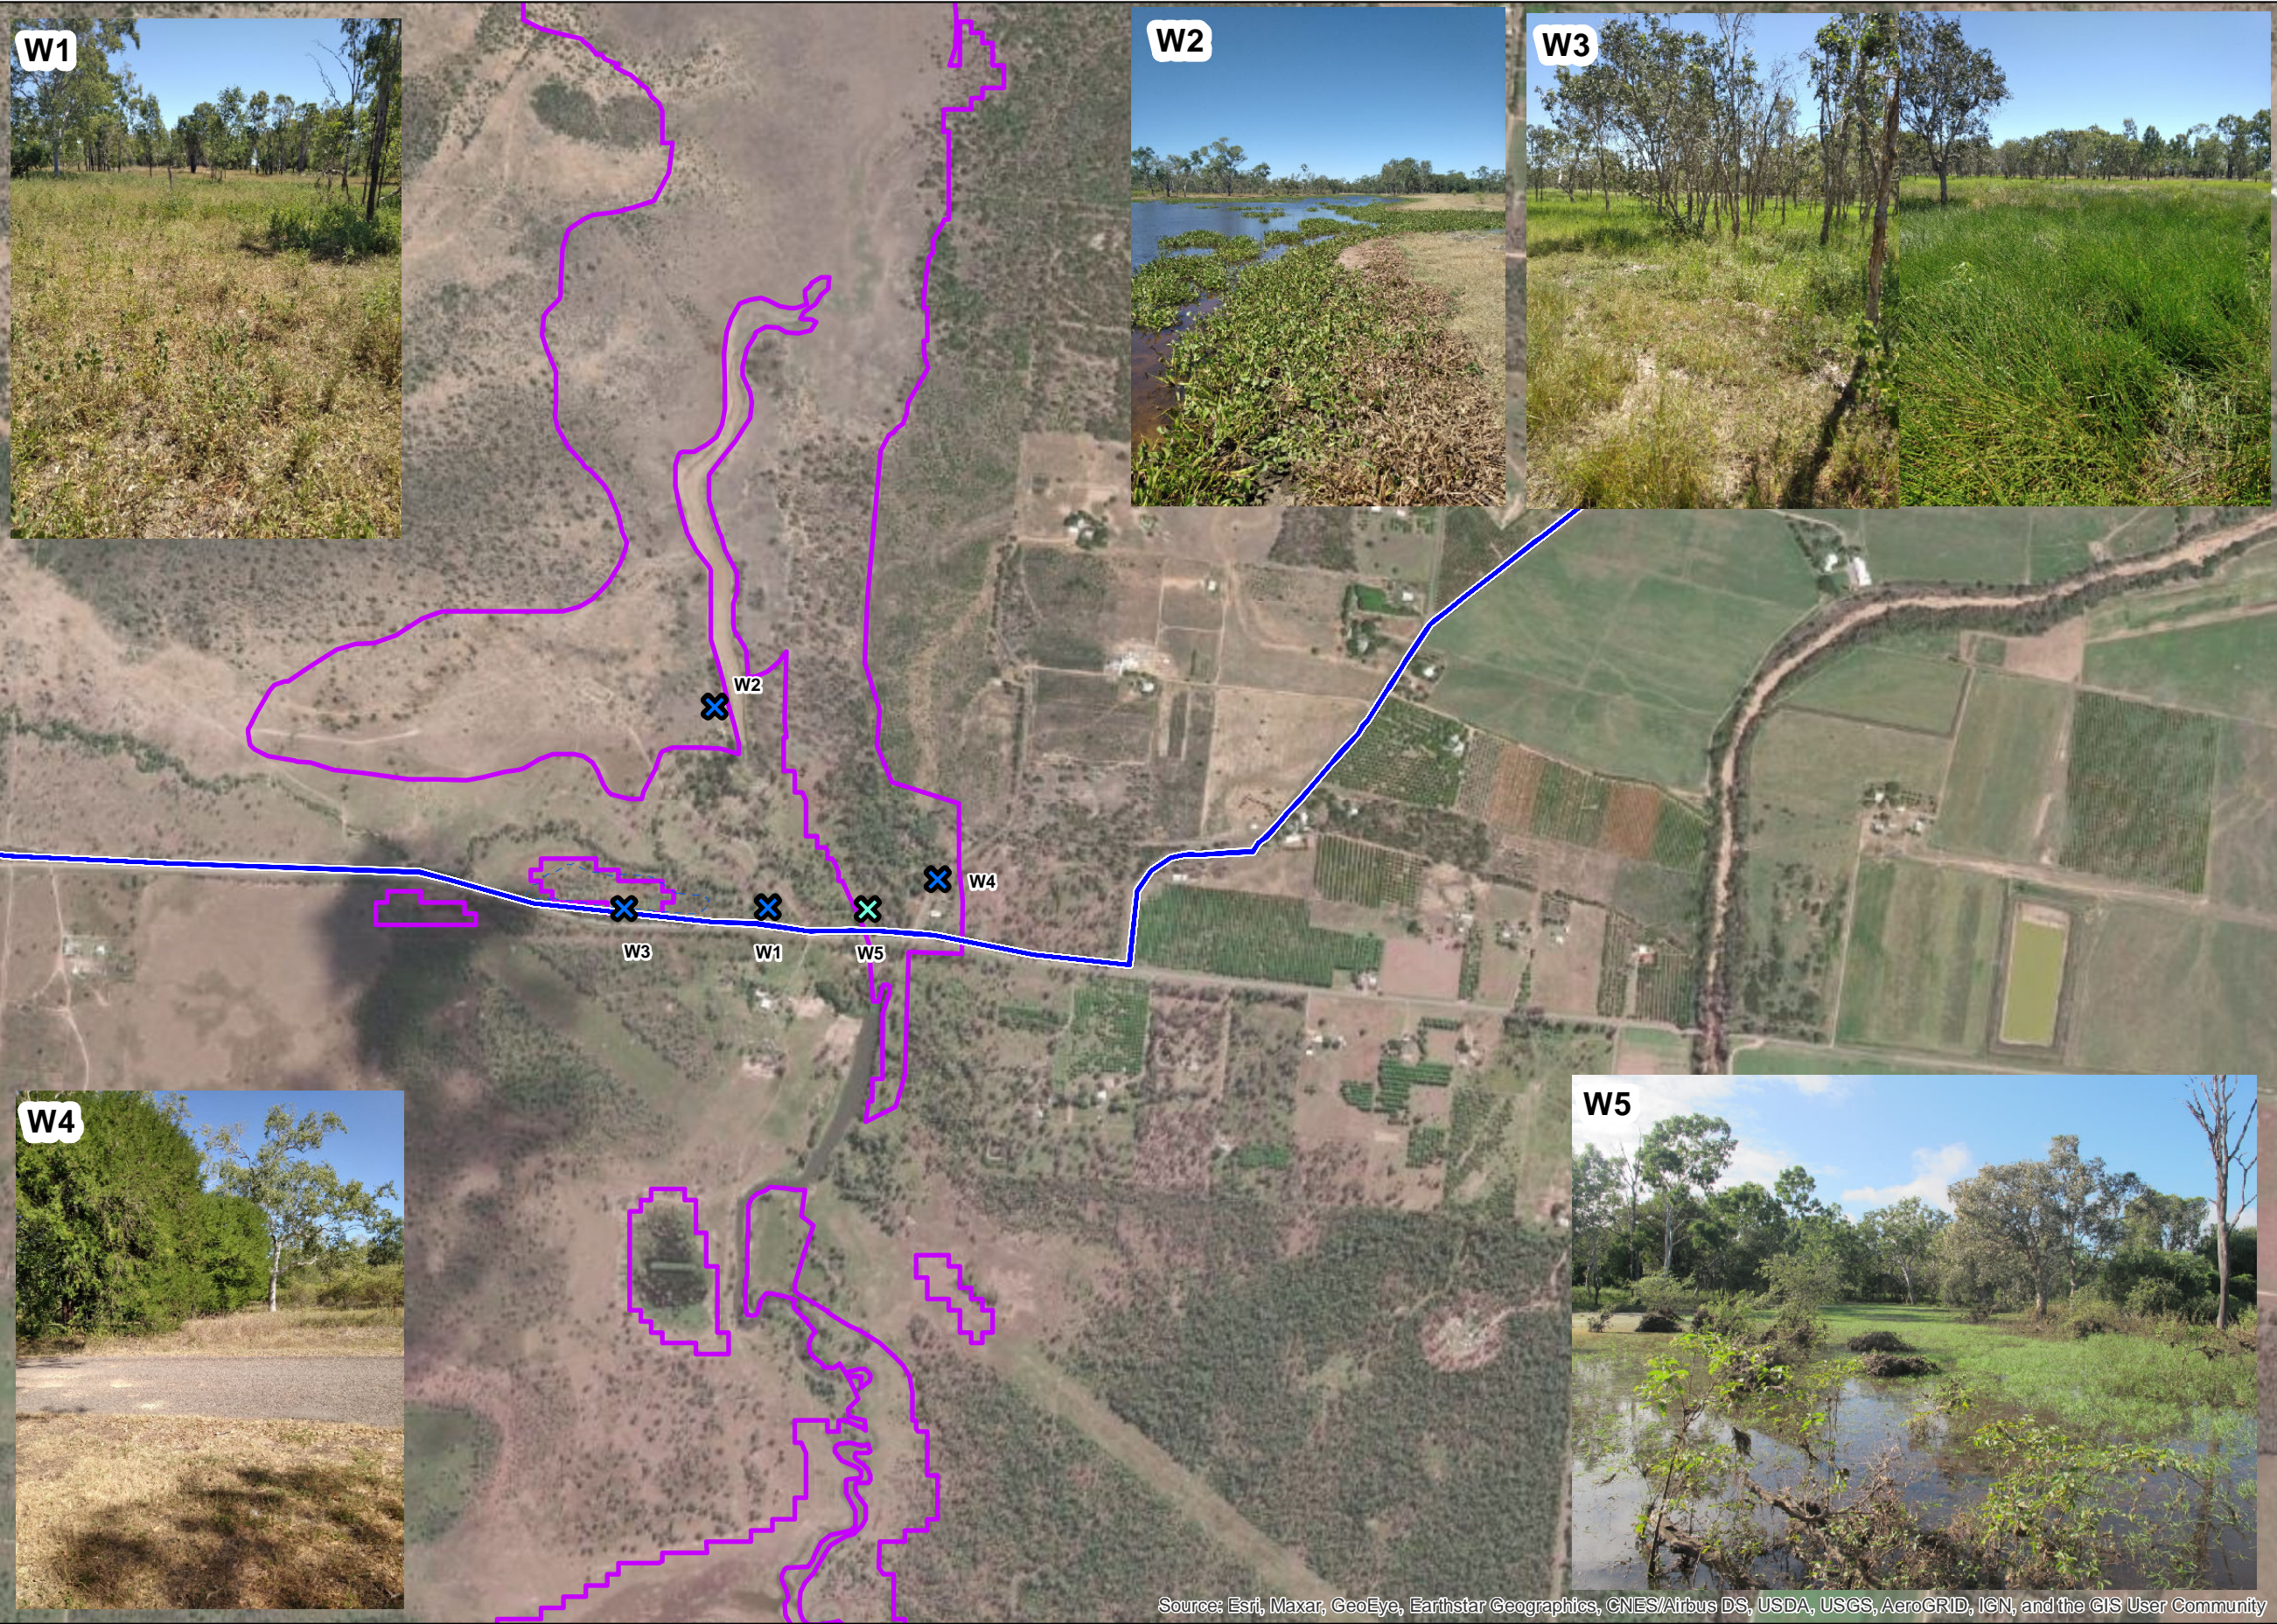
Plan 3: Wetland Assessment

Refer to **Plan 3** for locations of this assessment.

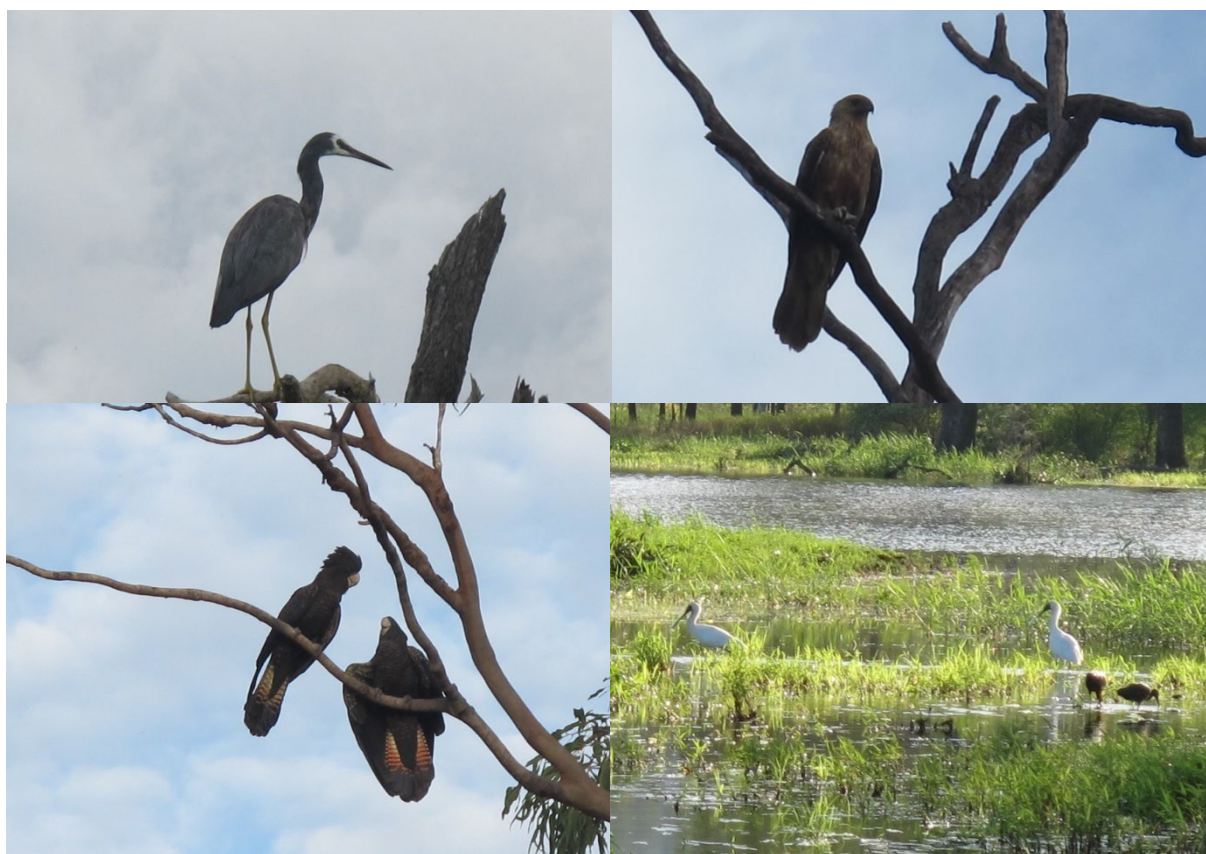
Photo Plate 1: A selection of bird species encountered during site surveys. Clockwise from top left; white-faced heron, whistling kite, red-tailed black cockatoos and royal spoonbills with glossy ibis.

Ninety-two (92) fauna species were recorded during the field survey effort, including domestic cattle. Eighty-five (85) of the detected species were native, with the majority (75) being avian species. Refer **Table 5** for full fauna species list, and **Plate 1** for a selection of bird species recorded.

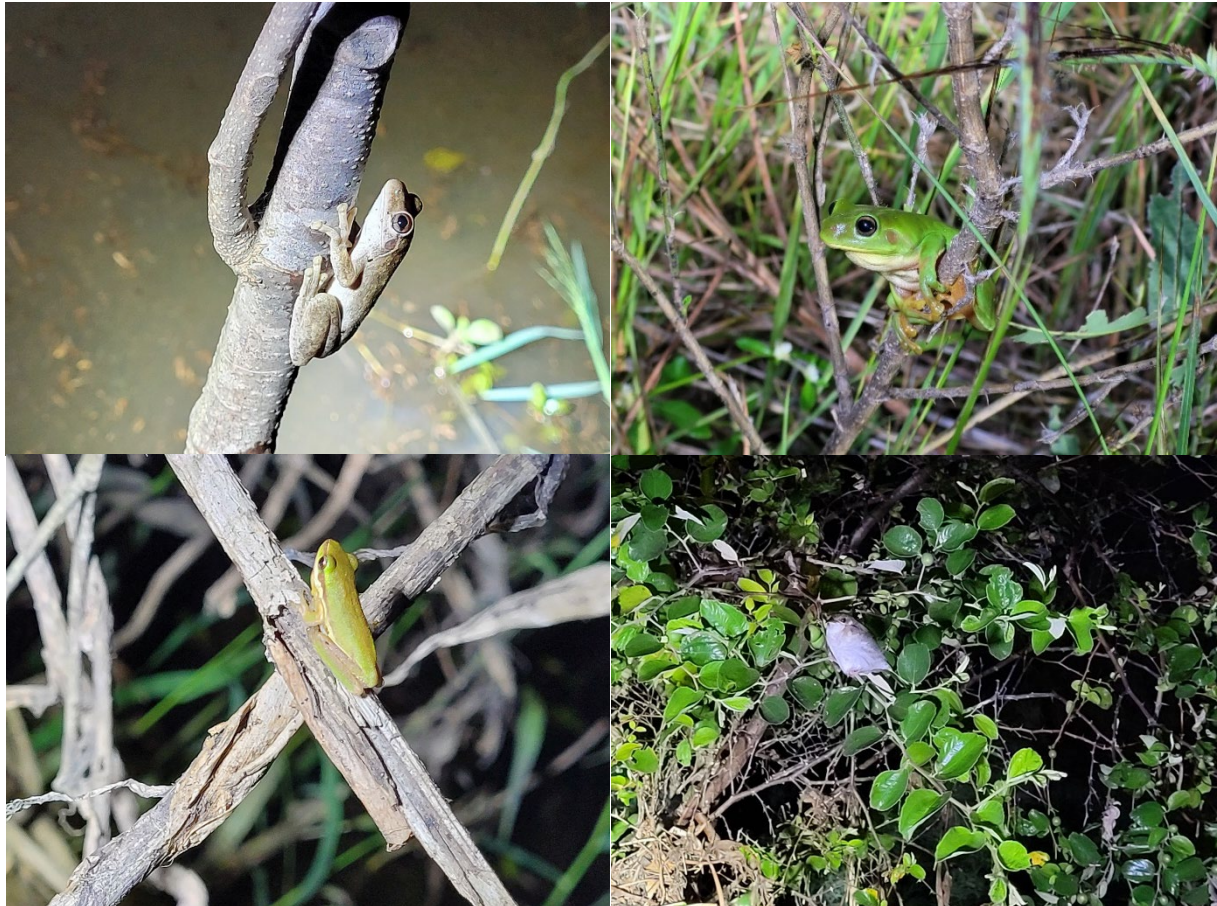
Photo Plate 2: A selection of species encountered during spotlighting surveys. Clockwise from top left; red tree frog, green tree frog, eastern sedge frog and a roosting brown gerygone.

A selection of fauna species identified during spotlighting and via camera capture are provided in **Photo Plate 2 and 3**. Bandicoot were detected from traces (see **Photo Plate 4**) and unable to be identified beyond a family level of categorisation. Two species of bandicoot are known to occur within the region; the northern brown bandicoot (*Isodon macrourus*) and the long-nosed bandicoot (*Perameles nasuta*). Neither species is conservation significant.

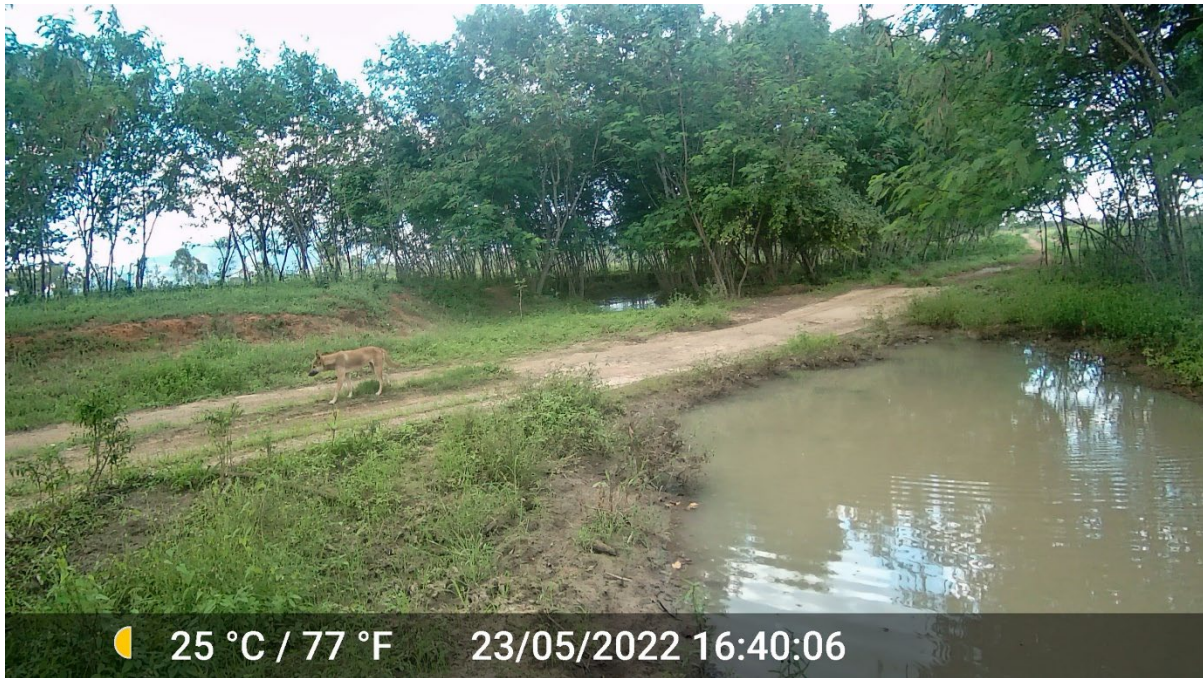
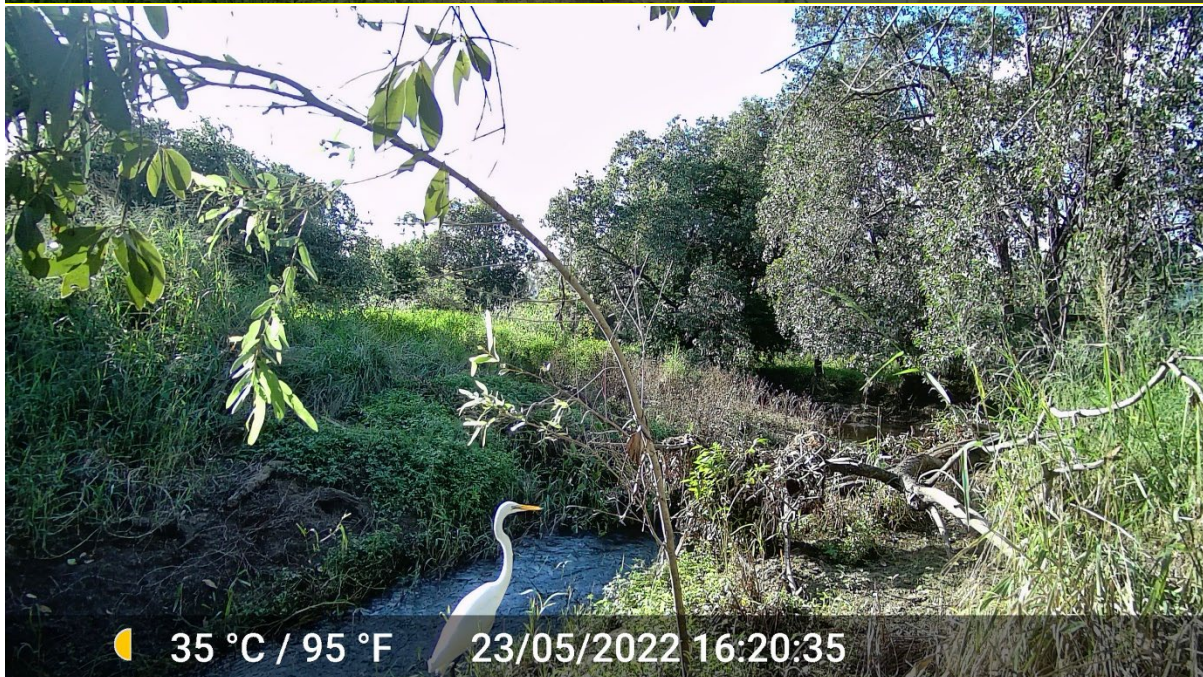
Photo Plate 3: Captures from fauna camera trapping; a dingo recorded by CAM008, and an intermediate egret recorded by CAM006.

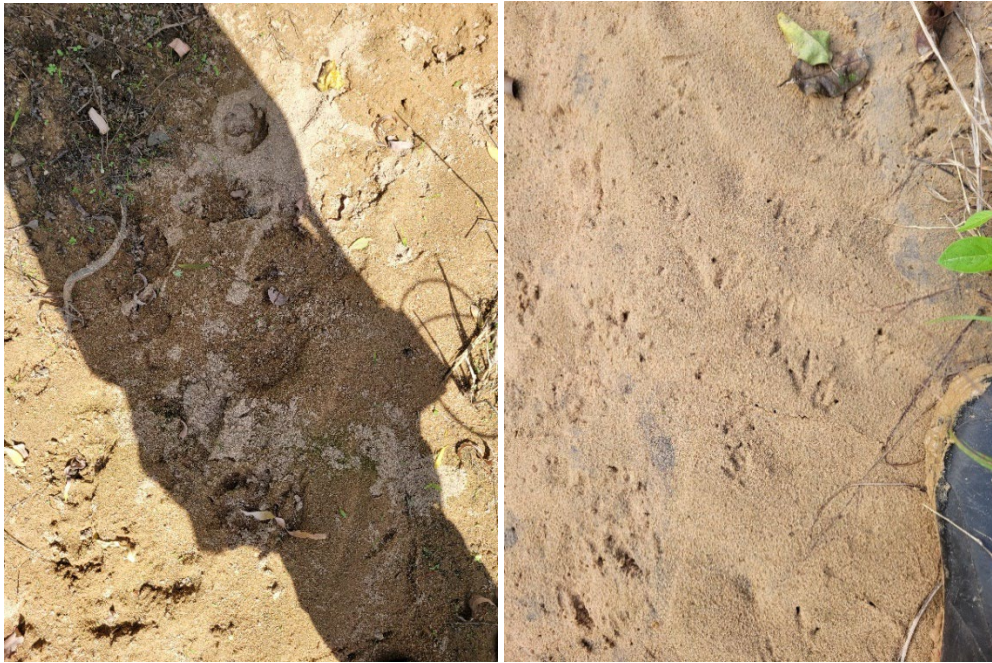
Photo Plate 4; Trace evidence in the form of tracks of wild dog (left) and bandicoot (right).

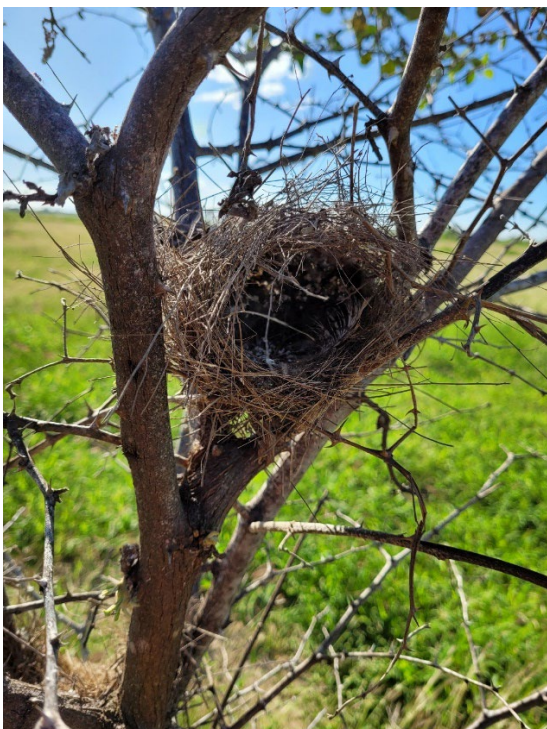
Multiple finch nests were observed during surveys (Refer **Photo Plate 5**). None of these nests were in use at the time of survey. The bottle shaped woven grass nest of the black-throated finch (*Poephila cincta*) is similar in appearance to those of two co-occurring species observed during site surveys;

Photo Plate 3; Disused finch nest found within the survey area.

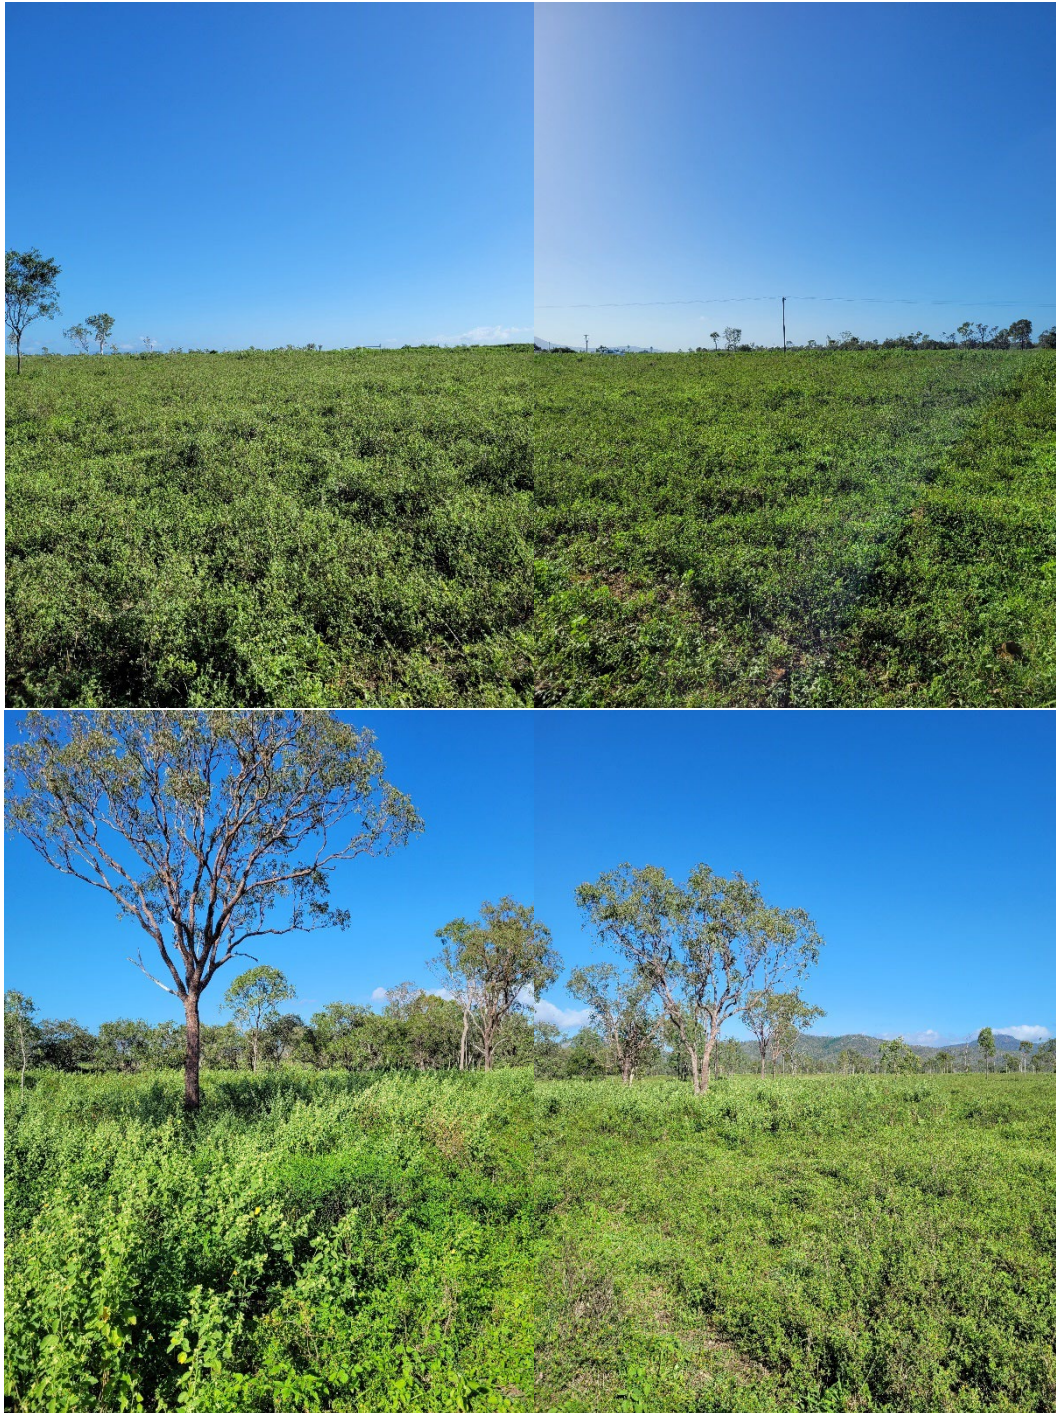
| Quaternary | Q41 | |
|---|---|---|
| Observed RE | 11.3.35 non-remnant | |

Photo Plate; Photos taken at quaternary assessment point forty-one (Q41) clockwise from top left facing; North, East, South and West, respectively.

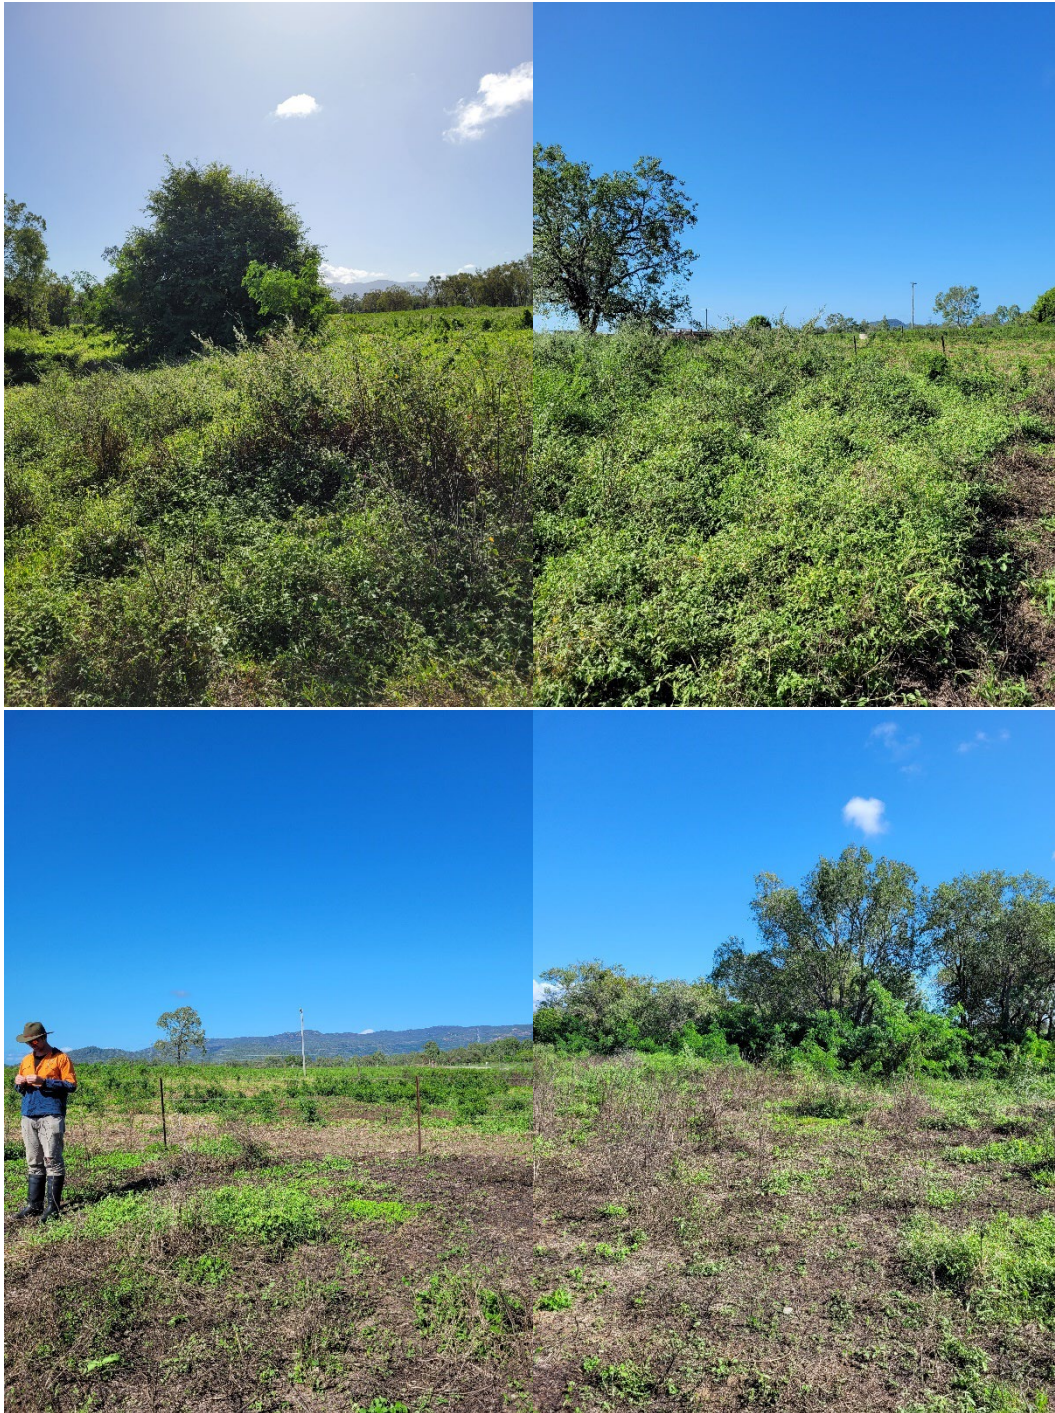
| Quaternary | Q42 | |
|---|--|--|
| Observed RE | Land-zone and non-remnant status consistent, assessable woody vegetation absent. | |

Photo Plate; Photos taken at quaternary assessment point forty-two (Q42) clockwise from top left facing; North, East, South and West, respectively.

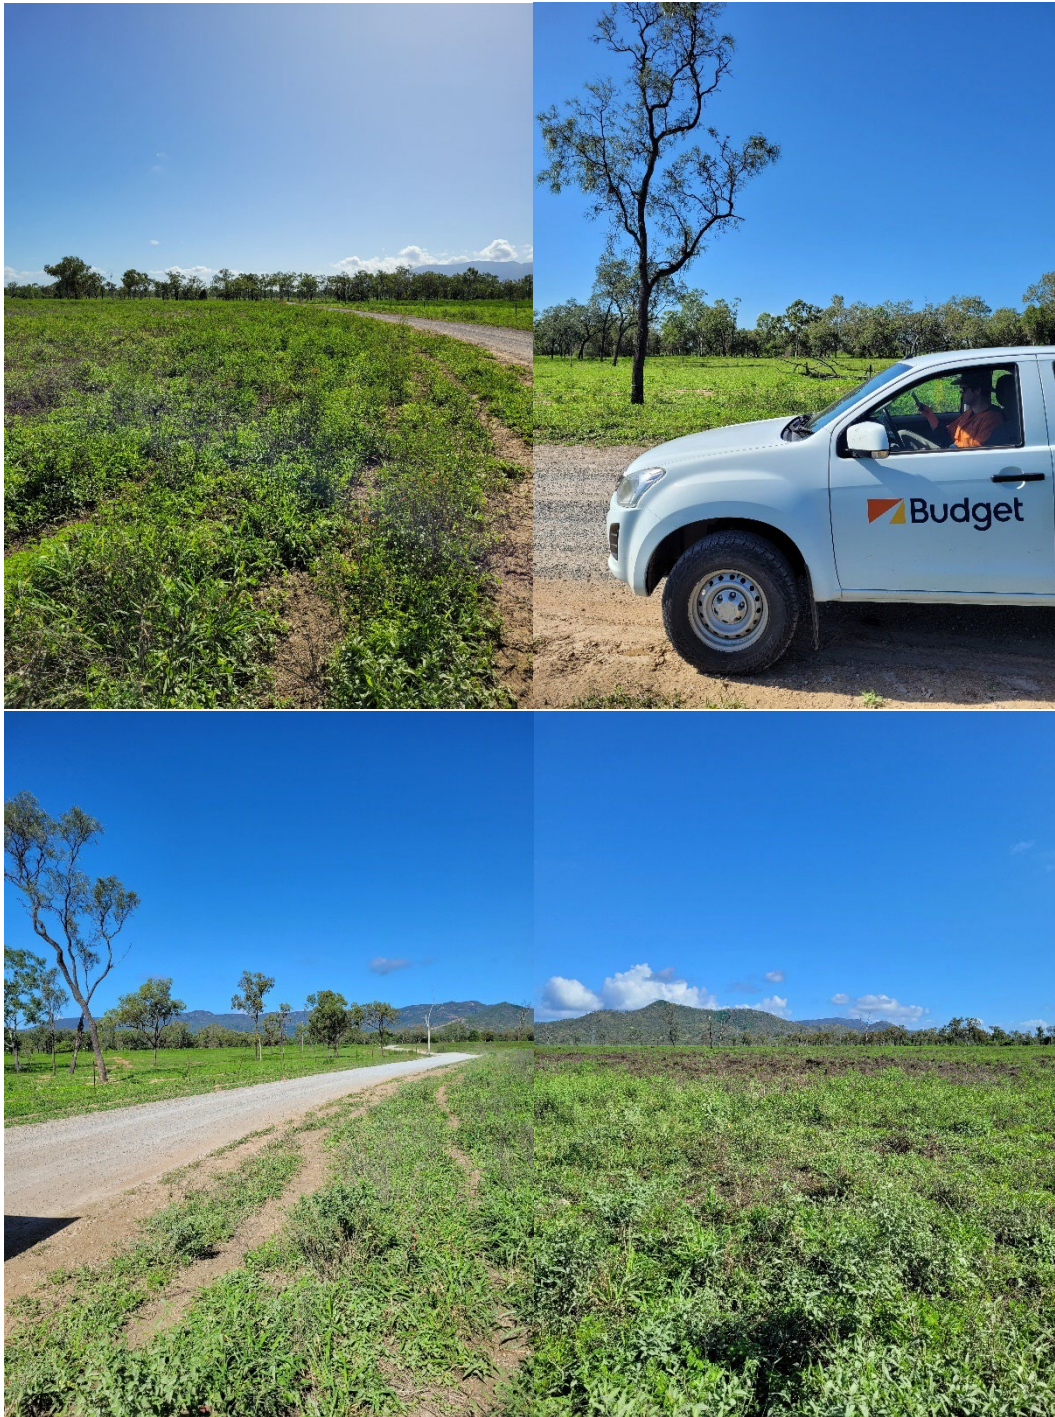
| Quaternary | Q43 | |
|---|--|---|
| Observed RE | Land-zone consistent, assessable woody vegetation absent, area is non-remnant. | |

Photo Plate; Photos taken at quaternary assessment point forty-three (Q43) clockwise from top left facing; North, East, South and West, respectively.

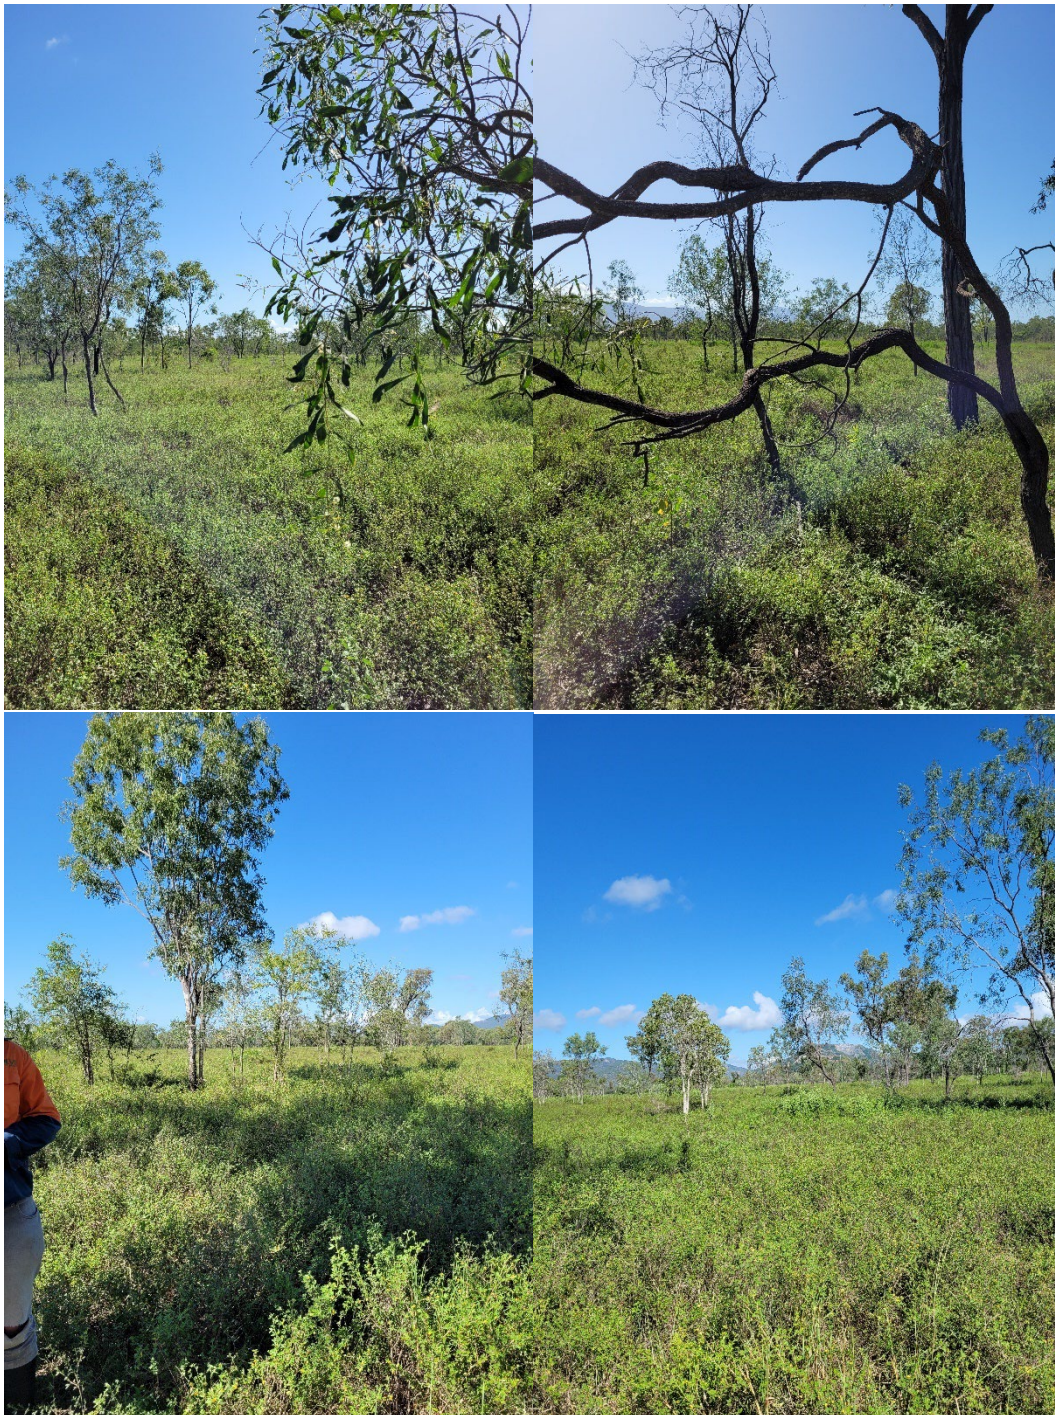
| Quaternary | Q44 | |
|---|---|---|
| Observed RE | 11.3.30 non-remnant | |

Photo Plate; Photos taken at quaternary assessment point forty-four (Q44) clockwise from top left facing; North, East, South and West, respectively
