CONTOUR & DETAIL PLAN

PROJECT: Contour & Detail Plan
LOCATION: 16 Poole Way Bushland Beach
Real Property Description: Lot 6 on SP333154
CLIENT: Poole Way Pty Ltd
Horiz. Datum: MGA Meridian Vide SP333154
Vert. Datum: AHD (Vide RTK GNSS)
Local Authority: Townsville City Council
Contour Interval: 0.10m

Scale: 1 : 400 @ A3	Drawing No: 25596-2-CD-01
Drawn: SB	Sheet: 1 of 1
Surveyor: JB 16/07/25	Revision: A

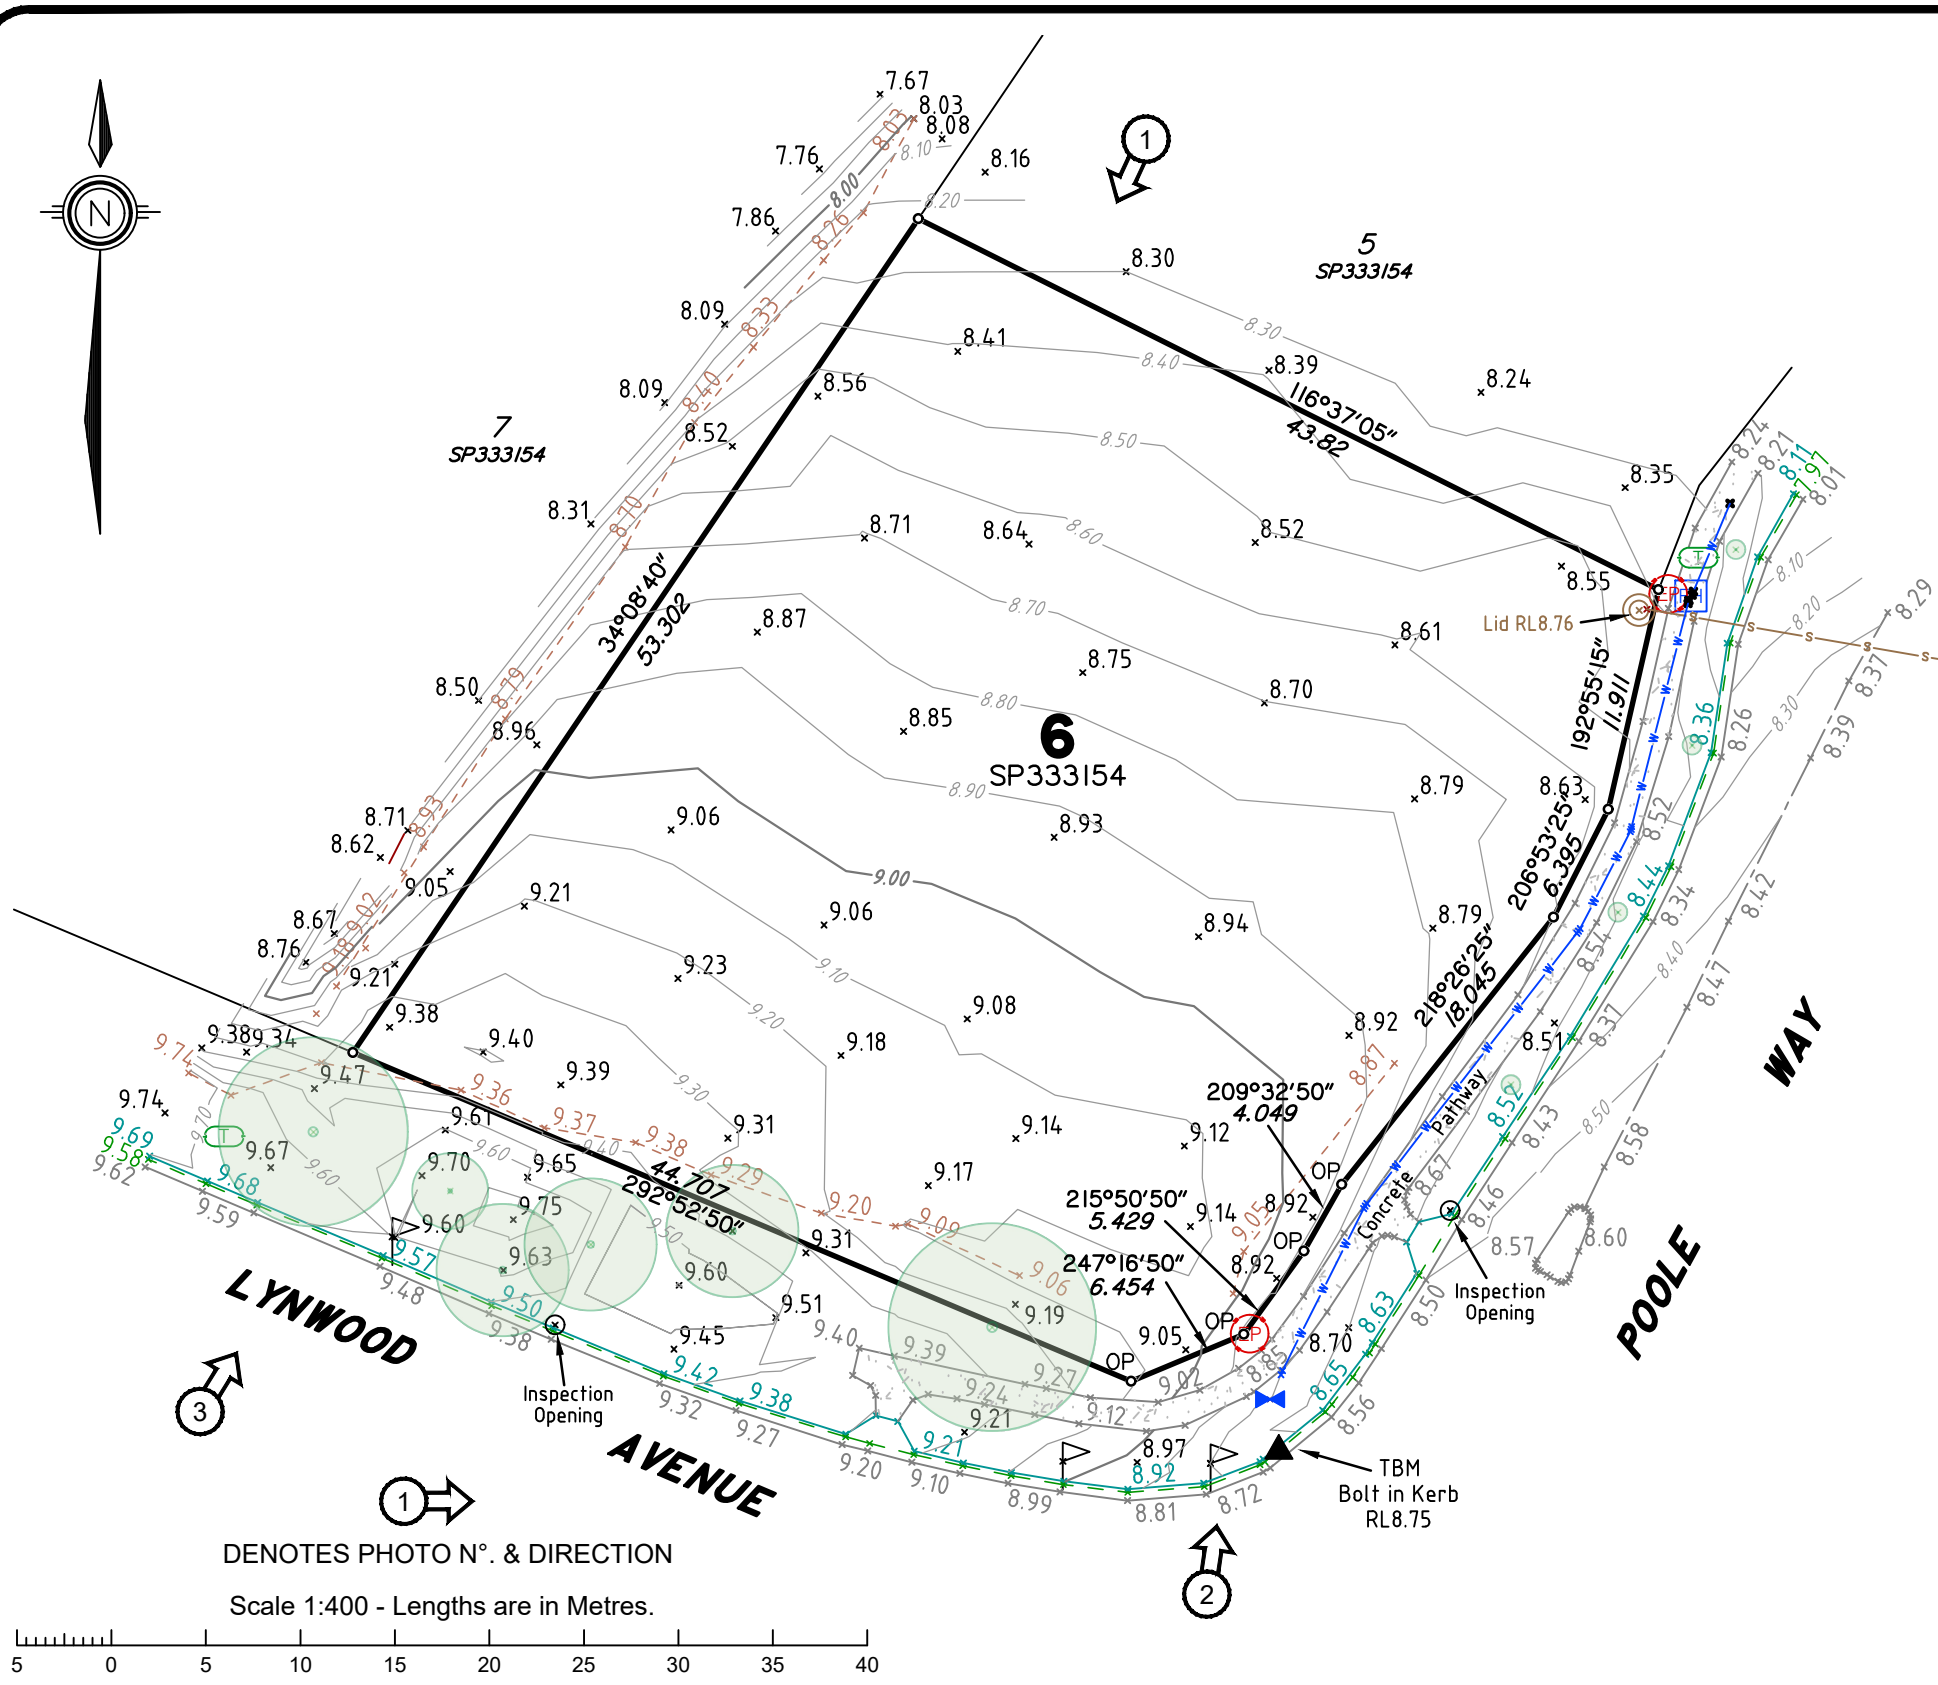
SERVICES REPORT	
Sewerage:	Reticulated
Stormwater:	To Street
Water:	Not Found
Electricity:	Underground
Telephone:	Underground
Gas:	N/A
Road:	Bitumen
Kerb:	Barrier

Note:
No Service As-Constructed information was received for this plan at time of survey therefore only visible services have been located. A Local Authority services search and the engagement of a Qualified Service Locator to accurately locate underground service infrastructure is also recommended prior to construction on this site.
