SAUNDERS BEACH

ASSESSMENT OF COASTAL EROSION MITIGATION OPTIONS

Townsville City Council

June 2011

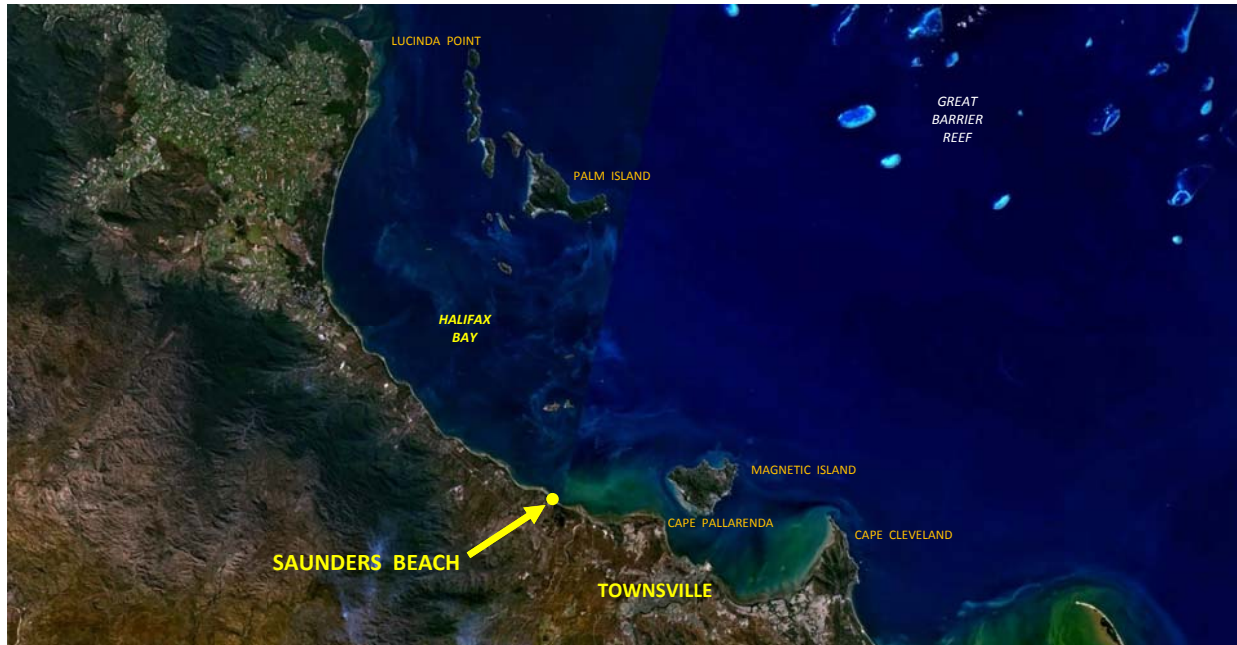
As shown on Figure 1, Saunders Beach is located on the southern shores of Halifax Bay. The Bay is a wide crescent-shaped embayment between Cape Pallarenda and Lucinda Point. It faces approximately north-east onto the broad open waters between the mainland and the Great Barrier Reef.

Figure 1 : Location of Saunders Beach in a regional context

Saunders Beach is an approximately 2.4 km long beach segment located to the north of Black River at the southern end of Halifax Bay (Figure 1). Saunders Beach is characterised by a broad (>80 m wide) low-tide bench composed of fine sand that extends seaward from a relatively narrow (10-20 m) and steep upper beach composed of coarser sediments. A sharp break in slope typically separates the upper beach and the low tide terrace at a level between Mean Low Water Spring (MLWS) tide and Mean Sea Level (MSL) position.

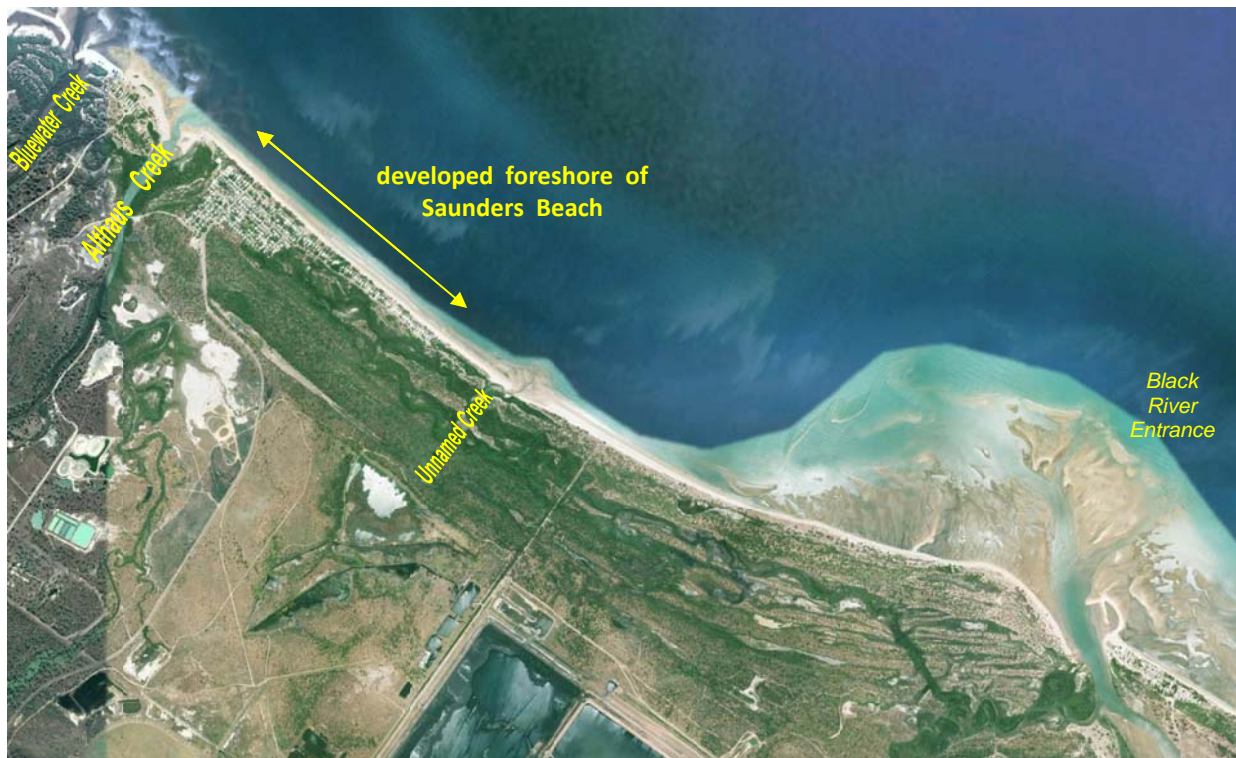
Figure 2 : Saunders Beach coastal reach

The survey results (supplemented by on-site observations) indicate that the foreshore level is somewhat variable. The foredune along the northern part of Saunders Beach is typically the highest - with levels generally around RL+5m AHD. The foreshore immediately behind this crest also tends to be around this level.

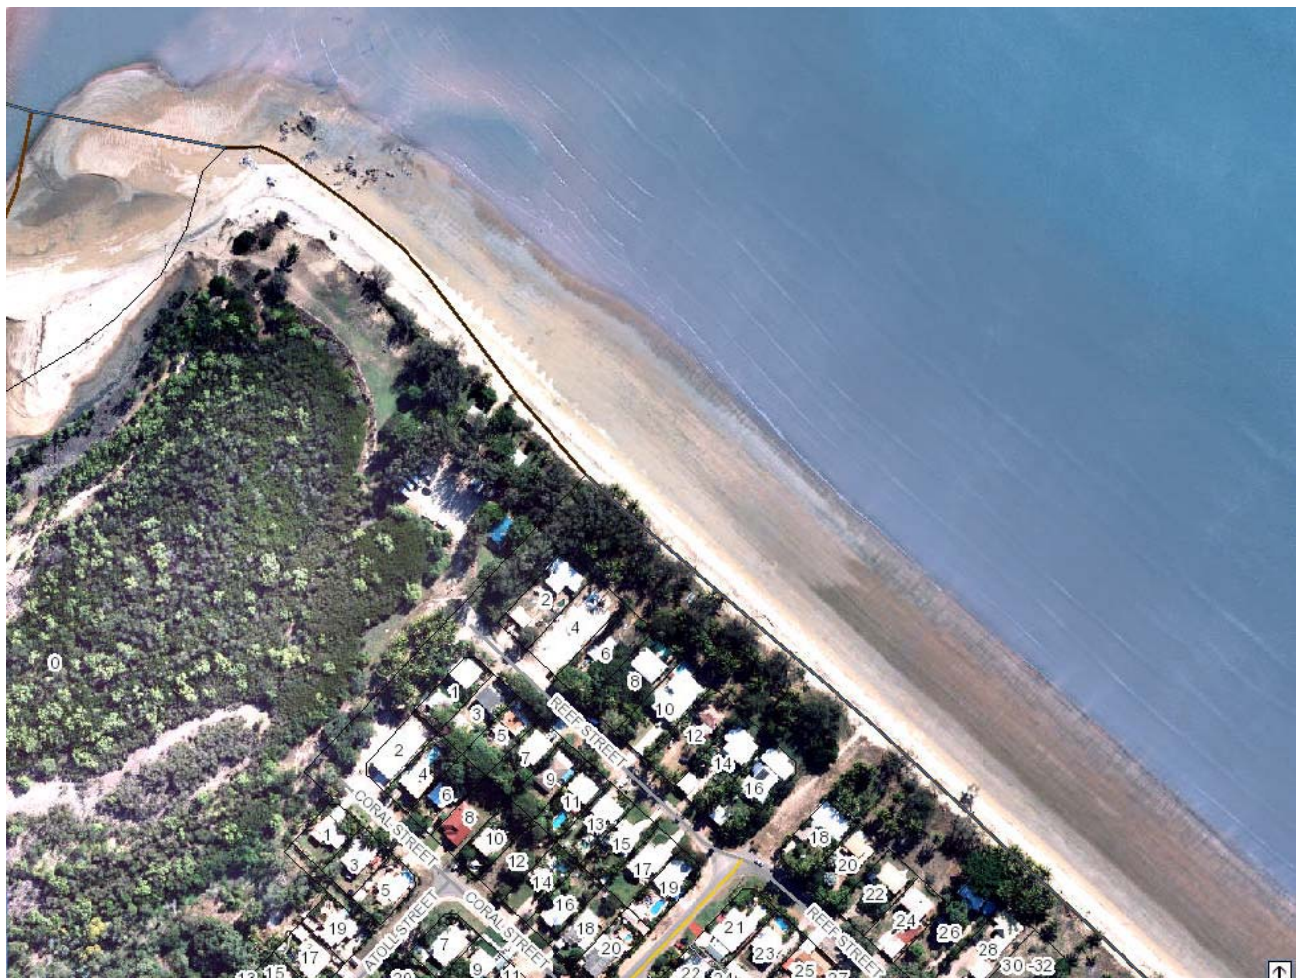
Figure 3 : Foreshore Properties & Survey Transects - northern Saunders Beach
(superimposed on a 2009 aerial photograph)

Property boundaries overlain on the aerial photographs of 2009 show the residual buffer widths following significant erosion earlier that year which was caused by high tides and rough sea conditions in the period of January to March. Minimum buffer widths of around 14m to 25m metres existed along most of the foreshore. These buffer widths have been further diminished since that time due to additional high tides and adverse sea conditions in January 2010; and as a consequence of TC Yasi in February 2011.

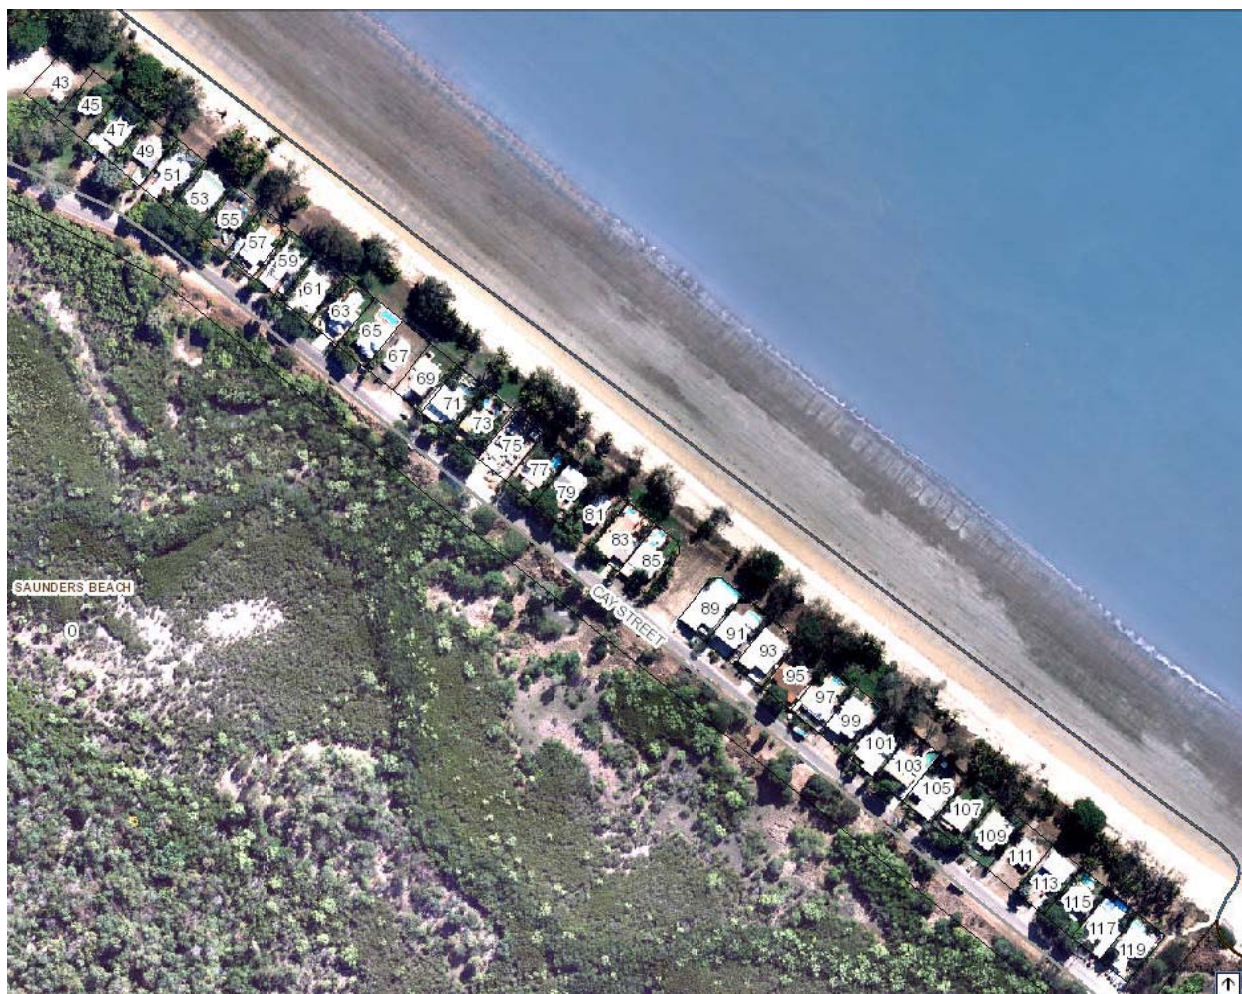
Figure 5 : Foreshore Properties - southern section of Saunders Beach
(superimposed on a 2009 aerial photograph)

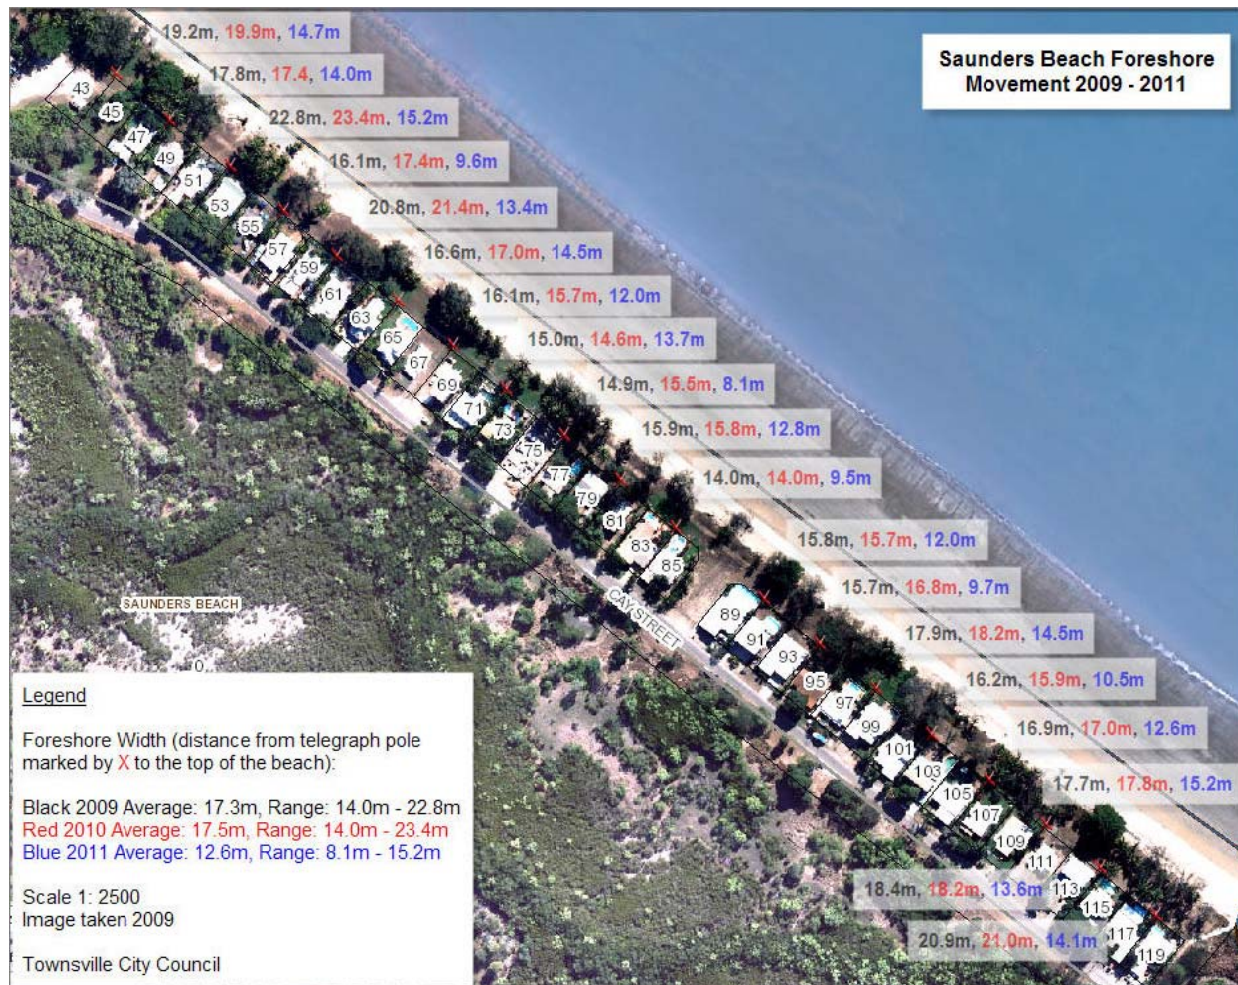
Figure 6 : Indicative buffer widths - Cay Street, Saunders Beach
(provided by Integrated Sustainability Services of Townsville City Council)

In recent years an informal survey of the position of a section of the beach opposite Cay Street has been undertaken by Integrated Sustainability Services of Townsville City Council (refer to Figure 6). The results indicate that since 2009 when the aerial photographs for the property overlays were prepared, foreshore buffers have been further reduced by some 5m to 6m.

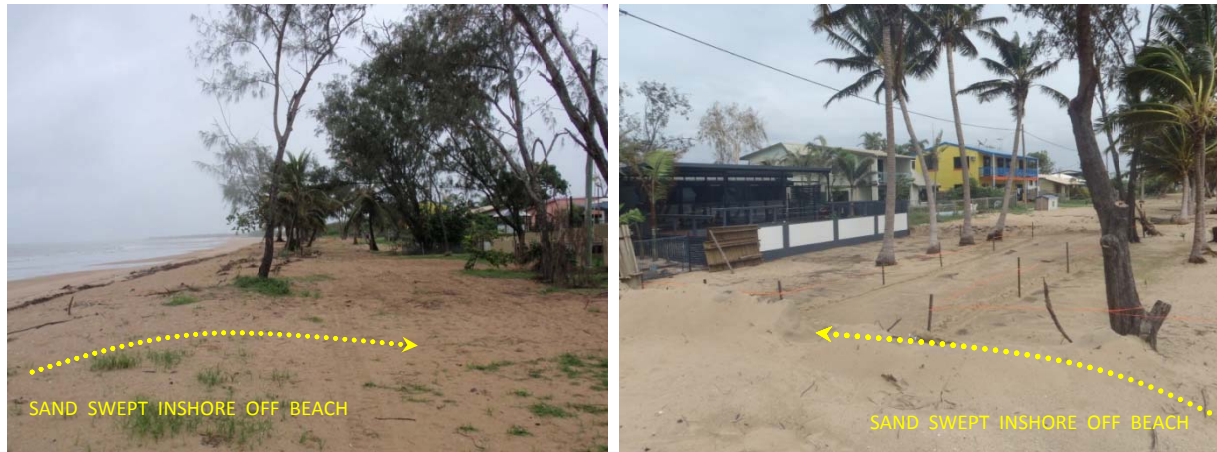
Figure 7 : Evidence of overwash during TC Yasi

Such storm tide inundation and simultaneous wave action can cause extensive damage - particularly to foreshore vegetation. Indeed considerable damage to the Saunders Beach foreshore occurred during TC Yasi as a result of overwash.

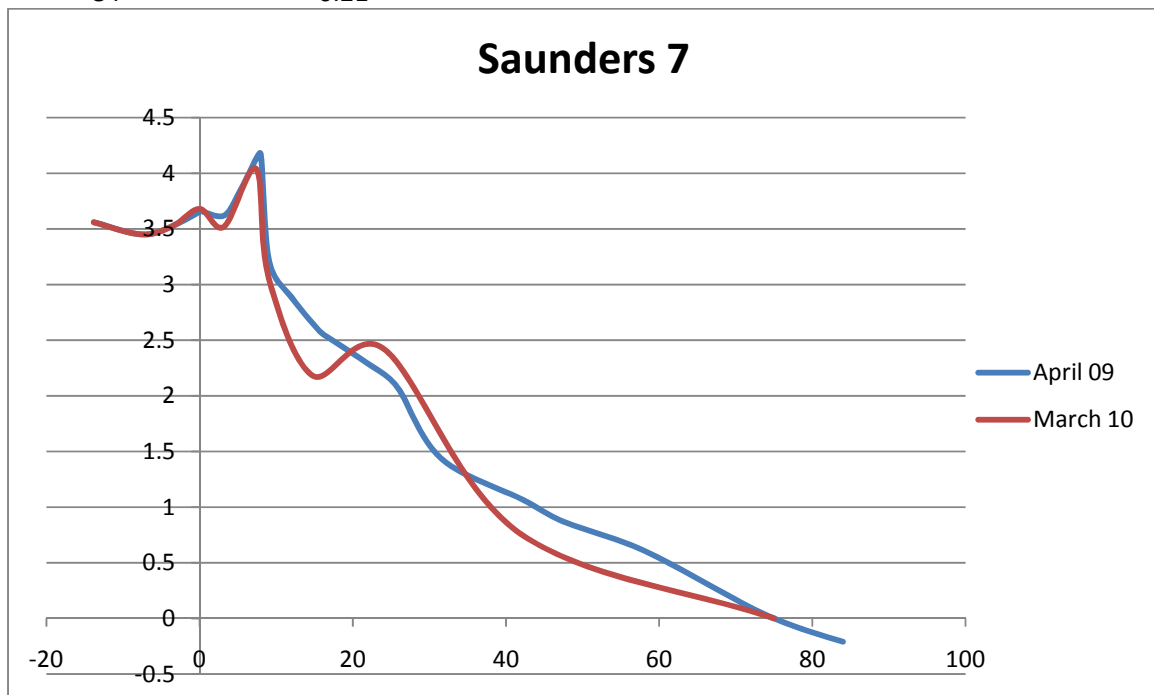
SAUNDERS 7**POST**

Chainage	April 09	Chainage	March 10
-13.8	3.56	-13.8	3.56
-7.5	3.45	-7.5	3.45
-3.4	3.53	-3.4	3.53
-0.1	3.65	0	3.68
0.2	3.66	3.2	3.52
3.2	3.62	7.4	4.04
5.2	3.83	9	3.07
7.1	4.09	14.8	2.18
8	4.17	24.1	2.42
9.1	3.21	41.9	0.76
12.2	2.87	75	0
15.7	2.58		
16.9	2.52		
22.4	2.27		
25.8	2.08		
31.5	1.44		
42.4	1.06		
47.5	0.87		
58.3	0.6		
74	0.03		
84	-0.21

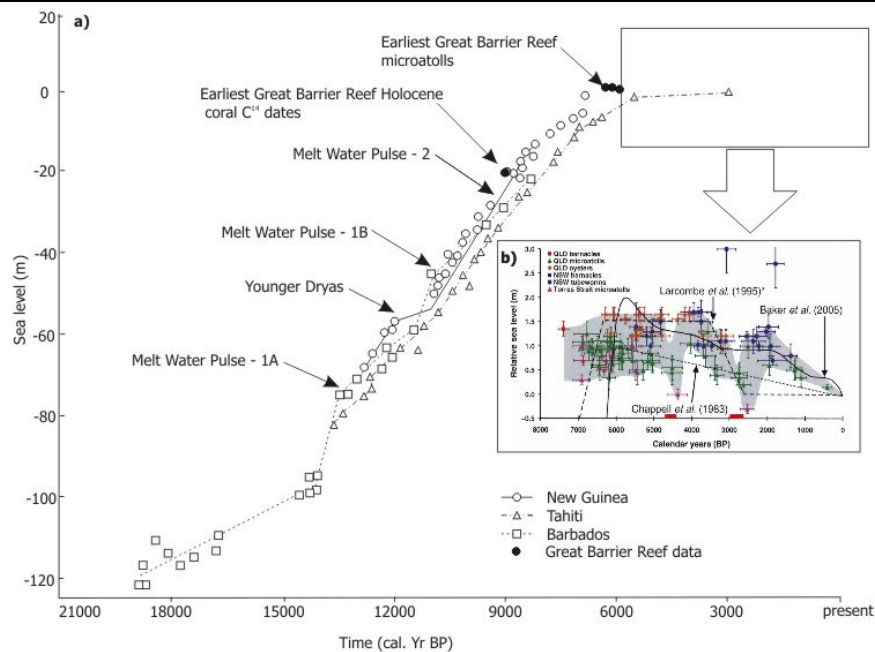
Figure 3 a) Global postglacial sea-level history from reef records (Hopley et al., 2007); b) data and various interpretations of sea level fall since around 6000 years ago on inshore Great Barrier Reef (from Lewis et al., 2008).

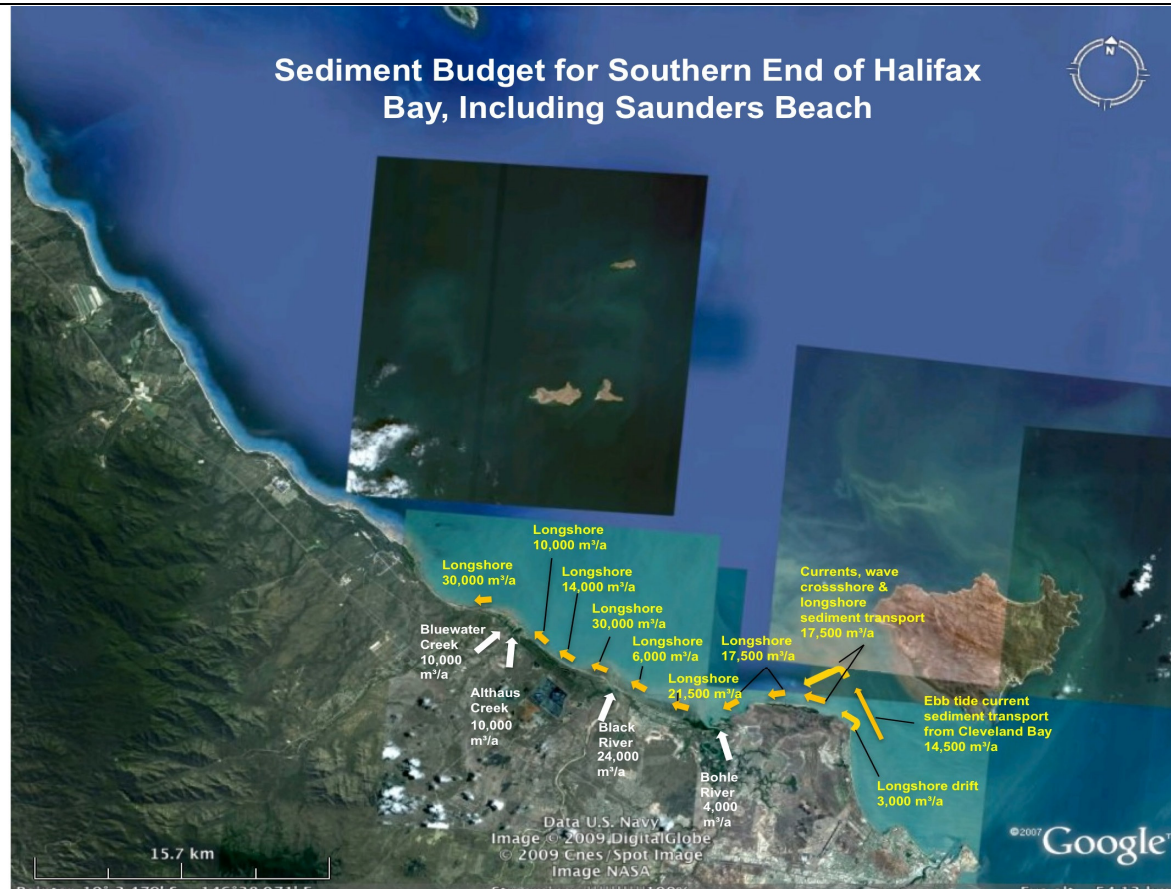
Figure 5 Coastal sediment budget for southern end of Halifax Bay estimated from several sources including Boral 1998, DallaPozza 2005 and Holmes 1992.

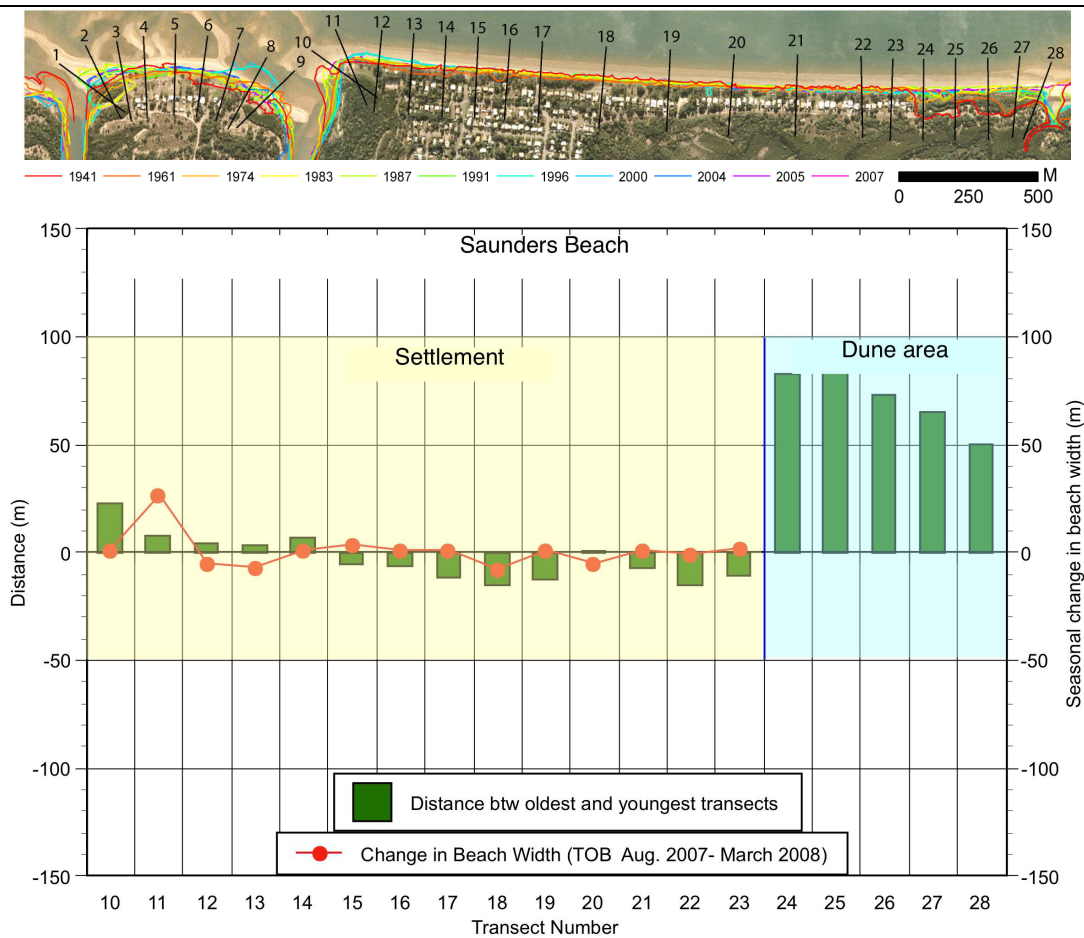
Figure 6 Net shoreline change between 1941 and 2007 derived from geo-rectified aerial photography along Saunders Beach

An analysis of geo-rectified aerial photography (Smithers, 2009) indicated that between 1941 and 2007 this foreshore had experienced net accretion. However it was noted that the position of the beach was highly variable over short timeframes and is significantly affected by the natural processes that occur at the entrance to Althaus Creek.
