**TOWNSVILLE CITY
COUNCIL**

**TOWNSVILLE FLOOD
HAZARD ASSESSMENT
STUDY**

**Phase 3 Report
Vulnerability Assessment
and Risk Analysis**

**December 2005
Job No. 80301202.01**

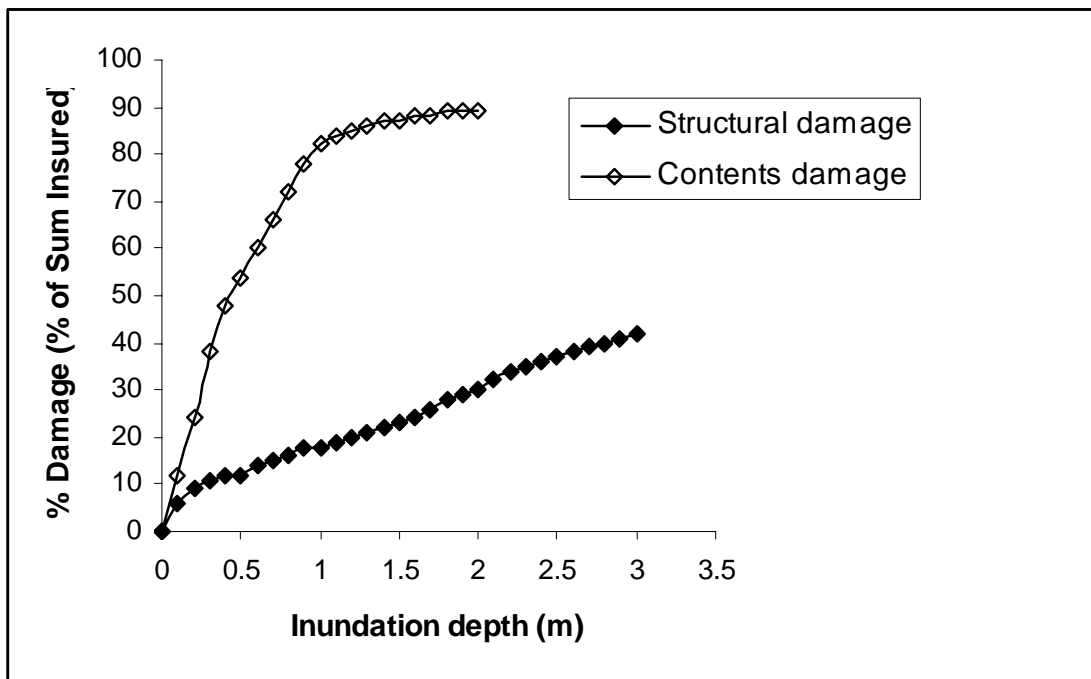
Figure 3
Relationship between Structural and Contents Damage

Note: Both curves are potential loss curves.

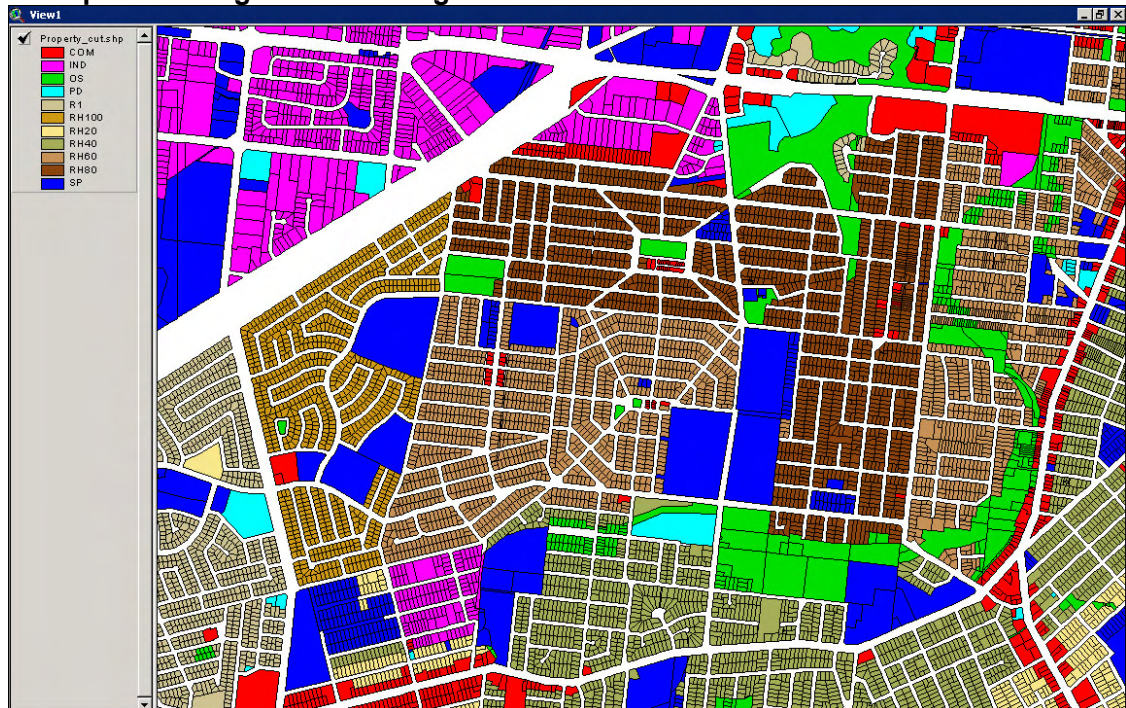
Figure 4
Example of Amalgamated Zoning for Townsville

In Townsville, properties zoned Residential 1, 2 & 3 exhibit a mix of low-set and high-set homes, varying in density between suburbs. Generally, older suburbs and those historically flood prone have a higher proportion of high-set homes. Initially, stage-damage curves were developed for a typical low-set and high-set house in Townsville, based on the available literature described in **Section 5.2** above. In both cases, depths are taken as over the ground floor level.

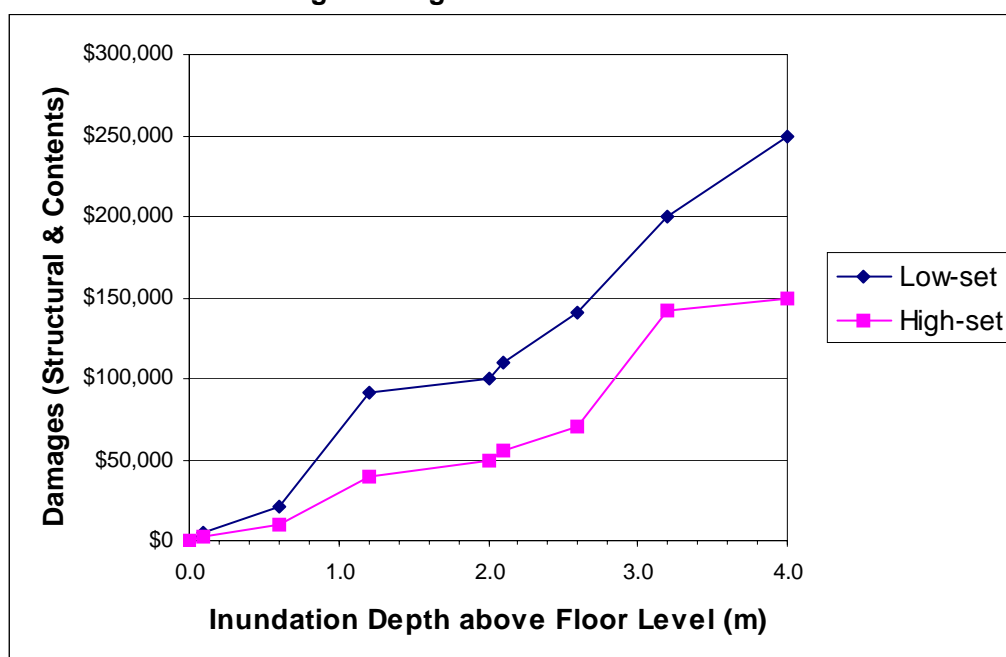
Figure 5
Derived Residential Stage-Damage Curves for Townsville

The derived curves are shown in **Figure 5**, and exhibit the following general features:

- between properties). Above that level, the high-set curve exhibits a similar trend as the low-set curve at the lower level.
- Four metres over-floor is the assumed limit of the damages curve. At 3.0 m deep, a low-set property is assumed to be a total loss; however, it is noted that this will depend heavily on flow velocities experienced. For a high-set house, a four metre depth approaches the roof level, so the losses are less than for a low-set property which would have the majority of roof underwater.

For Residential 1 zoned properties a reference floor level (height above ground) was nominated for each suburb (refer to following section), and the low-set damage curve used throughout for estimation of damages. For the Residential 2 & 3 zoned properties, which comprised a mix of low and high-set houses, a uniform reference floor level (height above ground) of 300mm was selected. Based on the estimated proportion of low and high-set properties in each suburb, an additional five damage curves based on the two basic curves featured in **Figure 5**. Note that in using this approach no property damage is recorded below the reference floor level

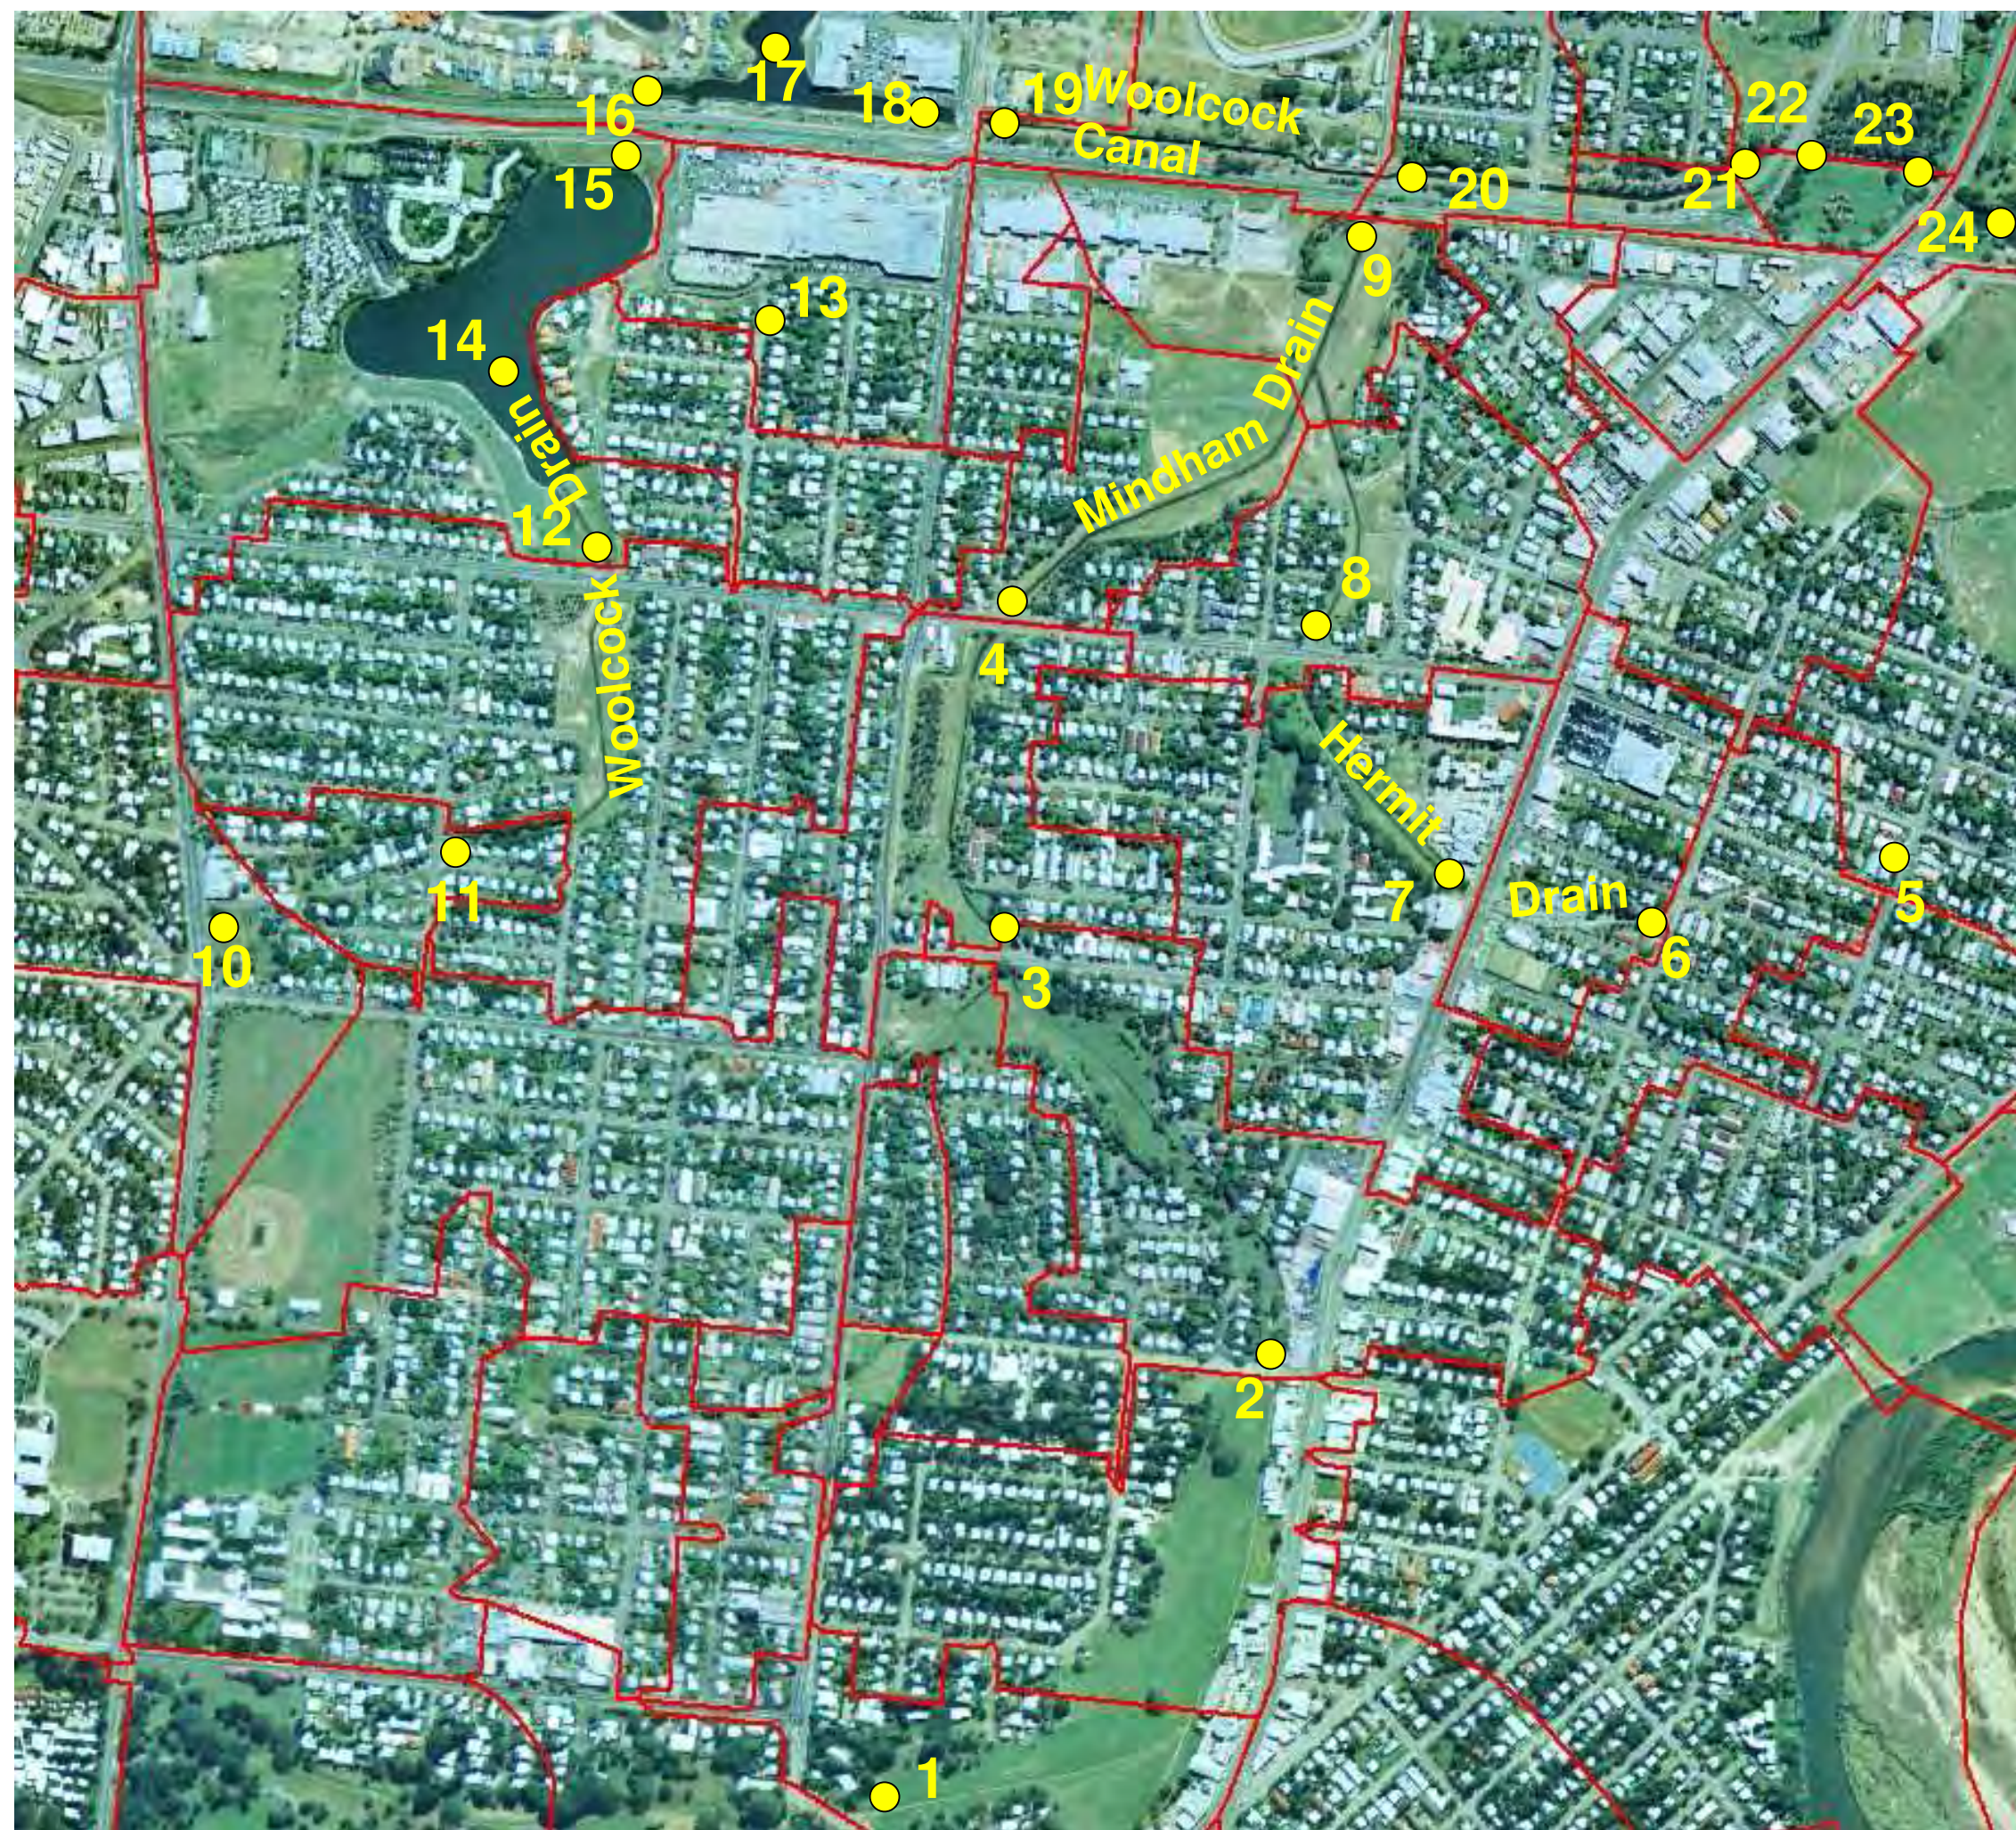
TOWNSVILLE CITY COUNCIL		
TOWNSVILLE FLOOD STUDY TOWNSVILLE WEST FLOOD MITIGATION PROJECT STAGE 2 - PIMLICO / BARRYMAN STREET		
CAD Ref: 80301202_02-fig10.dwg Date: 11 Sep 03 - 11:41	Status:	FIGURE 10

Council have applied for approximately \$2.0 million external funding through the RFMP scheme, to match an allocated Council contribution of more than \$1.0 million in this years budget. The locations of these works are shown in **Figure 10** (extract from RFMP application referred to as Stage 2 of the Townsville West Flood Mitigation Scheme).

Drainage upgrades in an urban catchment like that of Ross Creek should start with removing constrictions downstream before progressing upstream. The proposed works above (constituting Stages 1 & 2 of the Townsville West Flood Mitigation Scheme) were modelled to determine their beneficial impact (the results are shown in **Figure 11**). Significant improvements are achievable for the 20 Year ARI flood event, justifying the considerable expense of the works to date.

At Gulliver Street an upgrade to 4/3600×1500 RCBC has been proposed, to reduce the impact of flooding on the adjacent retirement home (Villa McAuley). In January 1998, the development was severely affected by flows in excess of the channel capacity, predominantly constricted by the Existing Gulliver Street culverts (9/1200 RCP's). Even in February 2002, a small event estimated to be equivalent to a 5 Year ARI, the upstream flood level almost caused overtopping of Gulliver Street.

The Balls Lane road profile would still represent a causeway subject to relative frequent flooding, and alternative routes exist for purposes of evacuation. However, recent floods have shown that the 750 mm diameter pipes are prone to collecting debris, and the upgrade would help to significantly reduce the risk of blockage.
