**Drinking
Water Quality
Management Plan**

SPID	506
Postal Address	PO Box 1268, Townsville Water, QLD 4810
Principal Contact	Trisha Knavel, Drinking Water Quality Officer
Report Prepared by	Trisha Knavel, Drinking Water Quality Officer
Report contains	Activities undertaken over the 2022/2023 financial year in operating Townsville City Council's drinking water service. Summary of drinking water quality for Townsville's three drinking water schemes. Summary of Council's performance in implementing their approved Drinking Water Quality Management Plans.

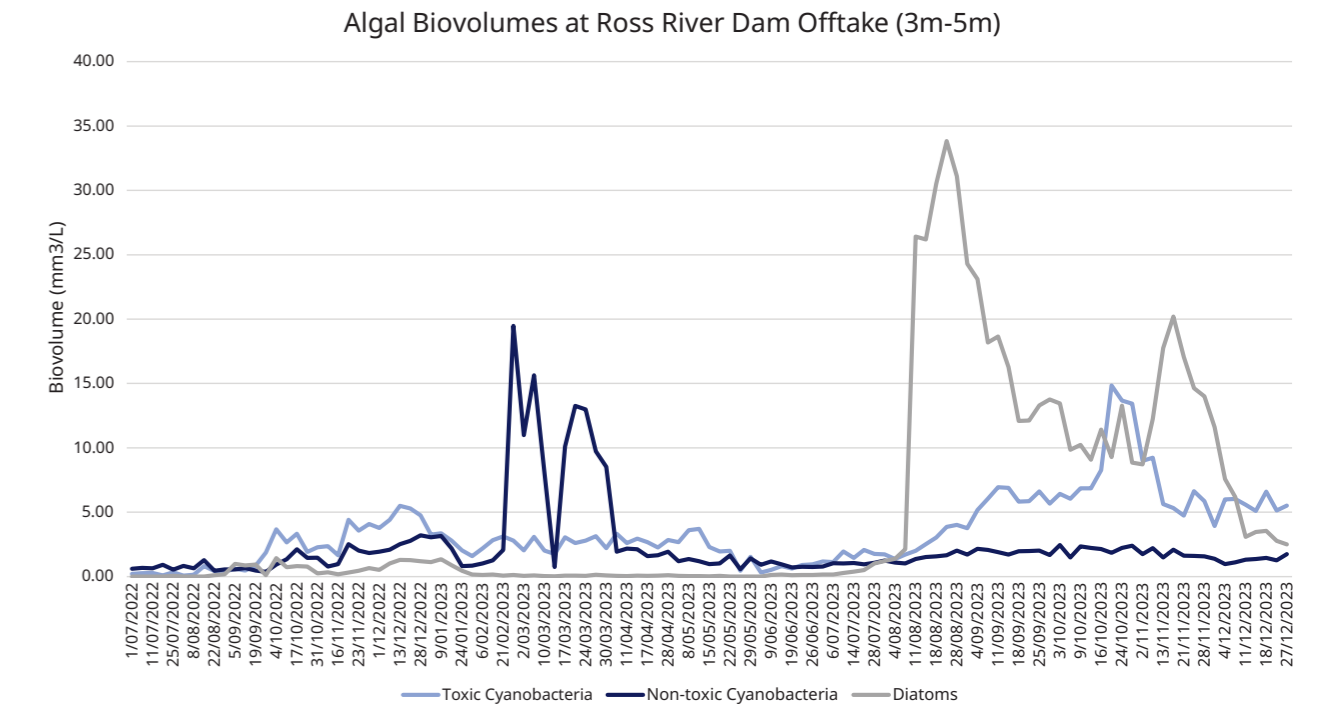
Figure 2. Average algae biovolumes at offtake level within Ross River Dam. Note the spike in February/March 2023 cyanobacteria event contributed by the species *Pseudoanabaena limnetica*.

Diatoms were first detected in high levels in the Ross River Dam in 2021. Their existence persists but were in low biovolumes throughout the 2022/2023 reporting period. Water and Resource Recovery continues to work with Trility, the Regulator, Queensland Health, and industry experts to mitigate and treat the cyanobacteria and diatoms.
