## **Appendix I Waterway Assessments**

## Waterway and Wetland Assessment:

**Table 3 Waterways Assessments**

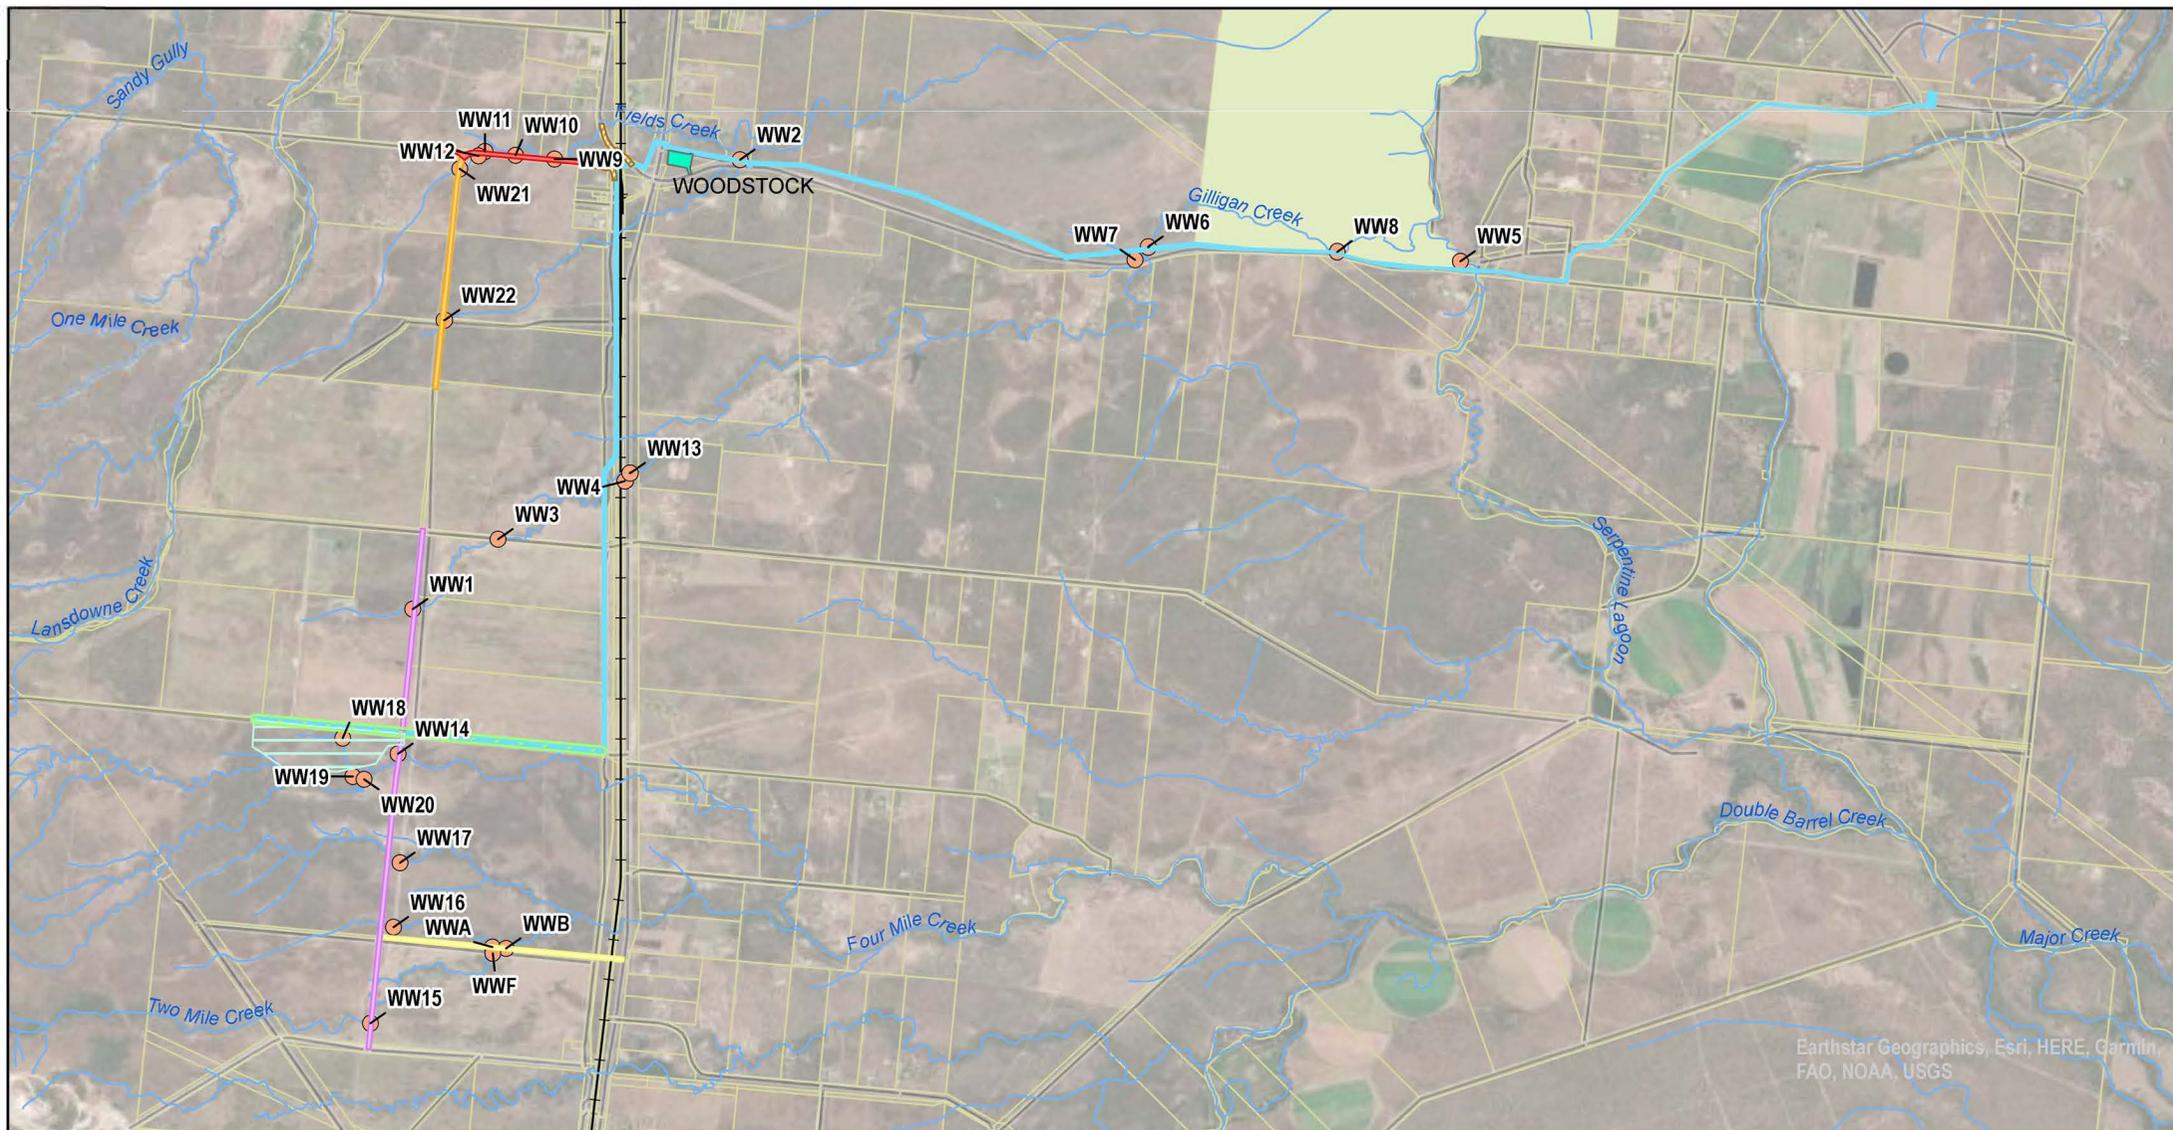
### Figure 1 Waterways Assessment Locations

Assessment of thirty-seven (37) waterway locations within the Project area were conducted using the four criteria above along with any other distinguishable features. Waterway assessment locations are shown in Figure 1.
