## TOWNSVILLE CITY NATURAL DISASTER RISK MANAGEMENT STUDY

# FORMER THURINGOWA CITY COUNCIL AREA

# **ADDENDUM REPORT**

October 2010

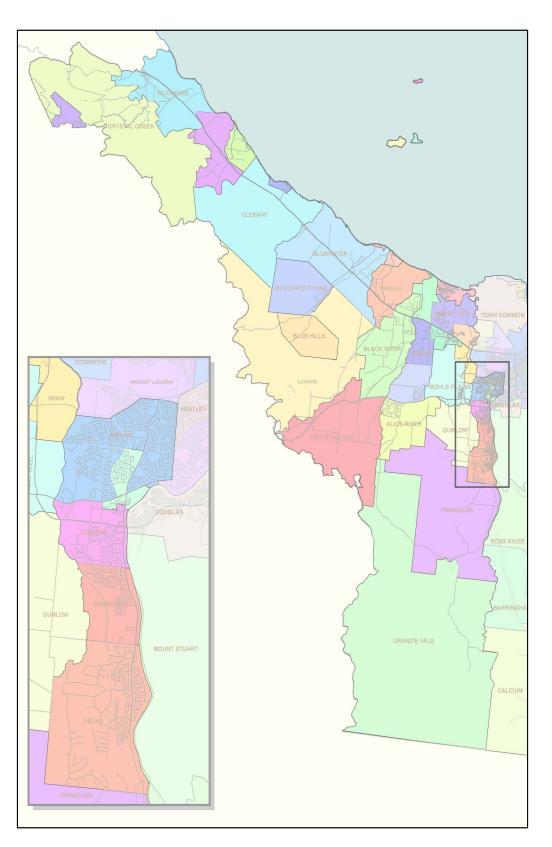
Figure 1.1 Former Thuringowa City

The study area is bounded on the south east by the Bohle River, to the north west by Crystal Creek and to the south west by the mountain ranges of Hervey and Paluma Ranges. The area is shown in fig 1.1 below.

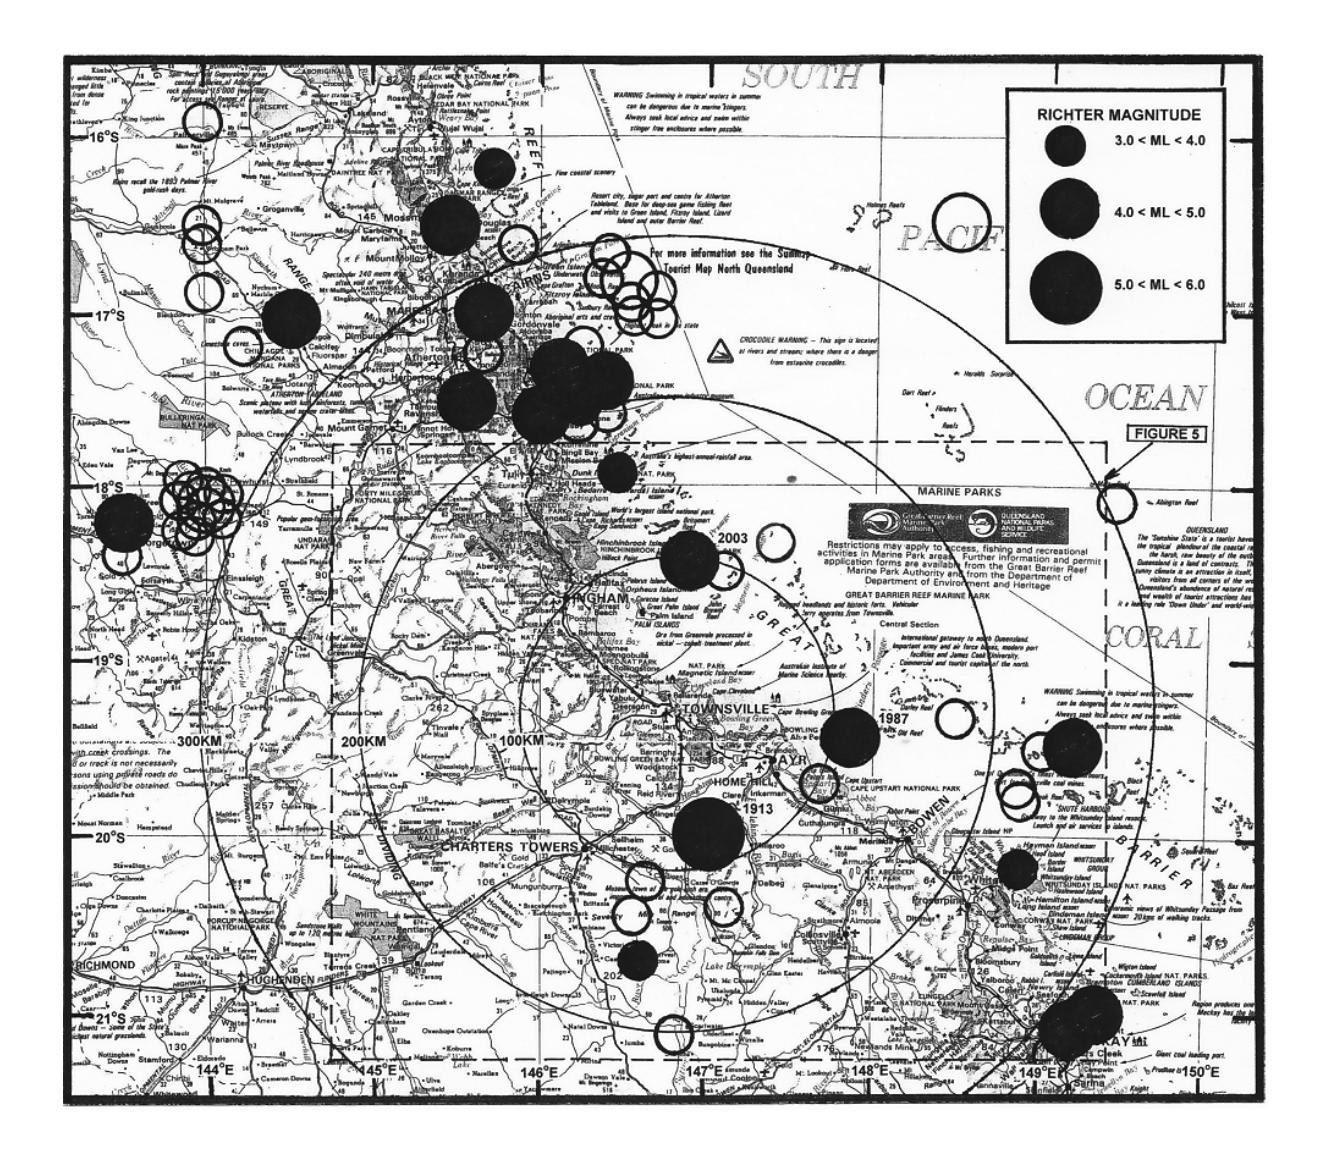
Figure 2.1: Epicentres Of Earthquakes With MI >3.0 That Have Occurred In North Queensland

(Epicentral Distances Within 400km From Townsville).

Closed Circles – Earthquakes that affected the populous

Open Circles – Earthquakes with no reported effects

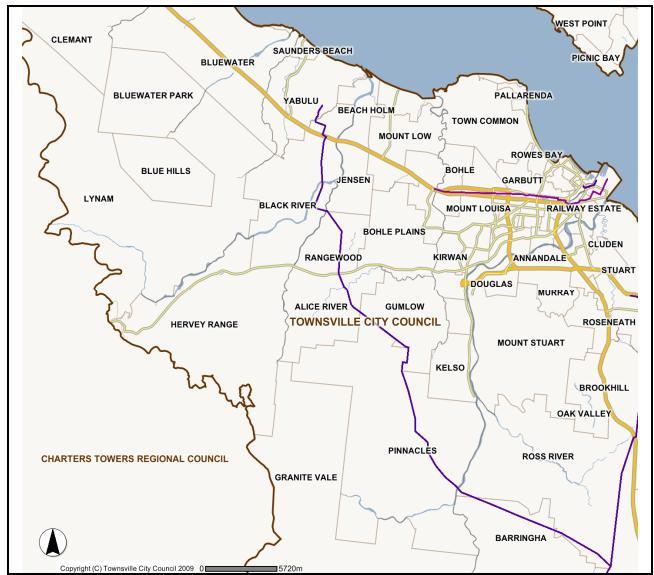
Figure 3.1 Route of natural gas pipeline

A high pressure natural gas pipeline, owned and operated by Chevron Australia, connecting Townsville to the Bowen Basin gas field has also been installed through the rural area. It follows a route to the south of the Ross River Dam then to the north west of the Upper Ross suburbs, following Black River Road and onto Yabulu. The pipeline also supplies the Townsville suburb of Stuart. The approximate length within the former Thuringowa area is 35.3 km. Figure 3.1 below indicated the approximate location of this pipeline. This gas supply is mainly utilised by industry and is owned and operated by Chevron Energy.

With respect to the high pressure **natural gas pipeline**, the supply pipeline is buried for its entire length and where it crosses a water course it has been concrete encased. The pipeline has been design to resist the natural hazards discussed in this study. The biggest risk posed to the pipeline is from an earthquake or accidental rupture by machinery. The pipeline material is polypropylene and is resistant to some differential movement of the earth. The pipeline easement is, at present, clearly marked and the owners are expected to maintain these markers in good order.

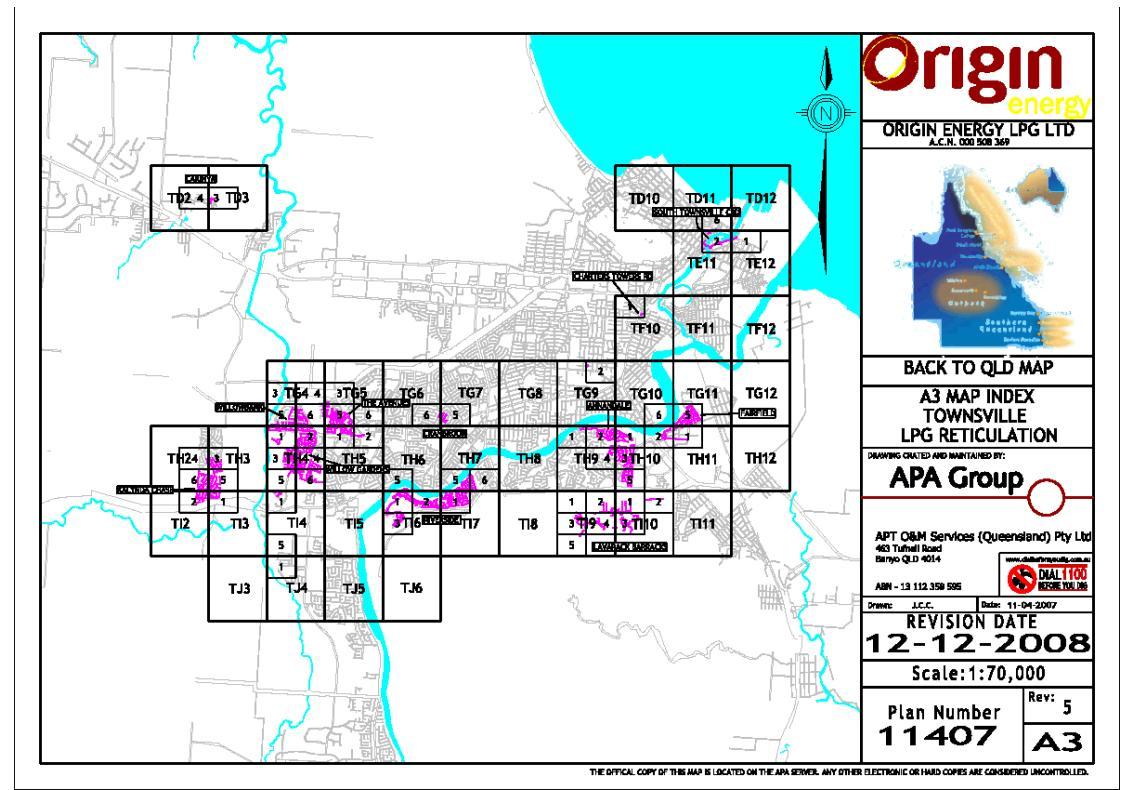
Figure 3.2 Reticulated gas network within Townsville

There is some limited reticulated natural gas supplied to residential areas. This is limited to the newer suburbs and is generally supplied via holding tanks within each suburb. Origin Energy operates and maintains this network. The following figure 3.2 shows the suburbs with reticulated gas and are in the western Kirwan area, Bohle Plains and in the new area of Burdell.

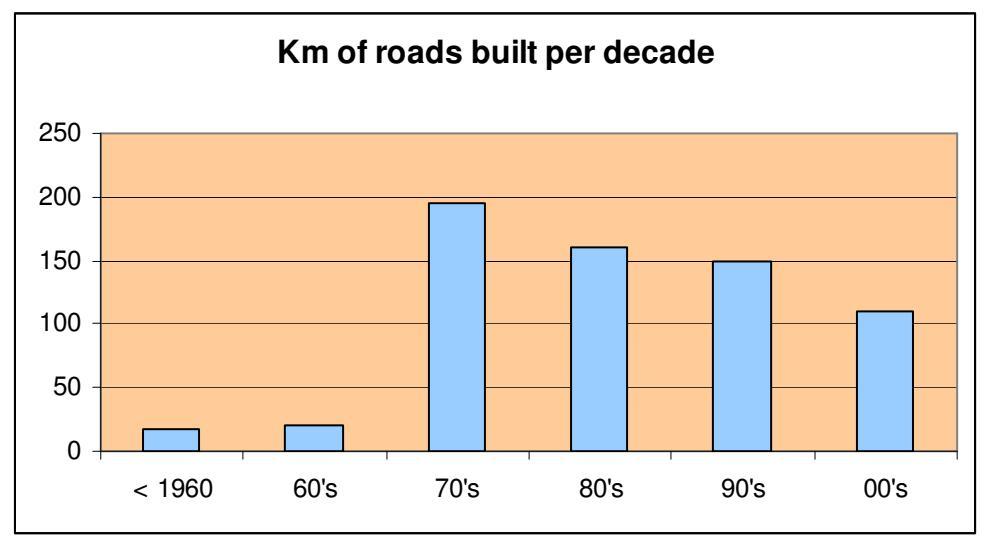
Figure 3.3 Study area development progression

The construction of roads is an integral part of urban development. Figure 3.3 below show the kilometres of roads built each decade. The figure shows that the majority of development has occurred from the 1970's onwards.

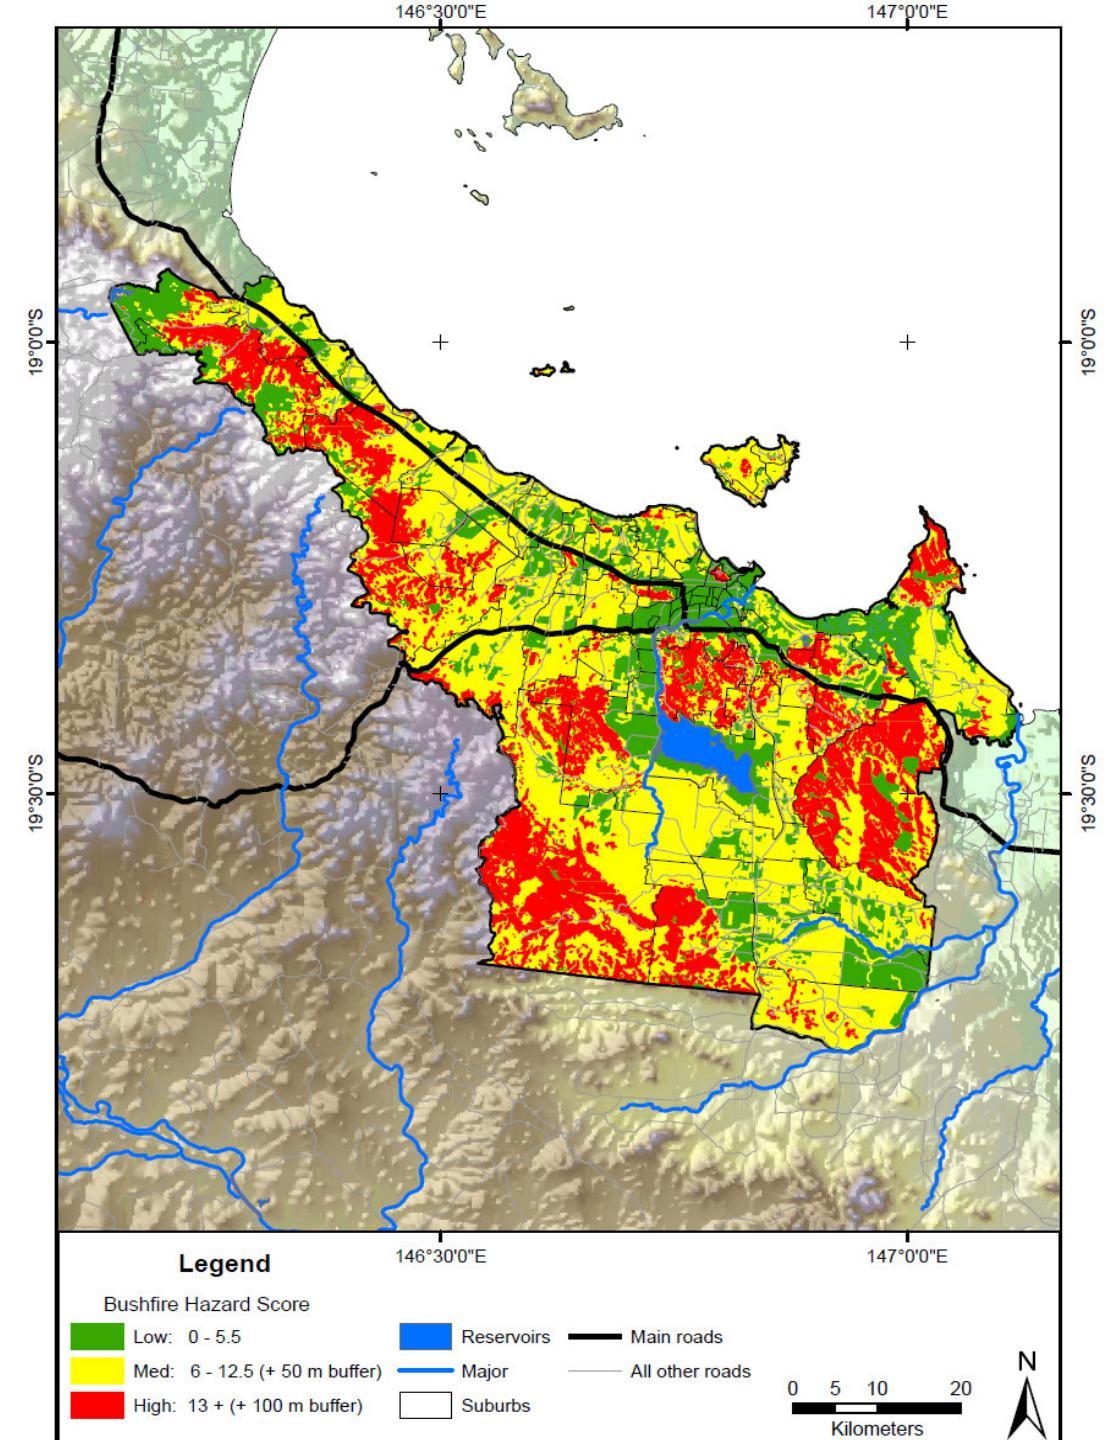
Figure 3.19: Buffered Bushfire Hazard Assessment of the Townsville LGA based on SPP 1/03 methodology

The area shown as high includes a 100 m buffer zone as required by SPP 1/02 and it is noted that there are no Extreme hazard areas within the LGA.

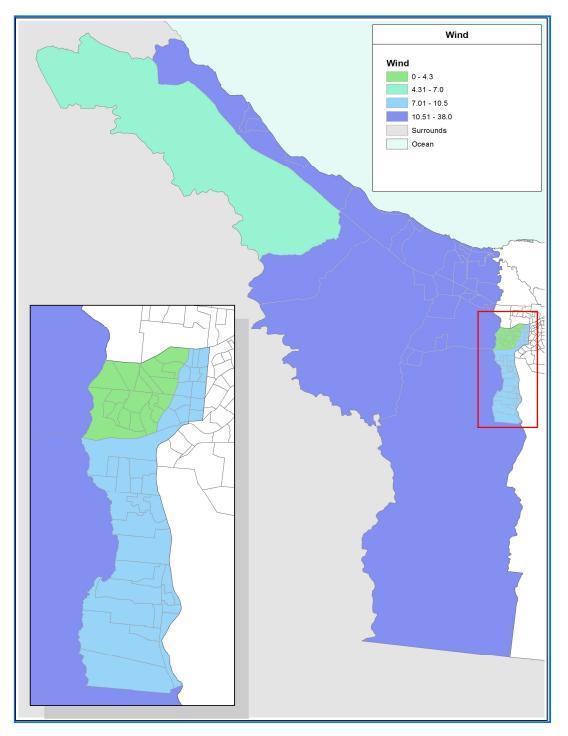
Figure 4.1: Relative wind risk by risk assessment zone

Figure 4.1 and table 4.1 indicated the wind risk index based on the above weightings.

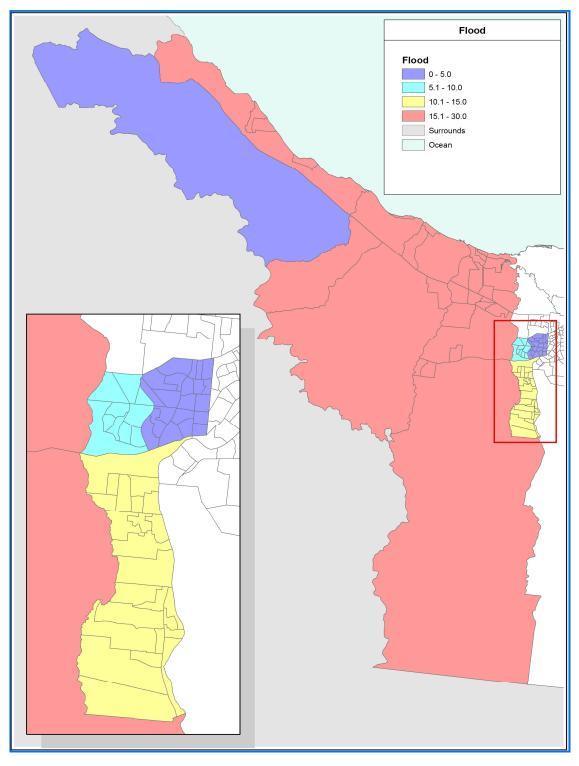
Figure 4.2: Relative flood risk by risk assessment zone

Figure 4.2 and table 4.2 indicated the flood risk index based on the above weightings.

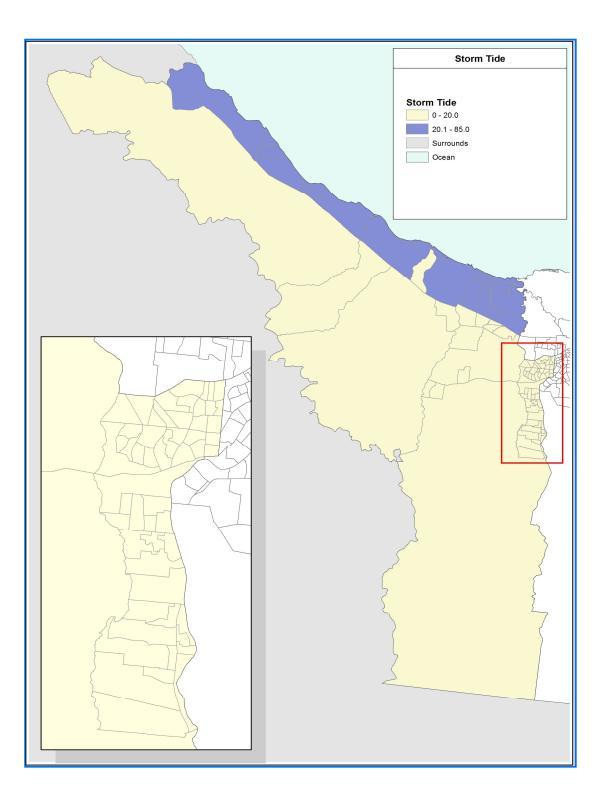
Figure 4.3: Relative Storm Tide risk by risk assessment zone

Figure 4.3 and table 4.3 indicated the storm tide risk index based on the above weightings.

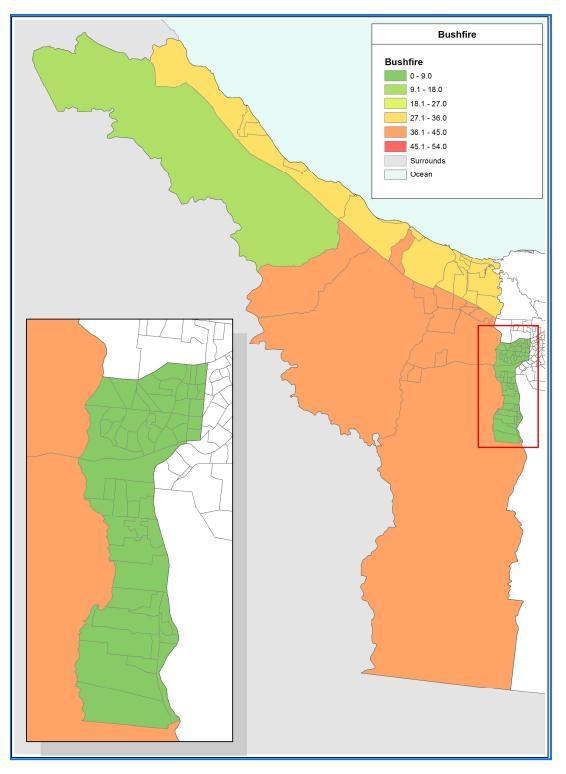
Figure 4.4: Relative Bushfire risk by risk assessment zone

Figure 4.4 and table 4.4 indicated the bushfire risk index based on the above weightings.
