MUNDY CREEK CATCHMENT

Why is Mundy Creek so straight?

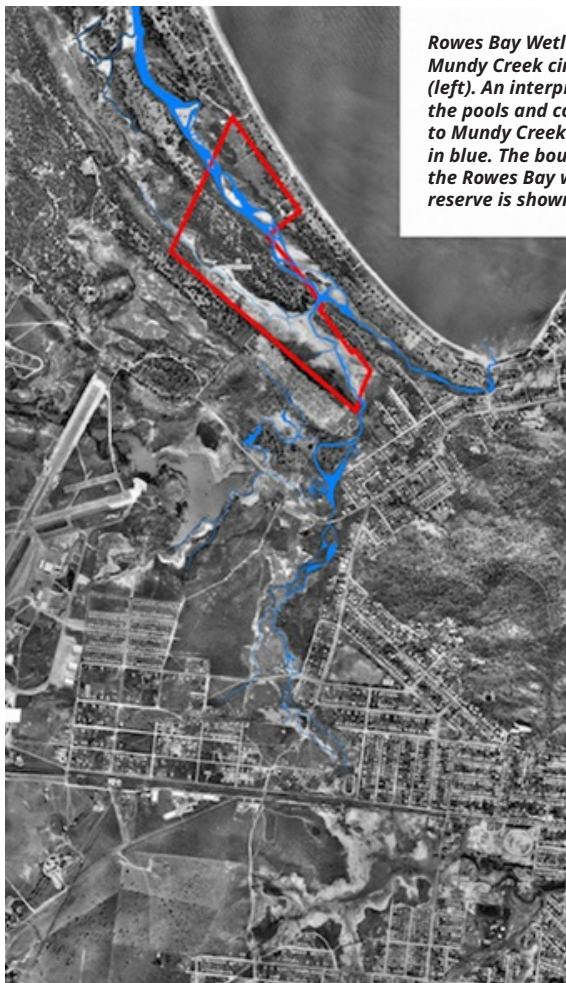
Rows Bay Wetland and Mundy Creek circa 1941 (left). An interpretation of the pools and connections to Mundy Creek are shown in blue. The boundary of the Rows Bay wetland reserve is shown in red.

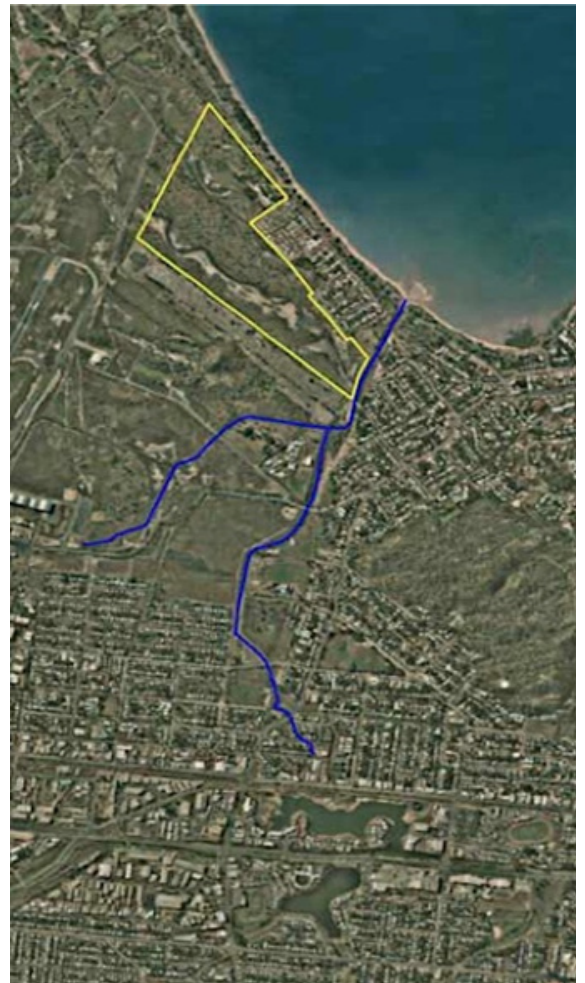
As seen in this 2009 image (right) Mundy Creek (shown in blue) bears little resemblance to the original waterway in the 1941 image (left). The boundary to Rows Bay wetland reserve is shown in yellow.

The natural creek line disappeared in 1968 when the new, man-made Mundy Creek that enters Rows Bay near the caravan park was formed. What is currently Primrose Street was once part of Mundy Creek catchment. After the Town Common drainage scheme was completed in 1968 the string of waterholes was reformed into the drainage channels that exist today.
